Damage Tolerance vs. Durability: Analysis for Sustainment of T-38 Aircraft

T-38 Structural Integrity
and Analysis Section

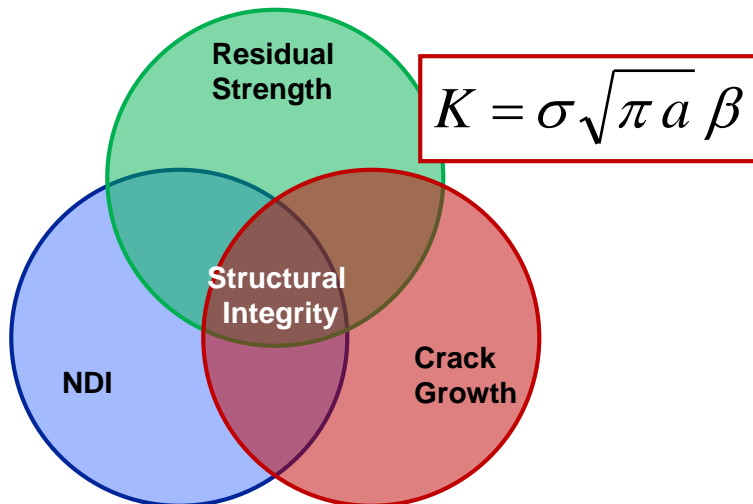
Damage Tolerance

- Rogue flaw
- Inspection
- Fracture mechanics approach

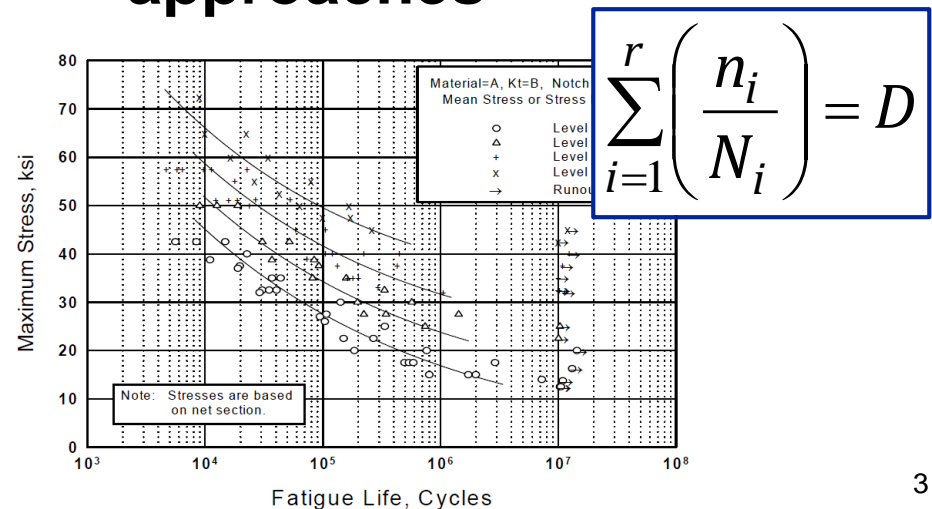
Durability

- No rogue flaw
- Remove and replace or retire (safe-life)
- Stress life, strain life, fracture mechanics approaches

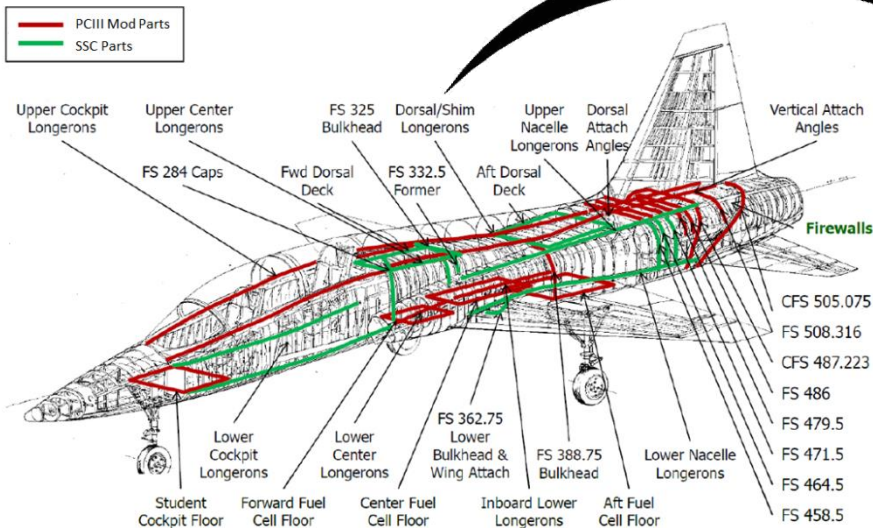
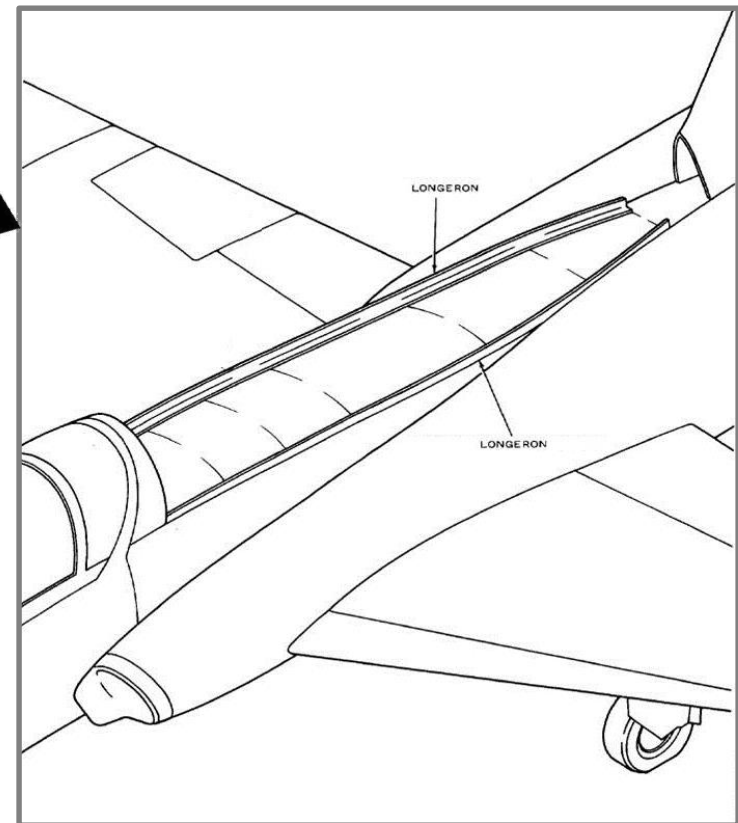
■ Pacer Classic III

- Structural modification
- Longerons, floors, frames, etc

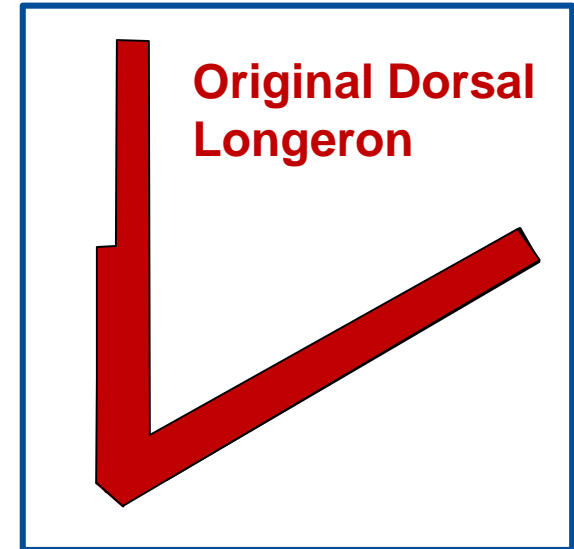
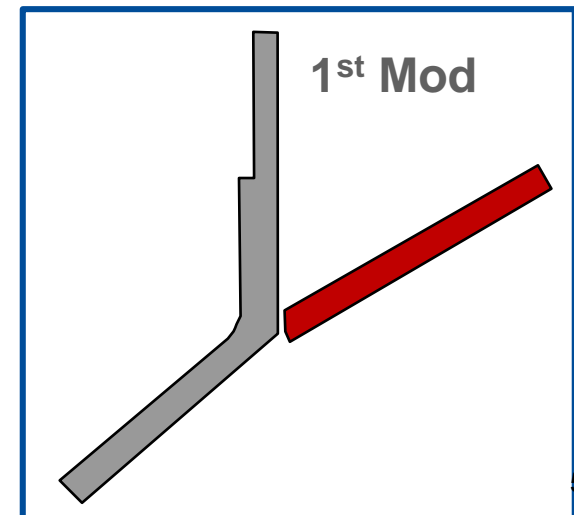
■ Original Dorsal Longeron

- Length is ~13 ft
- 300+ fasteners
- 20+ years

■ 1st Modification

- Recommended from first T-38 DTA
- Sized to take all longeron load
- Remnant remained (secondary)
- 20+ years

(Sketches not to scale)

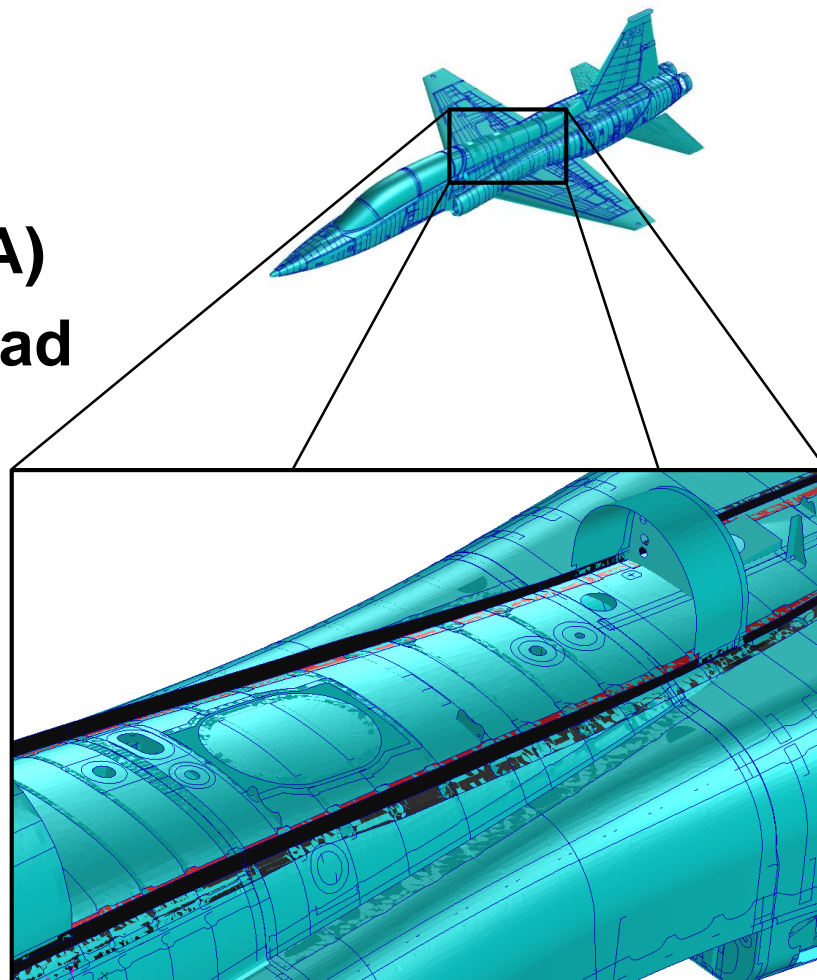
- **Remnant Included in:**
 - Fuselage fatigue test
 - Current models (FEA, DTA)
 - 1st mod doesn't take all load
 - Inspection intervals
- **2nd Dorsal Mod**
 - Part Removal Required
- **Loading**
 - 20+ years as primary
 - 20+ years as secondary

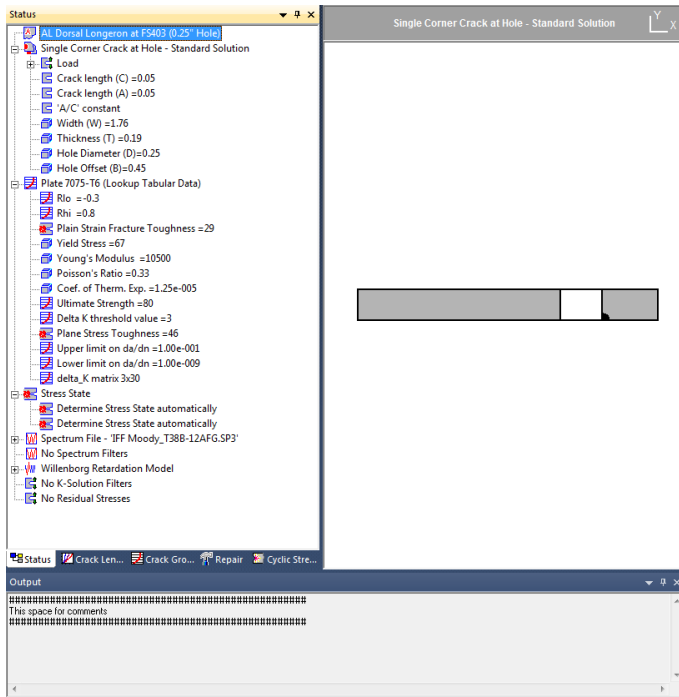
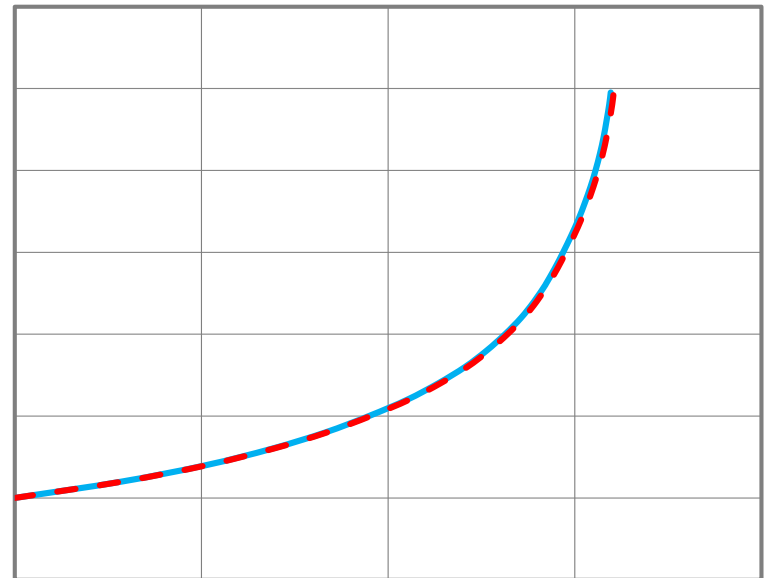
Damage Tolerance Method

■ Material, Loading, Geometry – Same

■ Flaw Sizes

- New IFS = 0.05”

- Bolt hole inspection for old → DFS = IFS = 0.05”

Crack Length

Life

- **BHEC is Feasible on Old During Mod**
- **Old vs New**
 - **Life and inspection intervals the same**
- **DTA Life < Design Service Life**
- **Recurring Inspection not Practical**

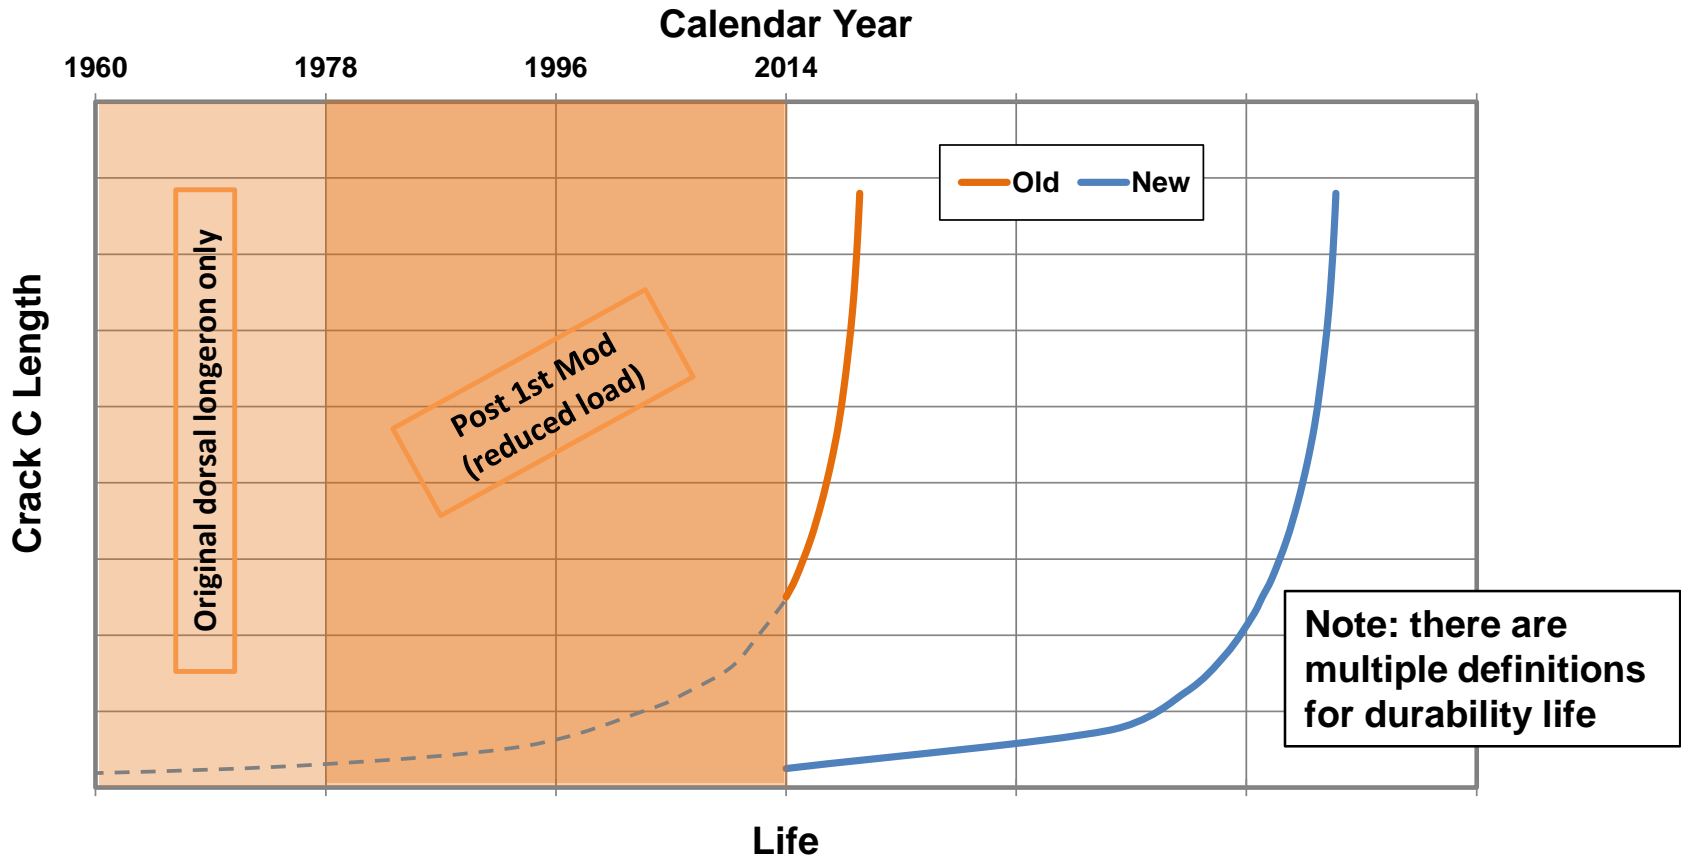
Durability (cont.)

- Durability Life (New = 7×Old) > Service Life

Recommendation: Remove and Replace

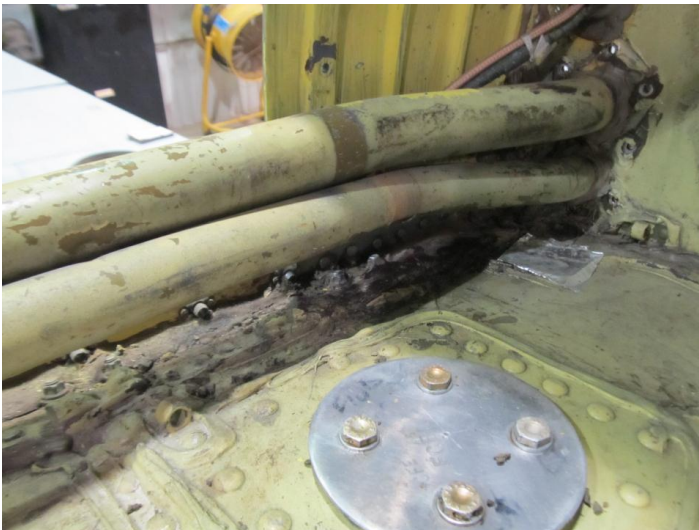
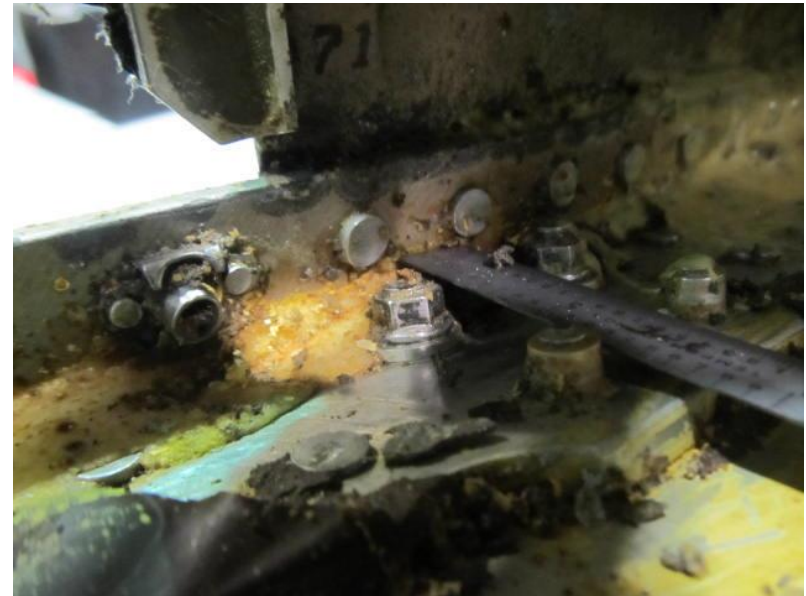
■ Manage using Durability

- Component is not a single load path (fail-safe)
- Future inspection not practical
 - Cost and a_{NDI} vs c_{cr}
 - Sealant removal
 - Limited access

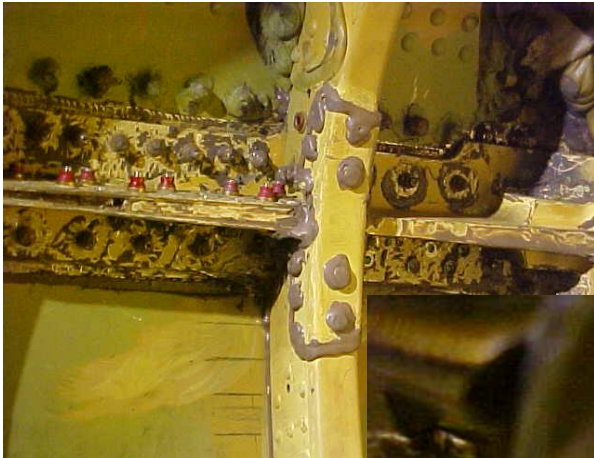
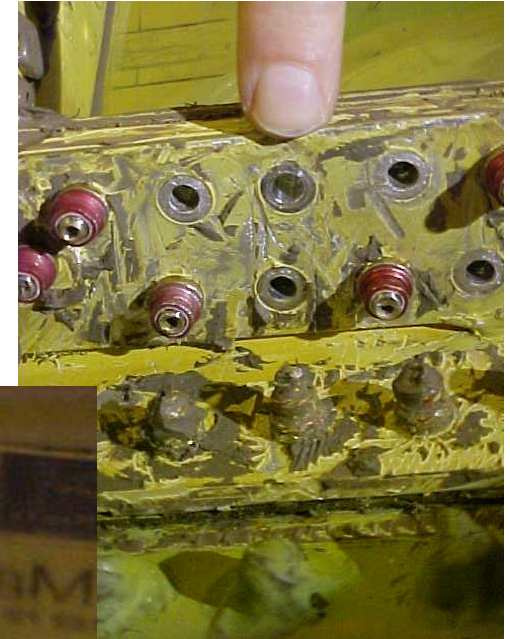
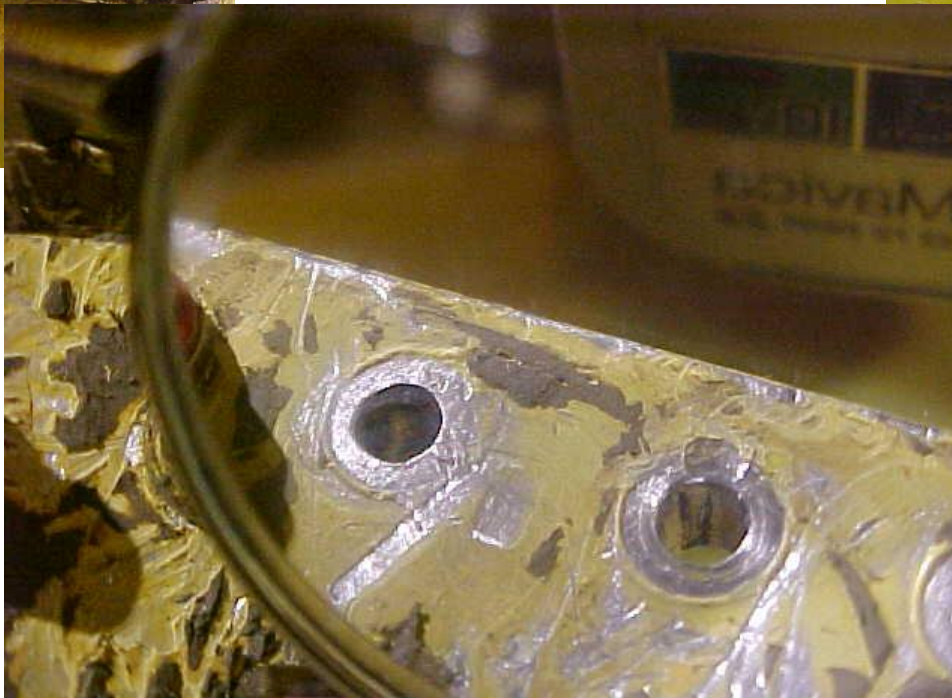
■ Sealant Removal Gone Bad
