A-10 Aft Cowl Cracking Analysis: An Example of Structural Digital Engineering

Brian Boeke
A-10 Structural Analysis, USAF
AFGROW Users Workshop
Sept 12-13, 2023

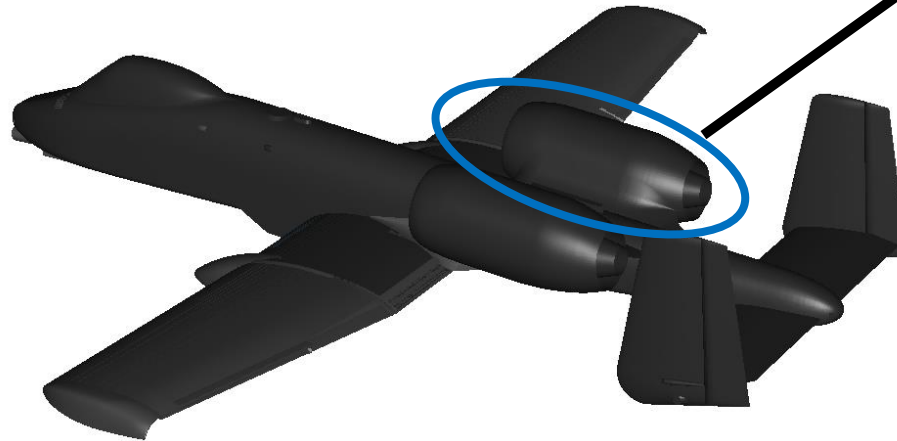
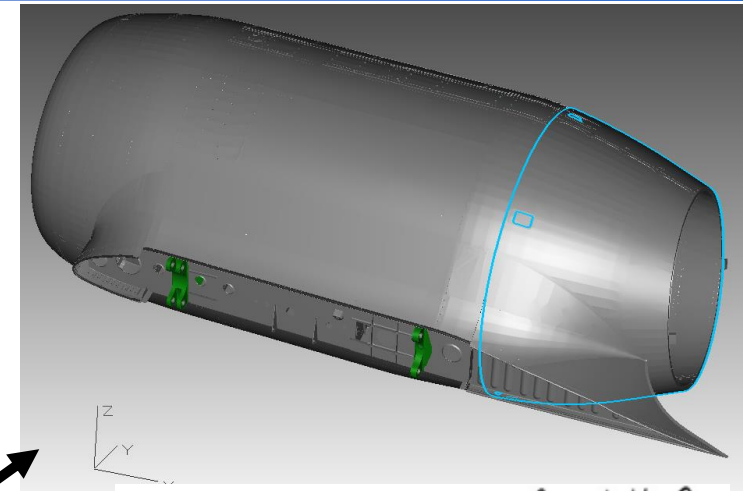
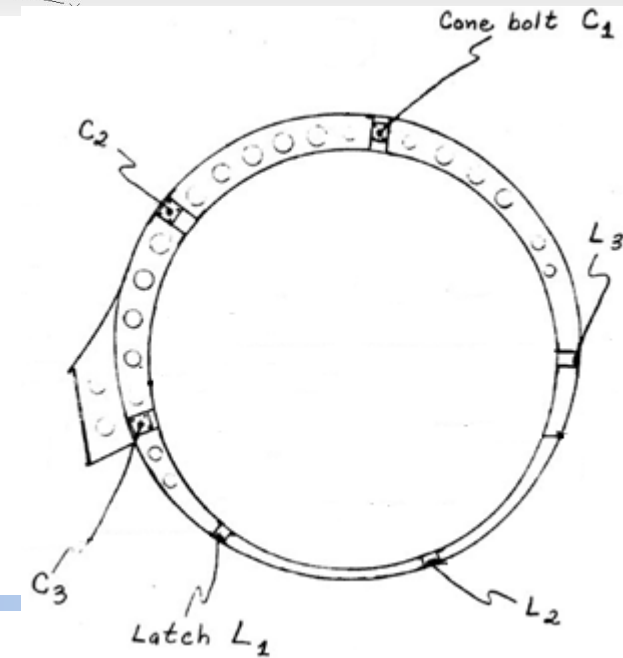
- Fleet inspection TCTO found significant cracking in aft cowl attachment locations
 - Aft cowl attached at 6 points
 - 3 cone fittings
 - 3 latches
 - Cracking located in support fitting and intercostals for cone fittings

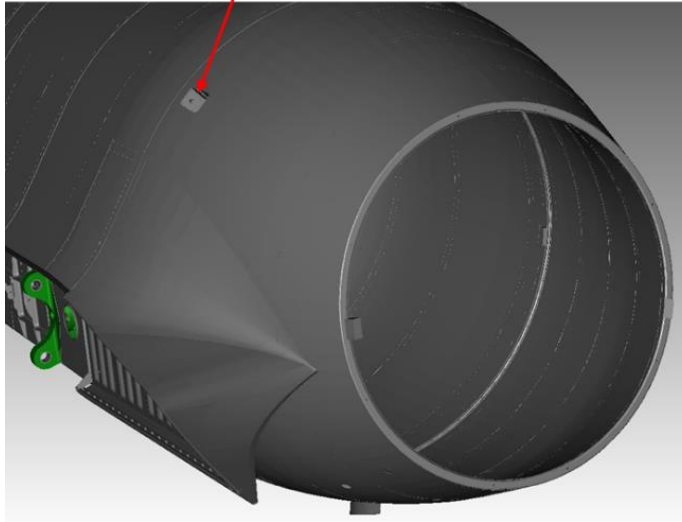
C2 location with cover plate removed

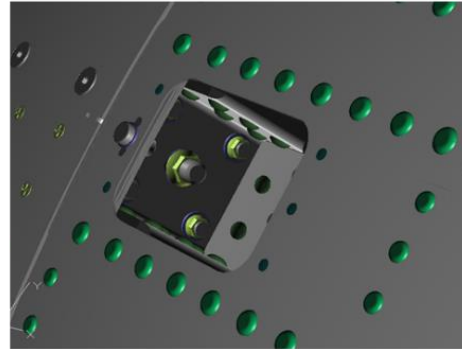
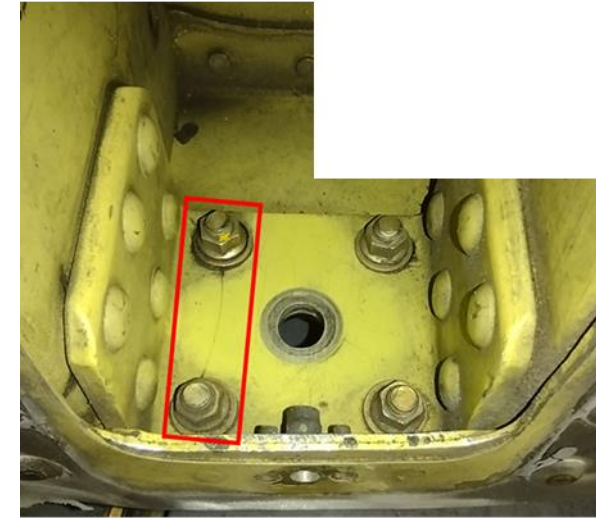
C2 location with cover plate removed close-up

Support Fitting Cracking

Attachment Cone

Support Fitting

Intercostals

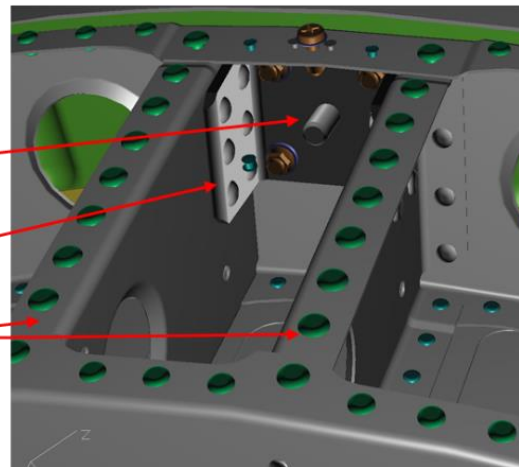
C2 with skin removed

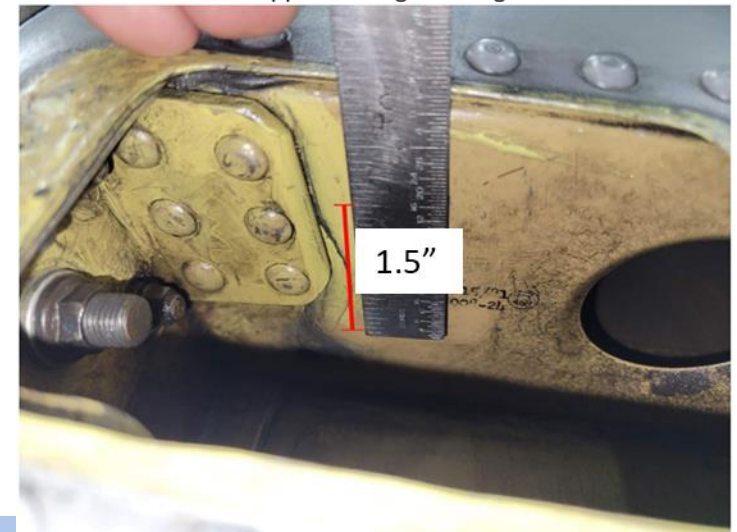
Intercostal Cracking

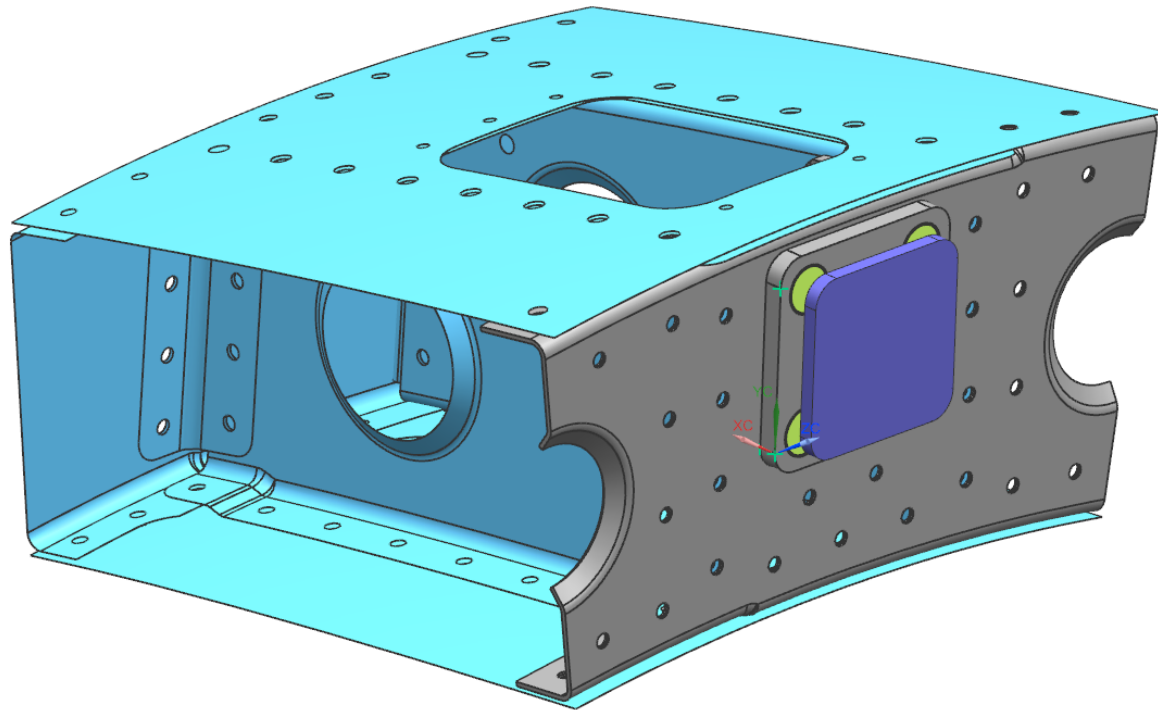
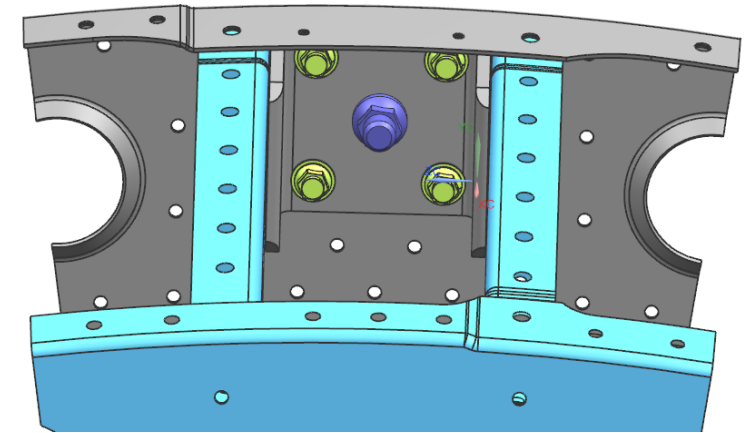
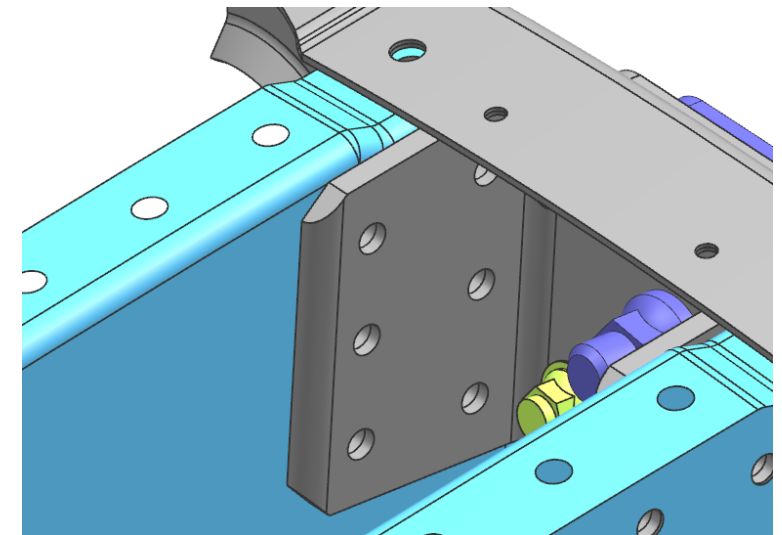
- Created Nastran model to understand reactions to applied load and load redistribution due to cracking
- Existing models enabled quick development

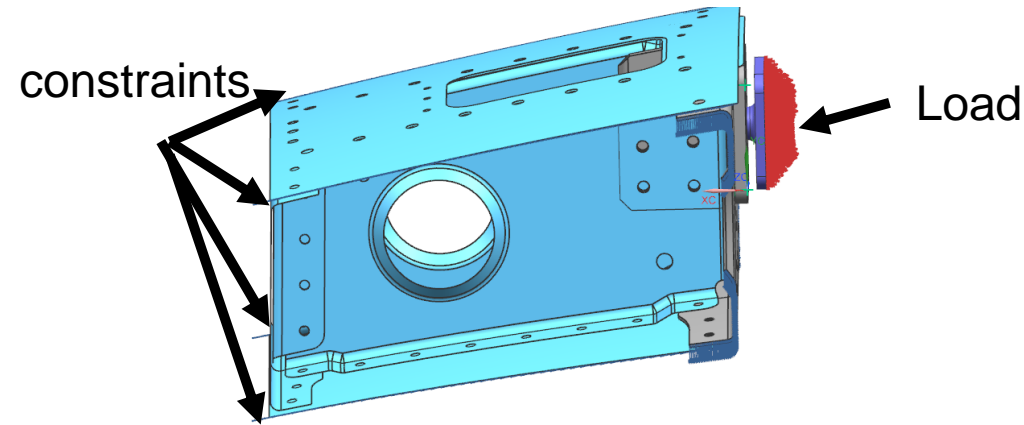
CF_con_nom_1D_2570 lbs : 2900 lbs Result
 Subcase - Static Loads 1, Static Step 1
 Displacement - Nodal, Magnitude
 Min : 0.000, Max : 0.132, Units = in
 Deformation - Displacement - Nodal, Magnitude

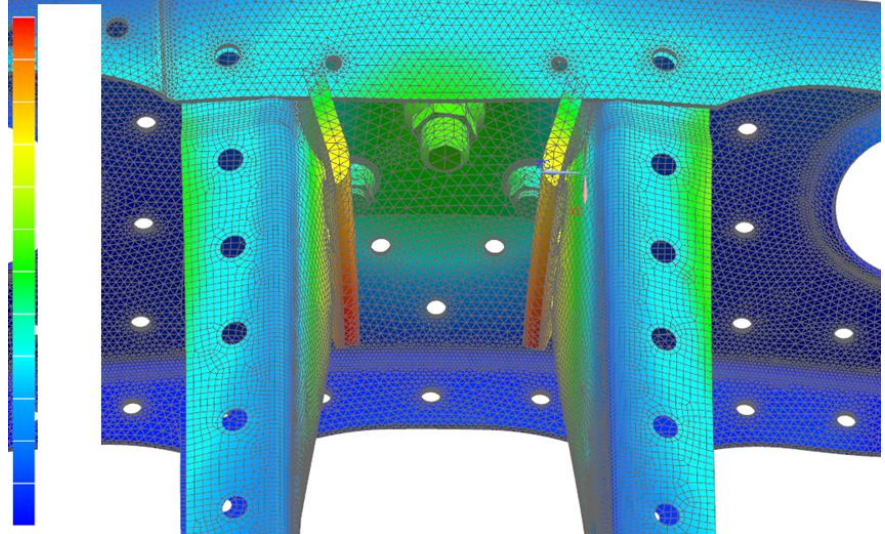
Intercostal Max Principal Stress

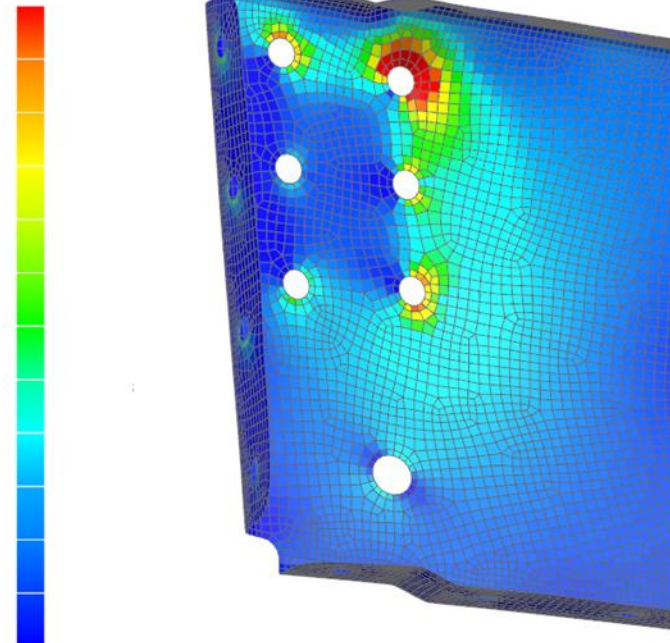
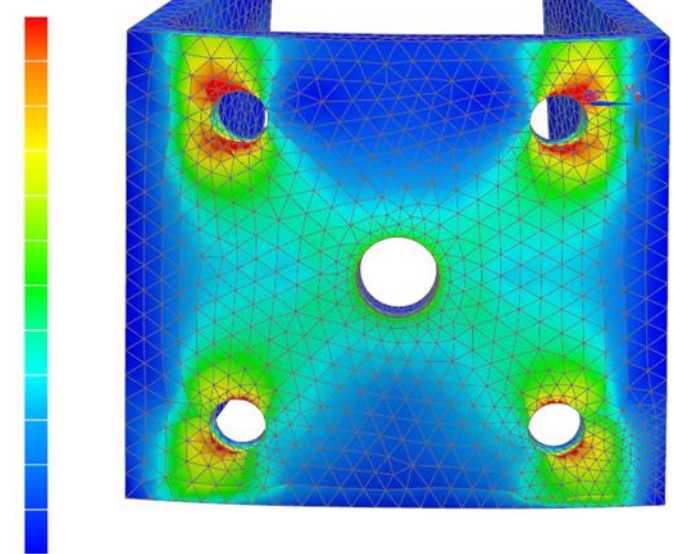
Support Fitting Max Principal Stress

Support Fitting Worst Principal Stress
 (blue is compression, red tension)

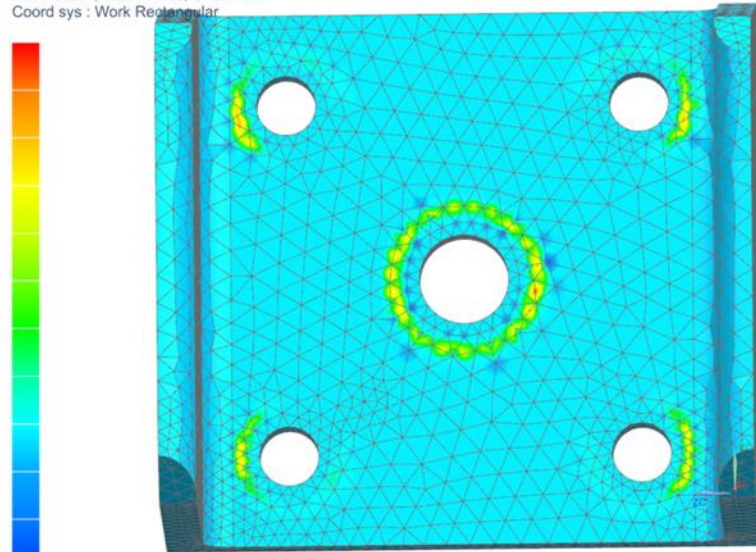
- All exterior grid point forces used as applied load in StressCheck
 - Imported as TLAPs
 - TLAP scale parameter used to scale loads to simulate different applied loads

GP Force on Aft Face

CF_con_nom_1D_2570 lbs : 2900 lbs Result
Subcase - Static Loads 1, Static Step 1
Grid Point Force - Element-Nodal, Sum, X
Min : -33.97, Max : 84.46, Units = lbf
Coord sys : Work Rectangular

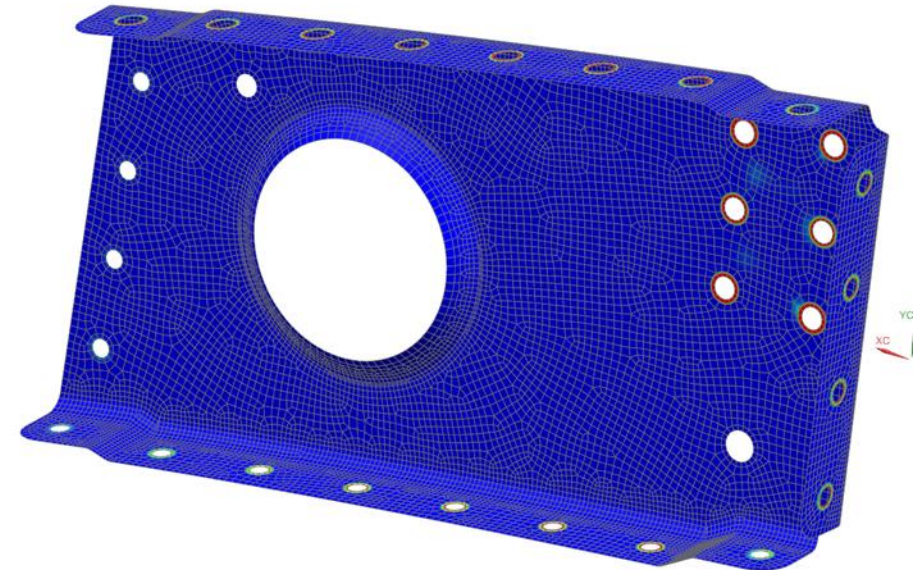
CF_con_nom_1D_2570 lbs : 2900 lbs Result
Subcase - Static Loads 1, Static Step 1
Grid Point Force - Element-Nodal, Sum, Magnitude
Min : 0.00, Max : 25.39, Units = lbf
Coord sys : Work Rectangular

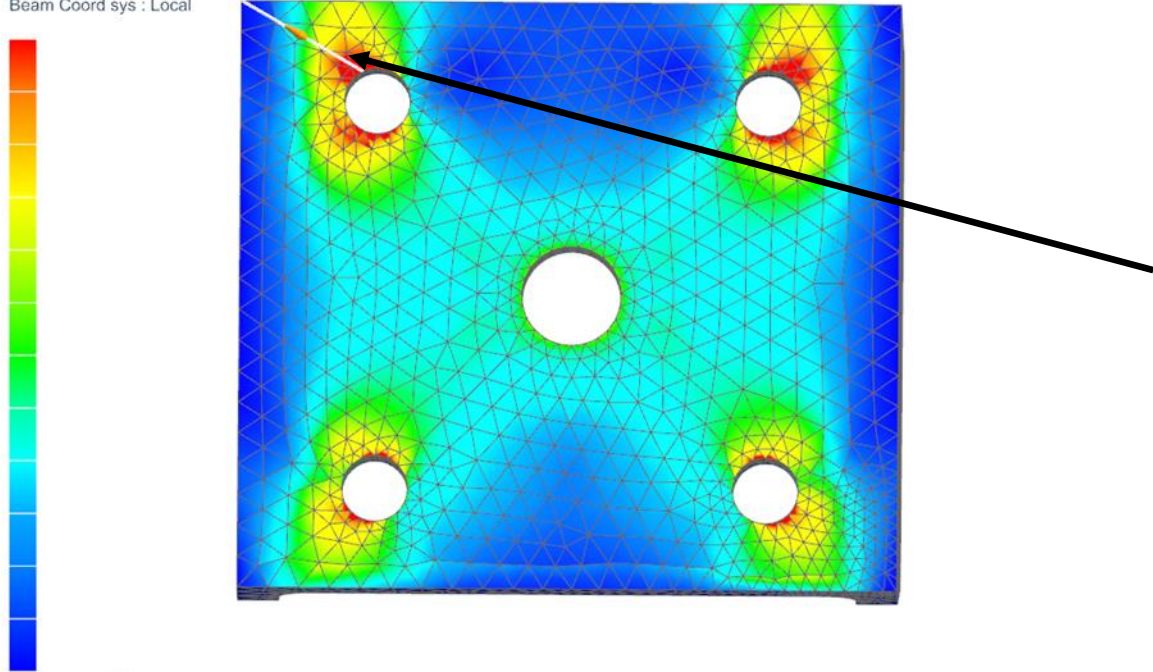
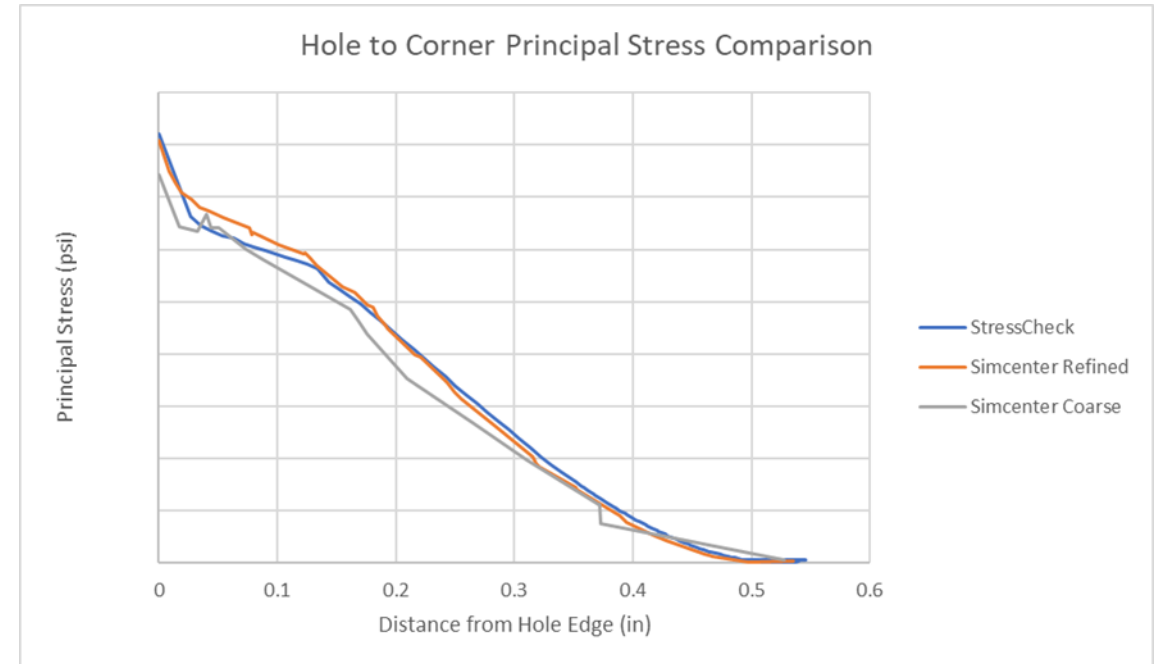
- Stresses along two paths compared to show StressCheck and Simcenter results are equivalent

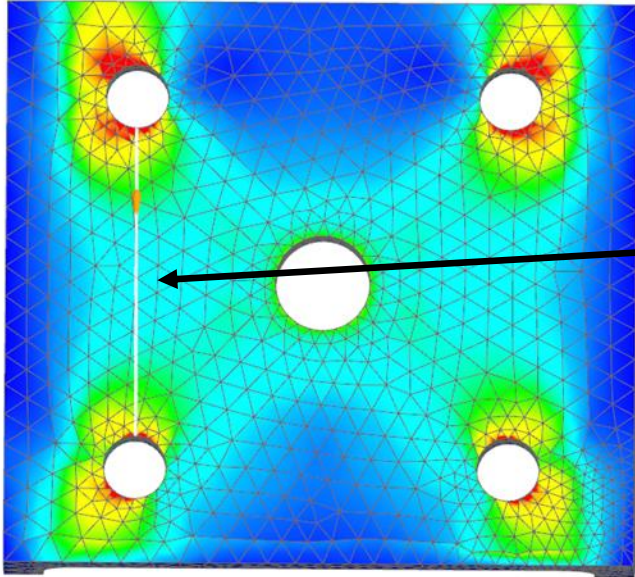
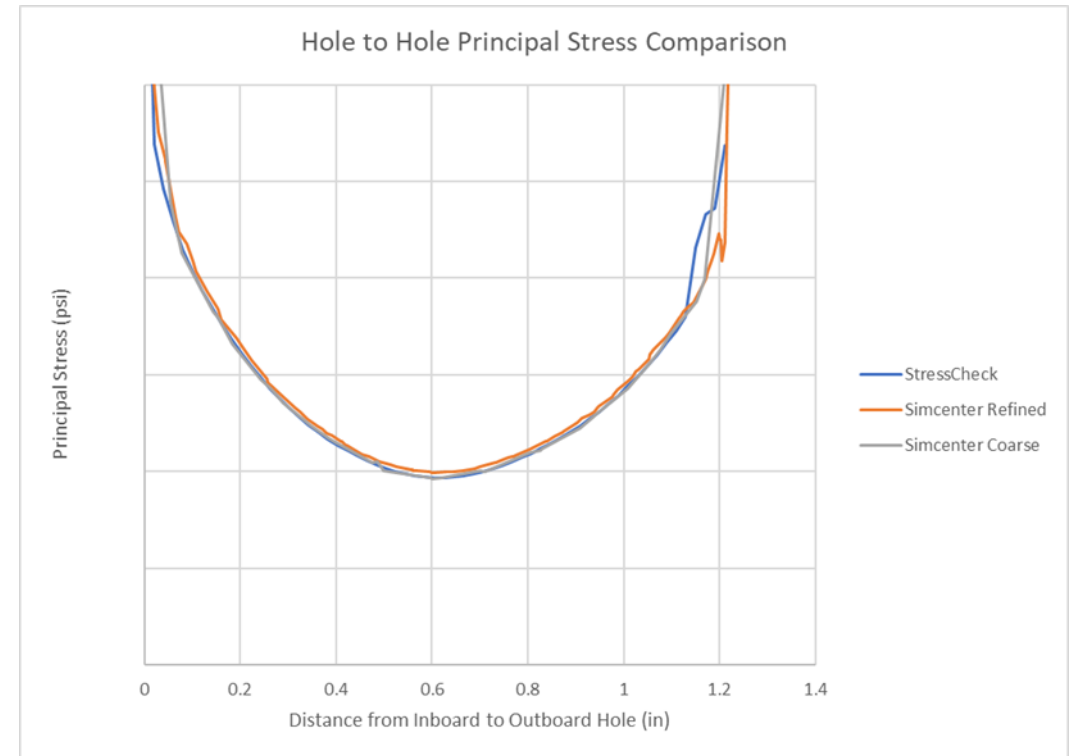
- Stresses along two paths compared to show StressCheck and Simcenter results are equivalent

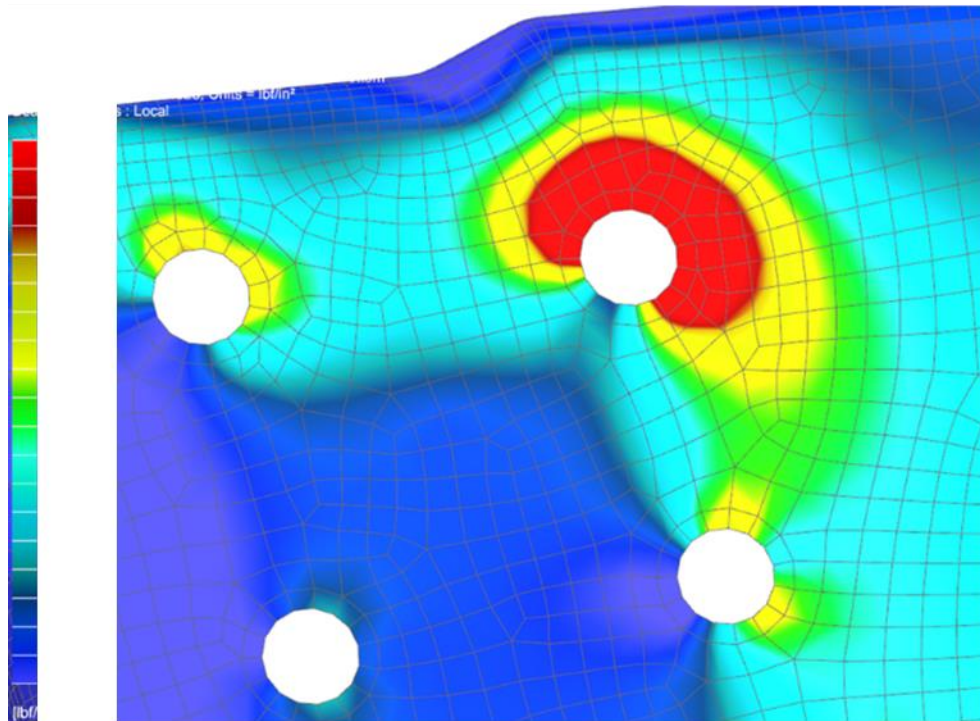
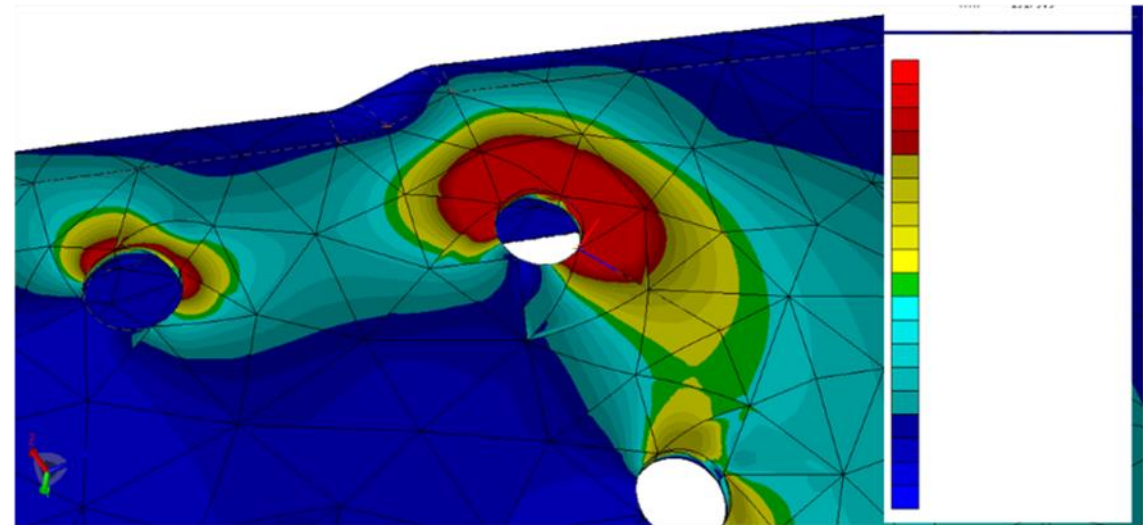
- Same process used for support fitting was applied to intercostal. A simple stress contour comparison completed

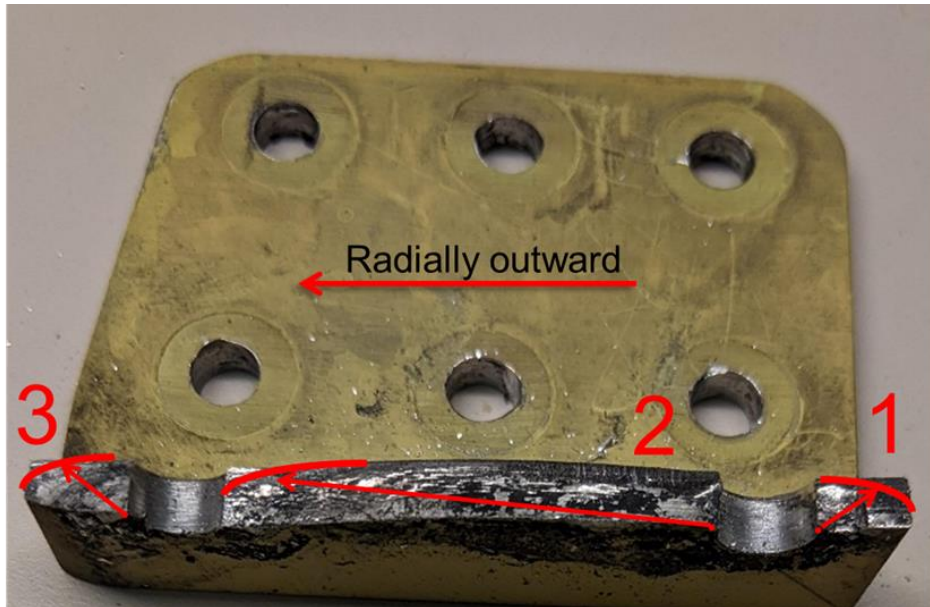
Specimen A

- Three cracked support fittings were used to develop the appropriate load for BAmPF analysis

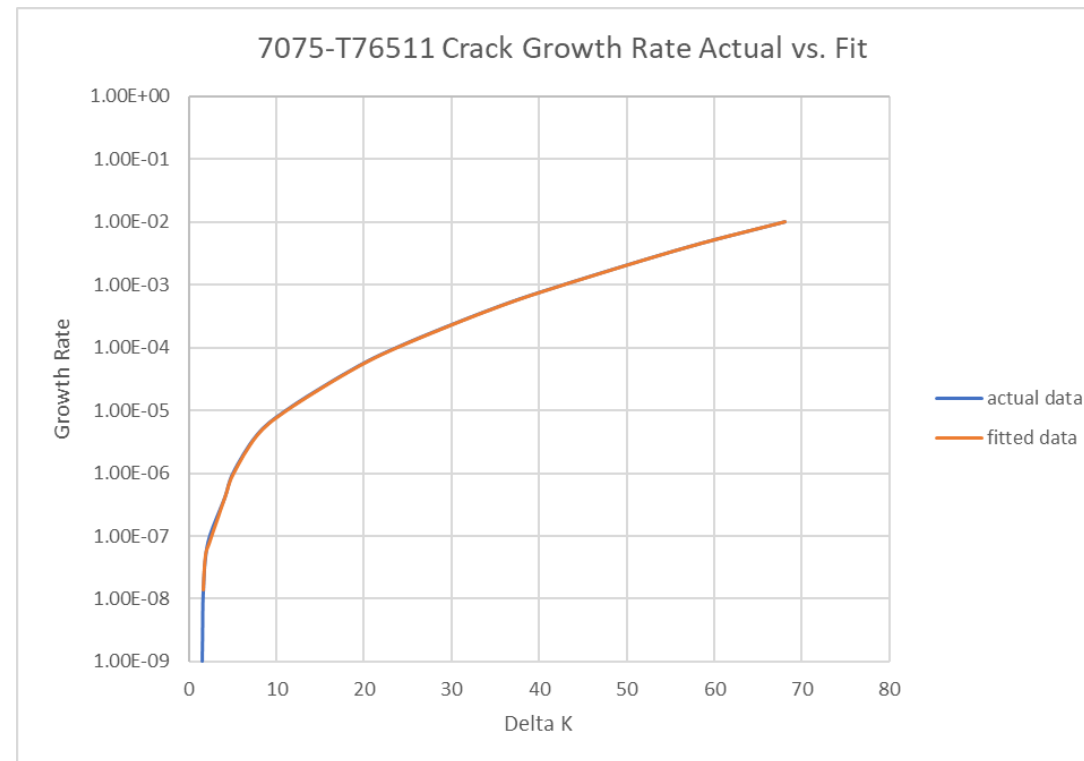
- Used latest 7075-T76511 tabular lookup file for A-10, with $R = 0$
- Created a polynomial fit to tabular data to determine appropriate ΔK for a given crack growth rate

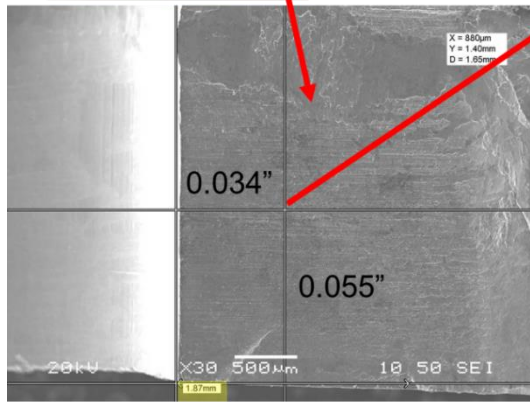
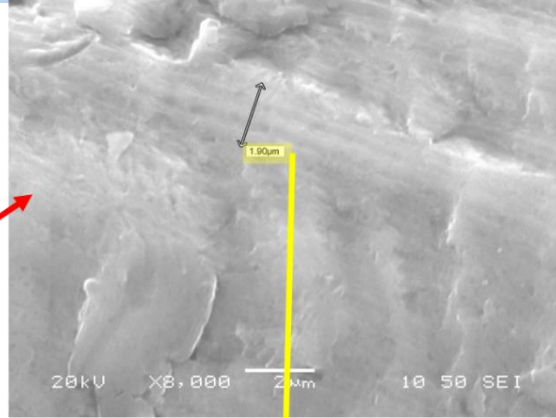
Crack 1
Point 1

4 striations
1.9 μm
 $da/dN = 0.475 \mu\text{m}/\text{cycle}$
 $= 1.87\text{e-}5 \text{ in}/\text{cycle}$

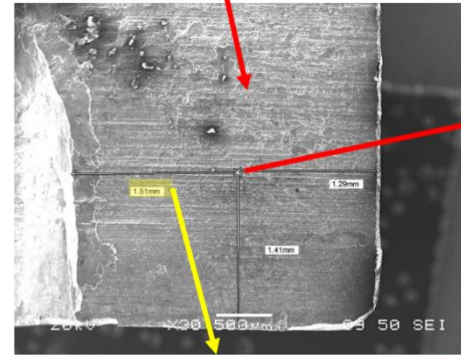
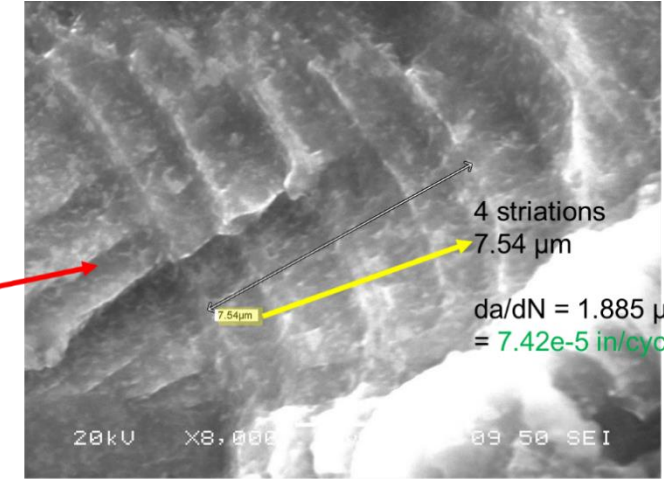
Crack 1
Point 2

$C = 1.51 + 2.81 \text{ mm} = 4.32 \text{ mm}$ from hole edge

4 striations
7.54 μm
 $da/dN = 1.885 \mu\text{m}/\text{cycle}$
 $= 7.42\text{e-}5 \text{ in}/\text{cycle}$

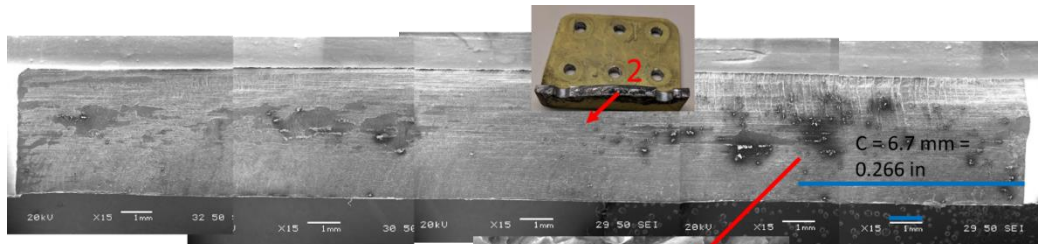
Crack 2
Point 1

7 striations
5.47 μm
 $da/dN = 0.78 \mu\text{m}/\text{cycle} = 3.07\text{e-}5 \text{ in}/\text{cycle}$

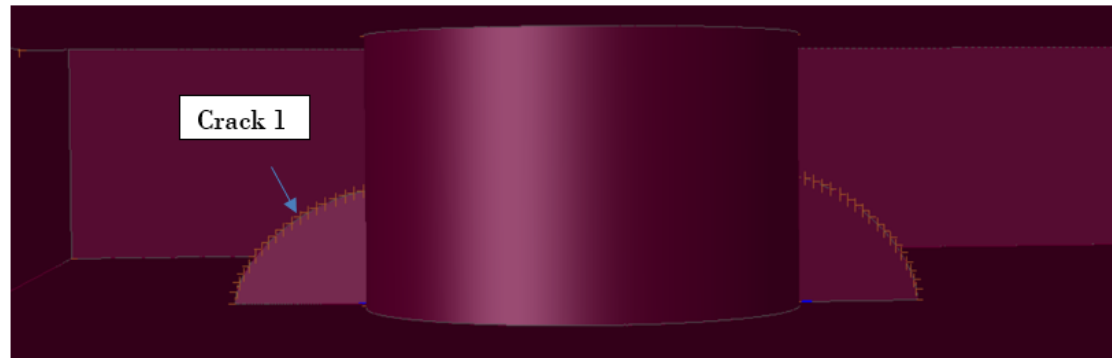
Crack 1 Point 1

- BAmP was used to allow cracks to evolve based on the loading imported from Simcenter
- Measurement correlation model created from nearest iteration with crack front growing through desired point
- StressCheck model geometry modified to better match specimen

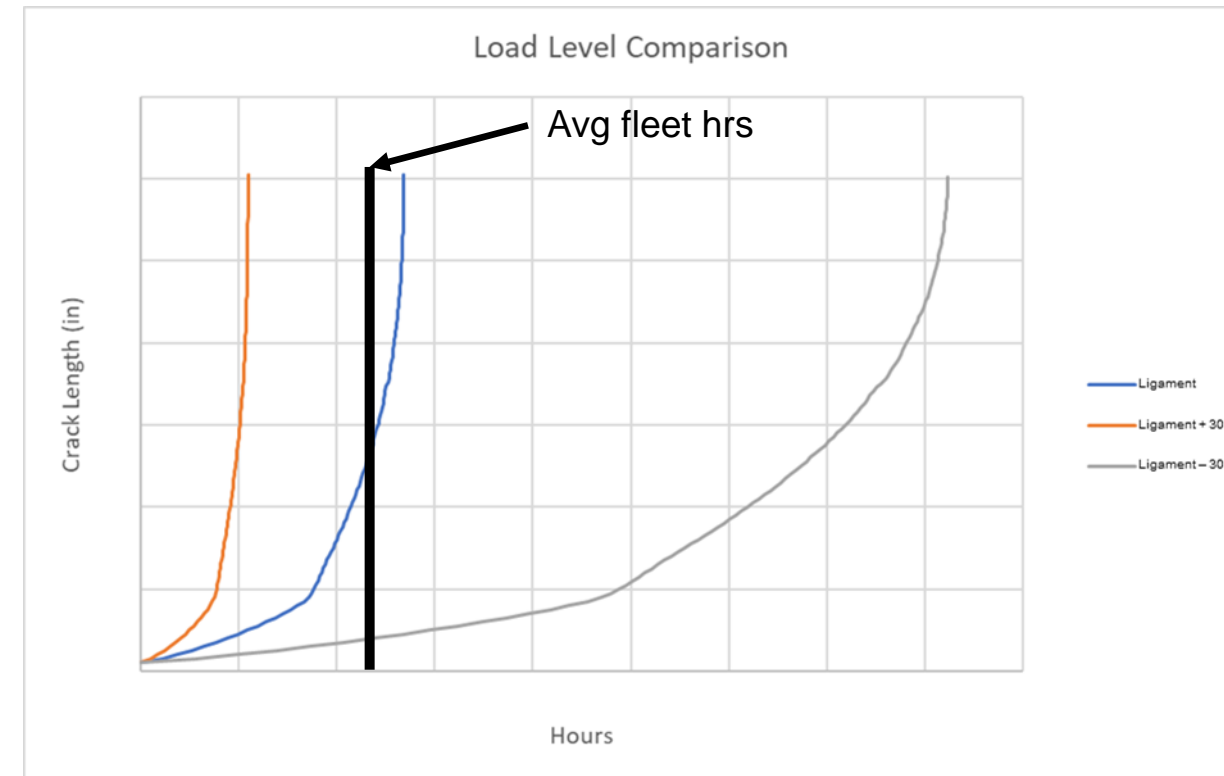
- Ligament points correlated well together
- Center crack points showed + or - 30%
- AFGROW model developed using BAMpF betas
 - Quickly compare load levels to fleet life
- IFS = 0.02 – stable in BAMpF
- Ligament load compared best to fleet experience

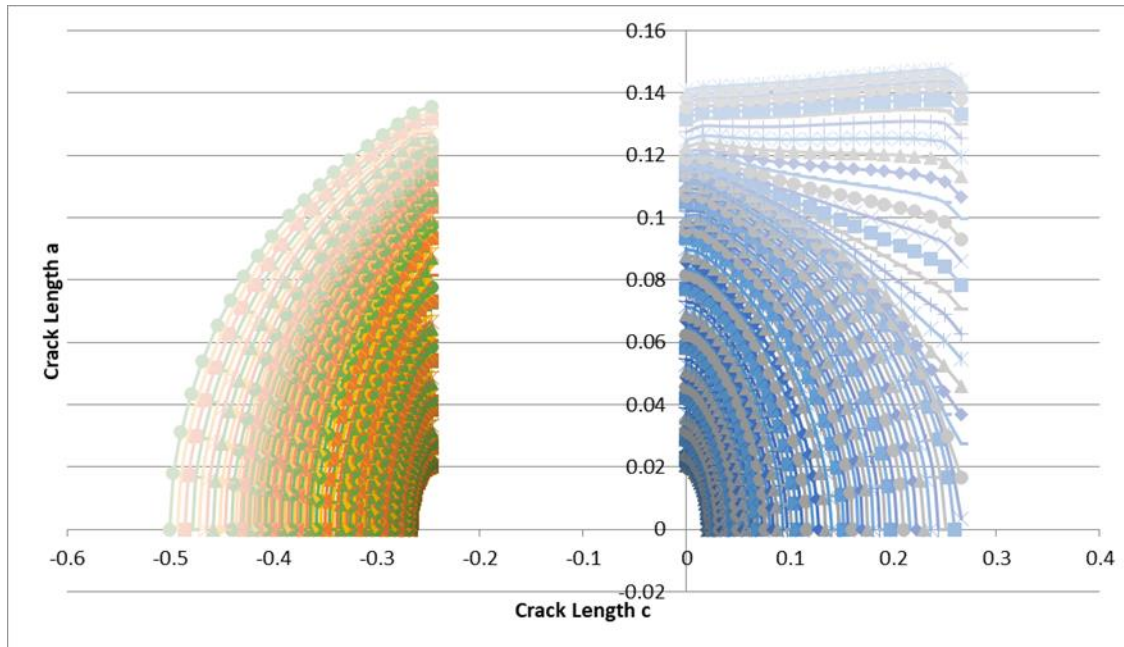
Phase 1 Crack Evolution

- Phase 1: two cracks from inboard hole
- Phase 2: inboard ligament severed, crack 2 grows toward opposite hole

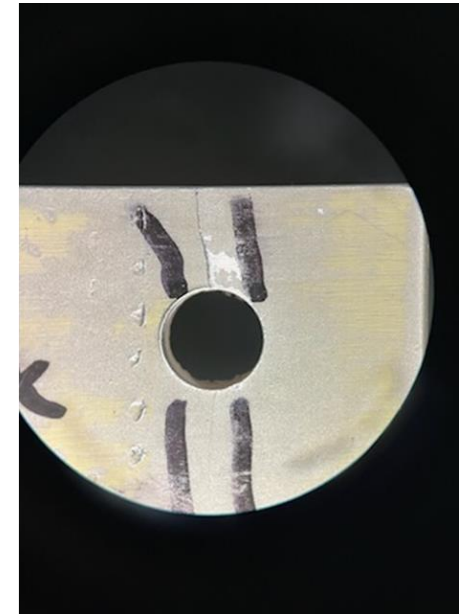
Observed Cracking

View looking aft at fwd face

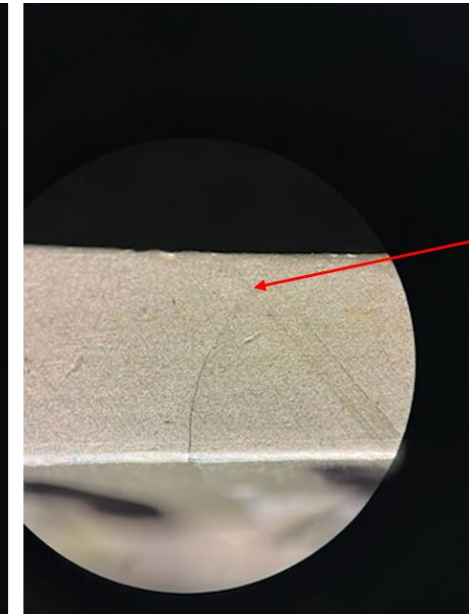
Hasn't broken through to aft face

View looking inbd edge of support fitting

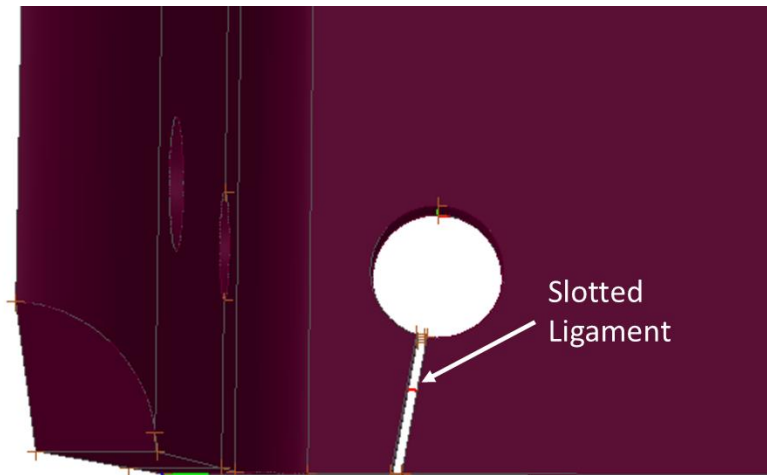
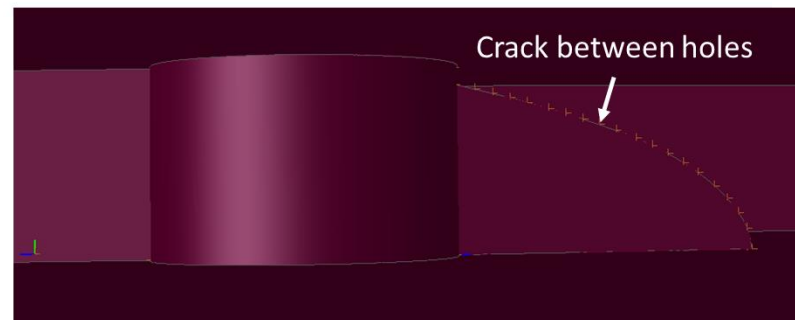
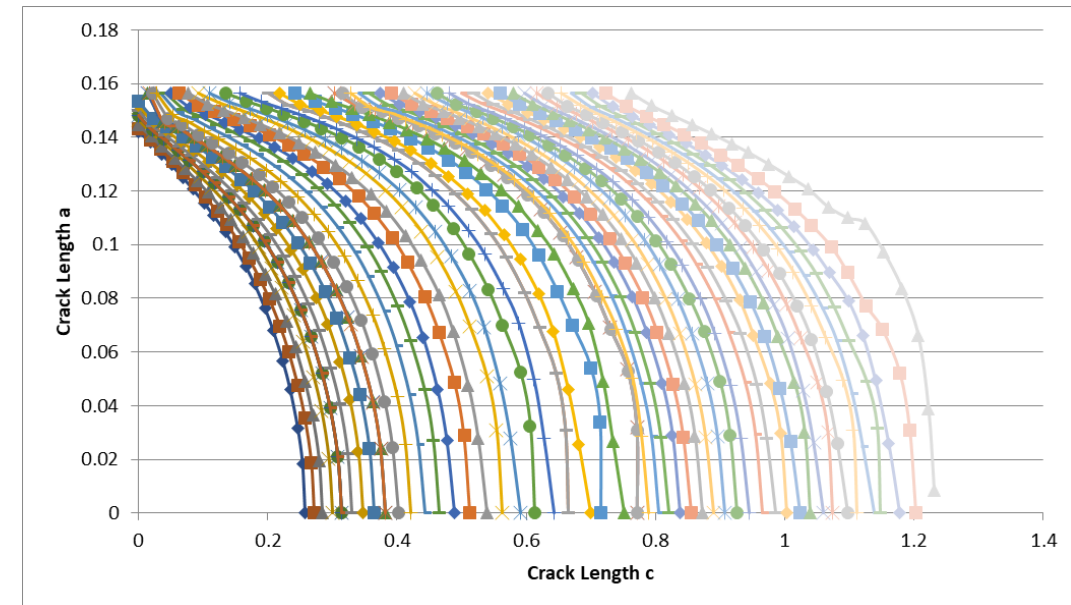
- Phase 2: crack 2 started at size from phase 1 where crack 1 broke through 95% of thickness

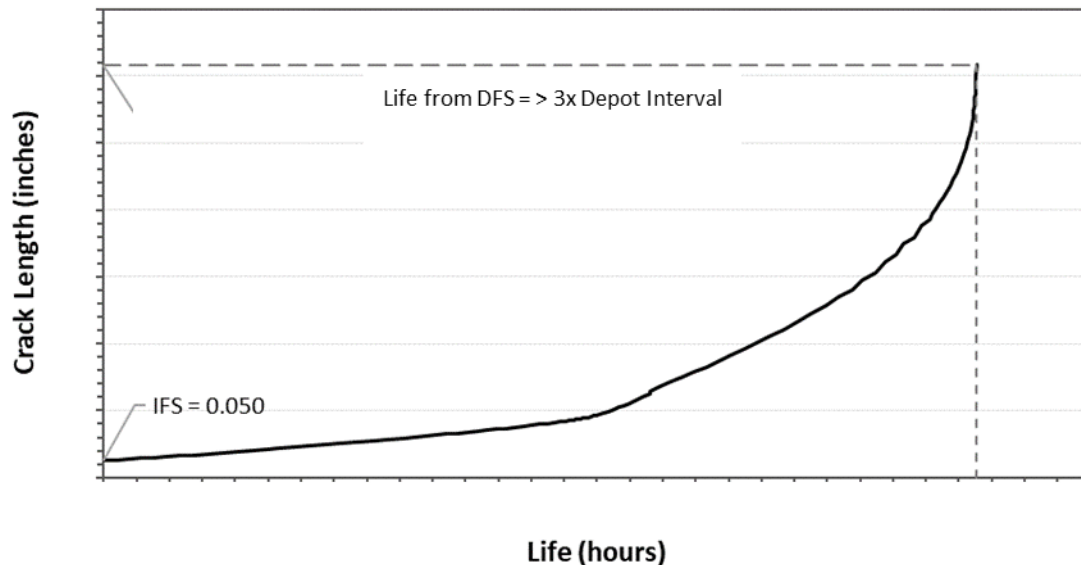
Crack 2 CGC, 0.05" DFS

■ Final crack growth curve based on crack 2 (center crack)

- 0.05" DFS for depot level BHEC inspection

- Based upon measurement of 15 support fitting cracks on fwd and aft faces. Showed cracks longer than 0.5" broke through aft face and were detectable

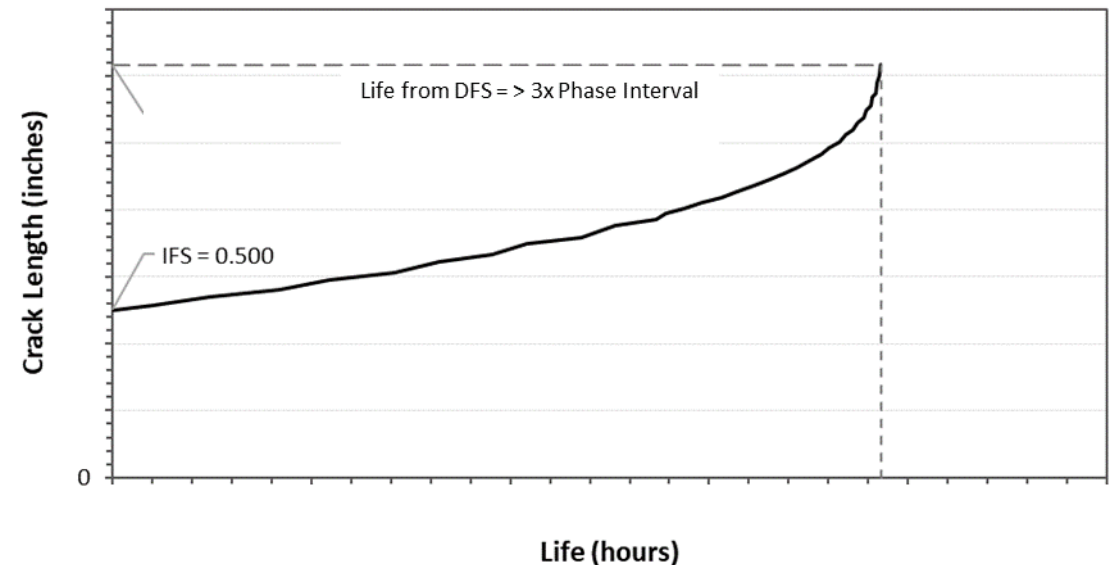
Crack 2 CGC, 0.5" DFS

- 0.5" DFS for SEC inspection in field

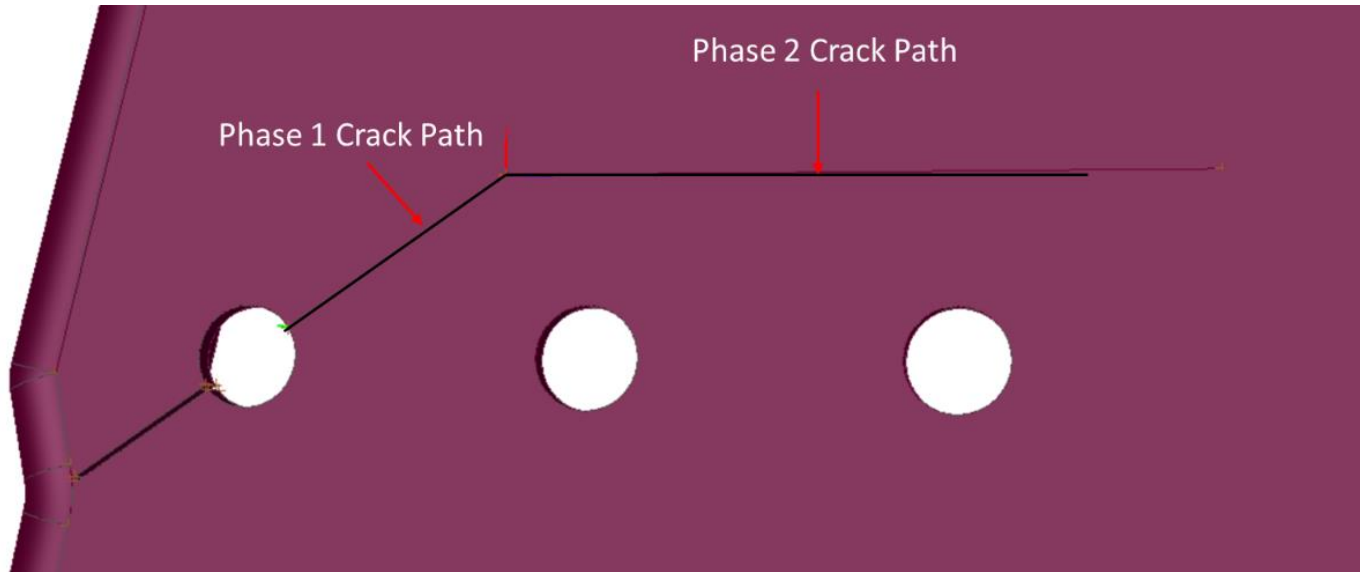
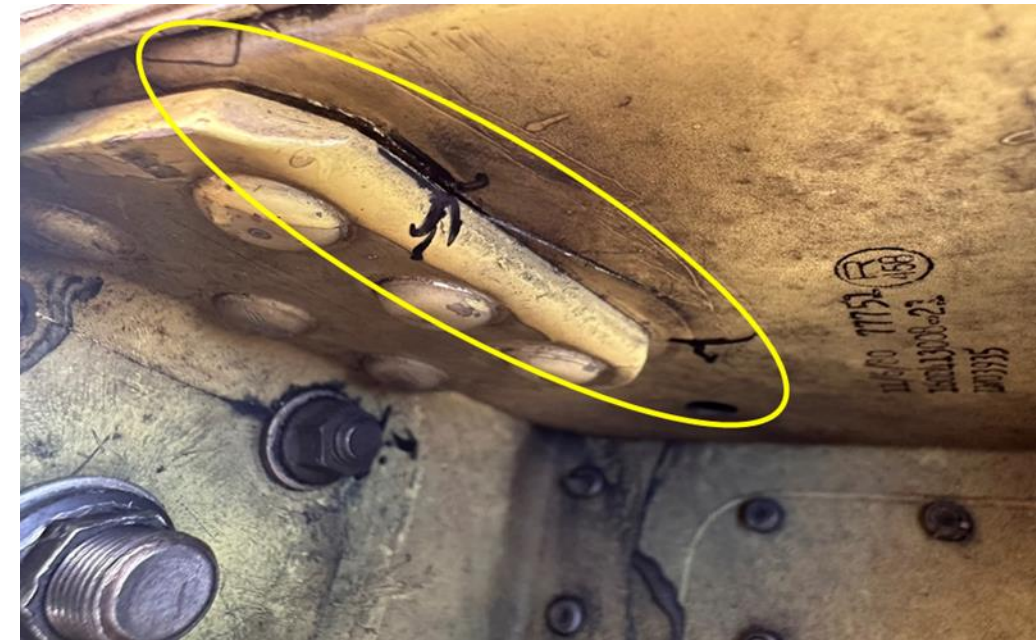
- Phase 1: growth along max principal stress plane until outside support fitting
- Phase 2: growth along edge of support fitting

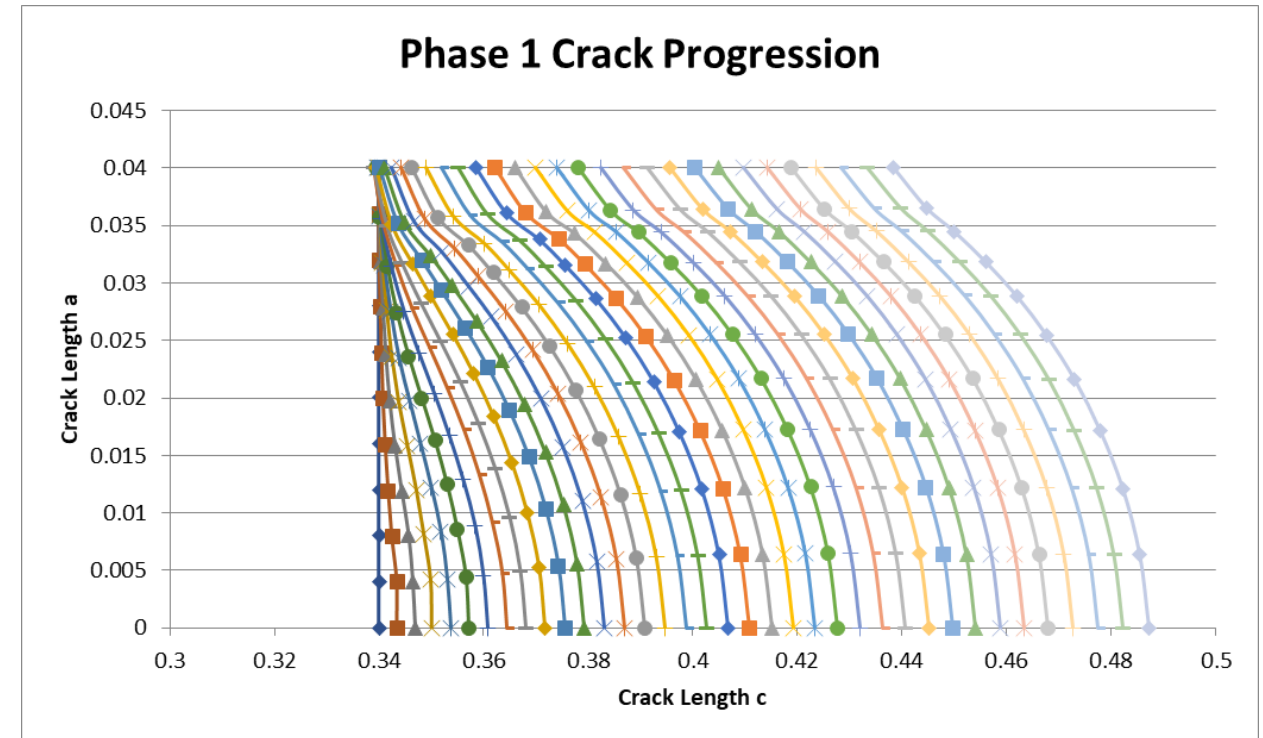
- Phase 1: DFS was 0.34" (surface scan (0.25" DFS) + Fastener head (0.09"))
