A-10 Aft Cowl Cracking Analysis: An Example of Structural Digital Engineering

Brian Boeke
A-10 Structural Analysis, USAF
AFGROW Users Workshop
Sept 12-13, 2023

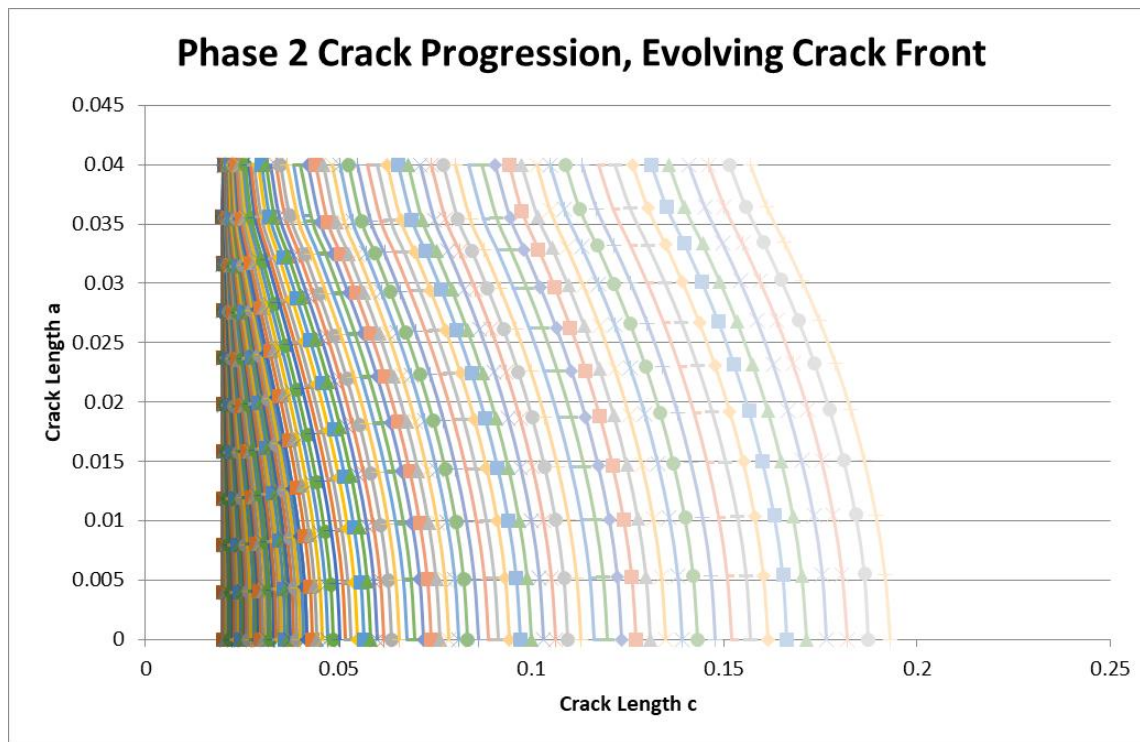
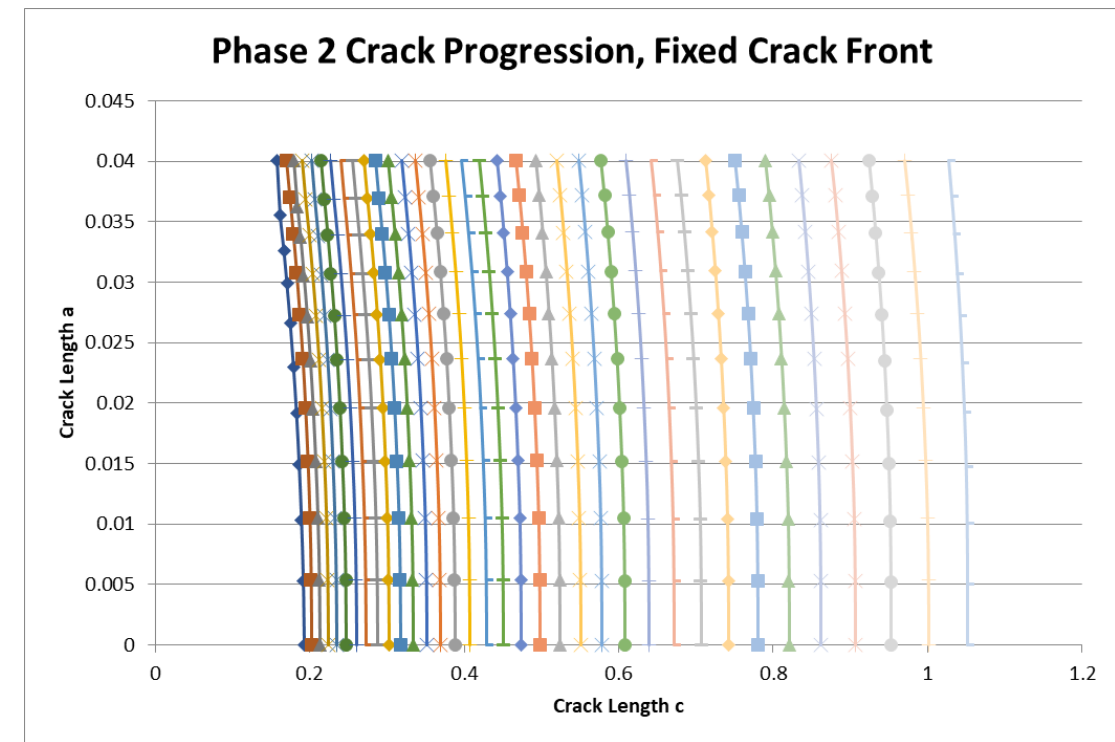
- Evolving crack front
- Fixed crack front based on growth of most critical point
- Note: Crack length does not include length from phase 1

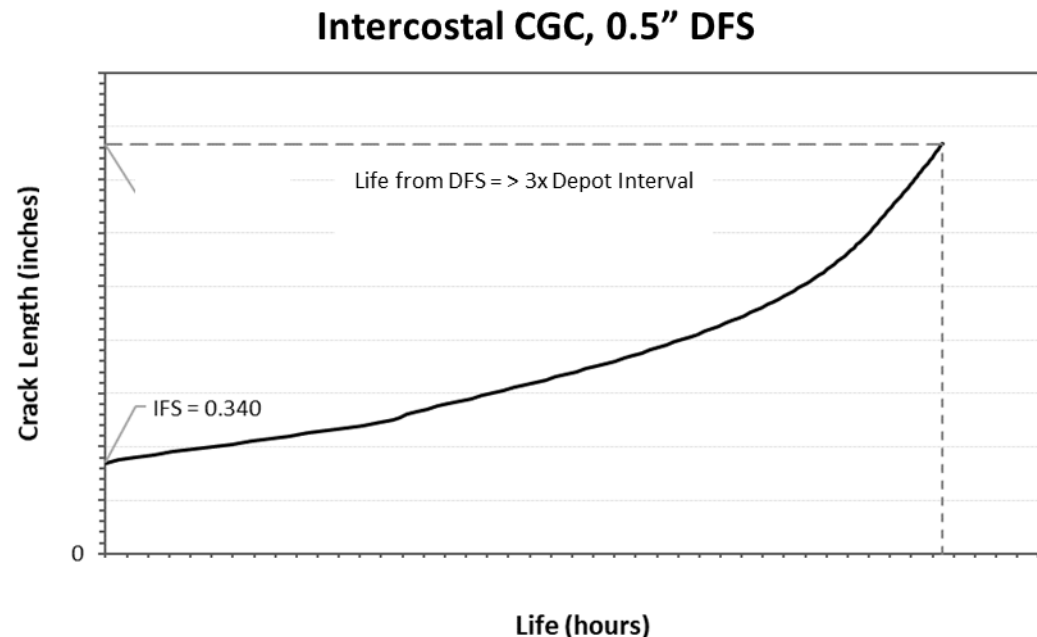
- Crack growth life supports depot level inspection
- Life more than expected compared to fleet experience
 - Potentially different crack path could affect this or Simcenter model change to include local influence of fastener head
 - Considered acceptable since life is divided by 3
