# A-10 Nose Landing Gear (NLG) Door Hinge Failure Assessment

**Mike Worley  
Southwest Research Institute**

**2024 AFGROW Conference  
Layton, Utah  
September 10-11, 2024**

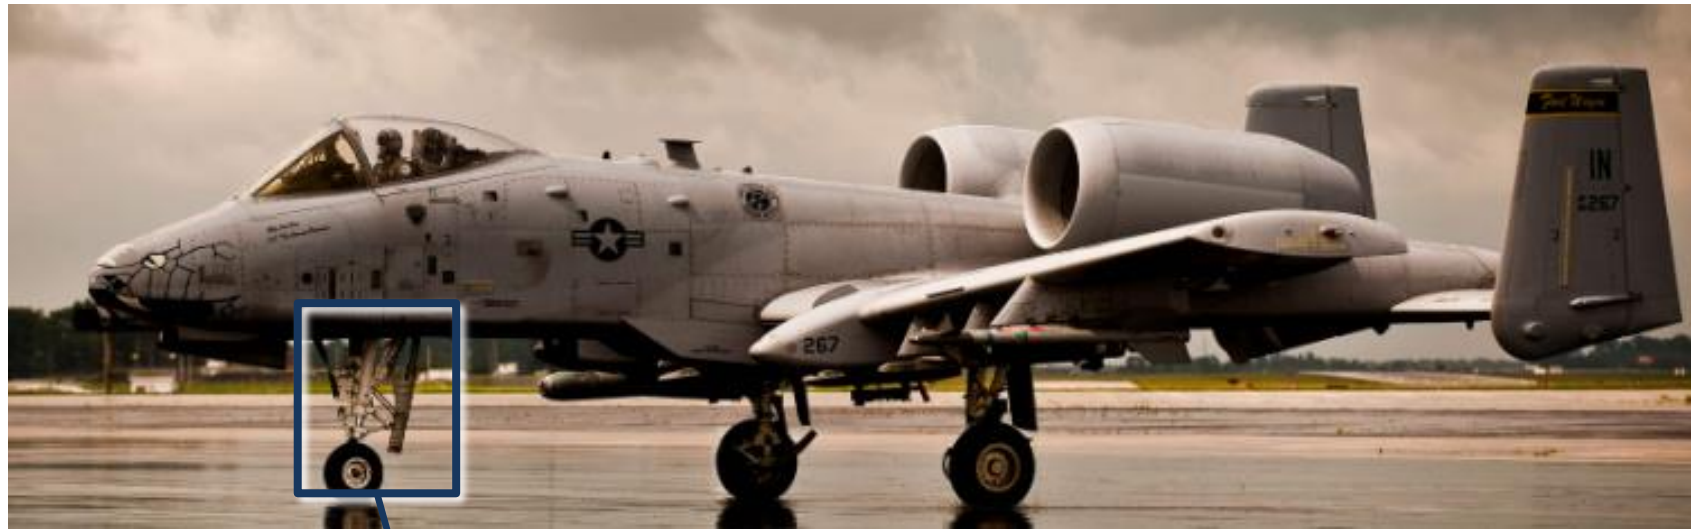
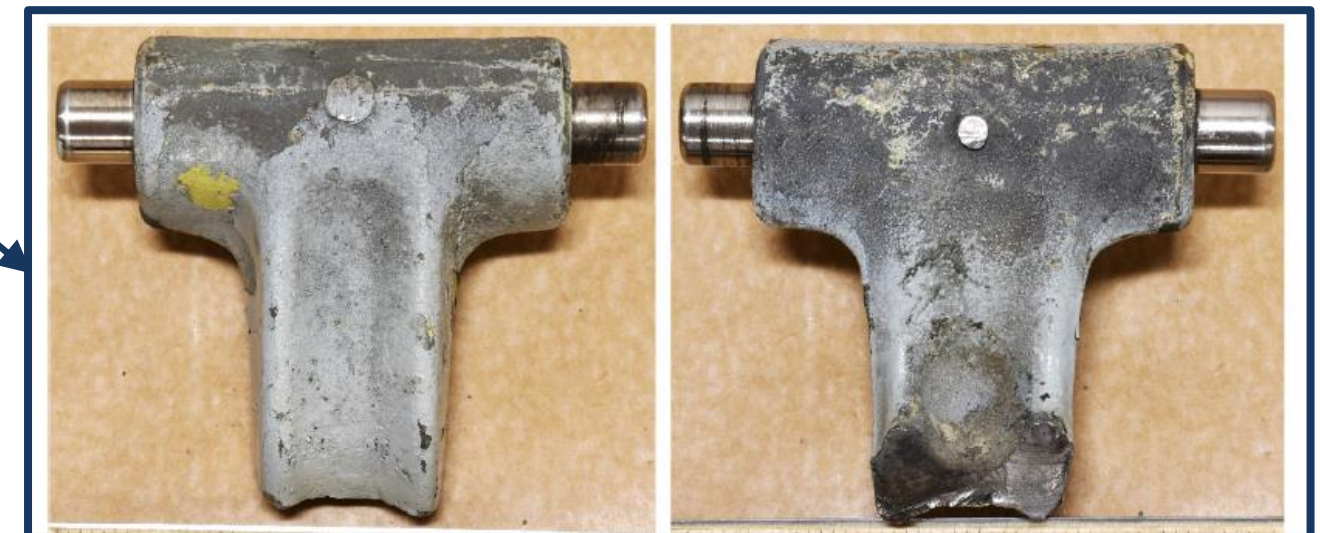
- Late 2023, the nose landing gear (NLG) aft door departed the aircraft in-flight during routine training sortie operating inside normal operating envelope of the A-10
- The door, struts, and forward half of the hinge were lost but the aft portion of the hinge remained and was available for evaluation
- The hinge is a 4340 steel forging

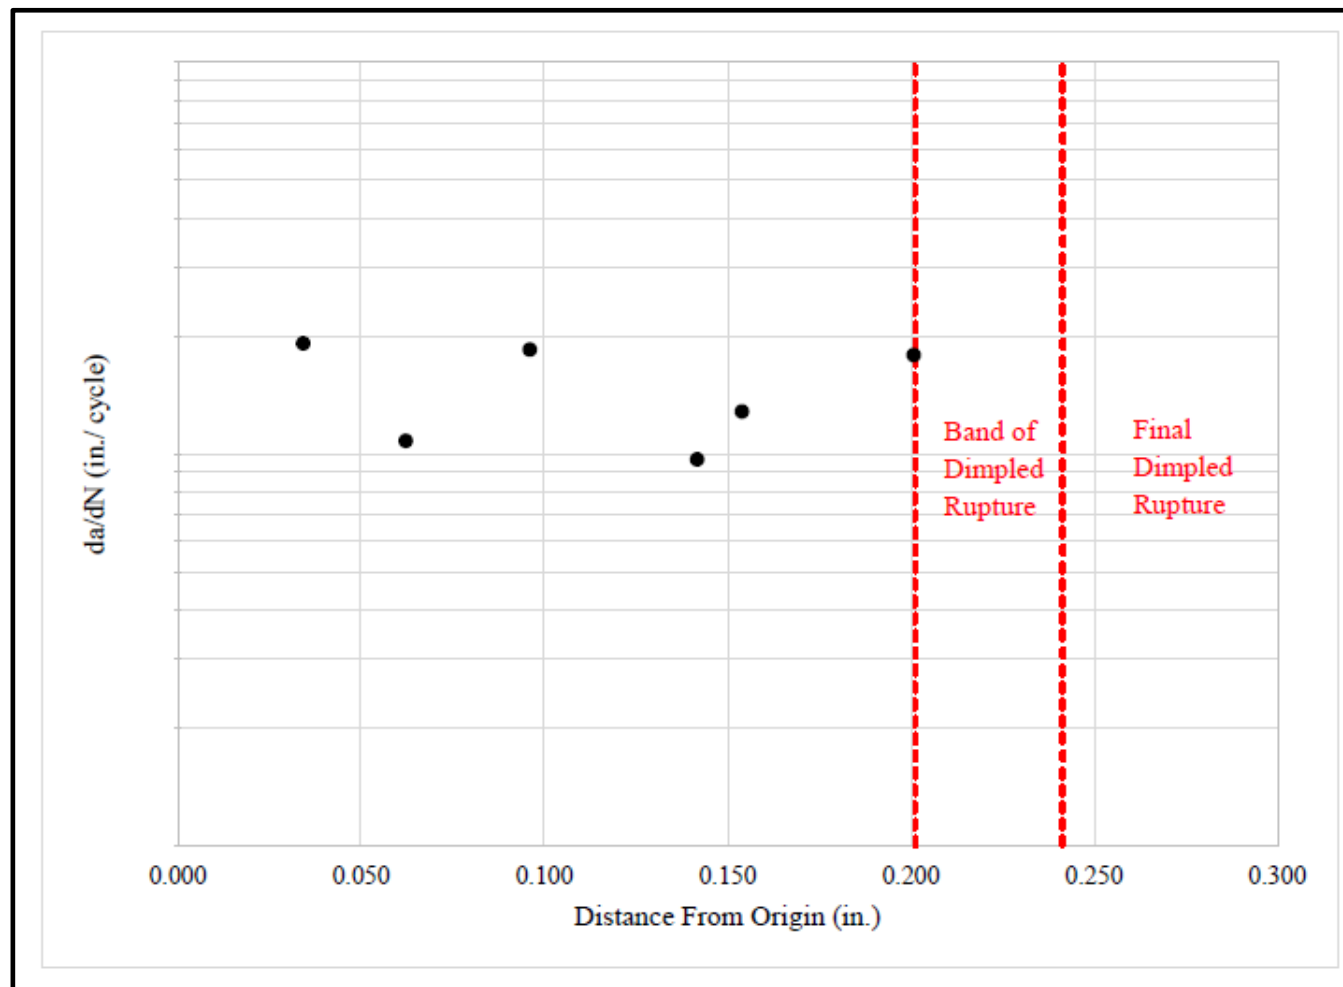
(RHS on aircraft)

- The RHS of bracket was too corroded to detect any striations
- Zones of dimpled rupture indicative of fast fracture were visible and identified
- Crack growth rates for the LHS of bracket were estimated using visible striation-like features at six locations along propagation direction
- The figure at right provides a crude map of fracture surface regions

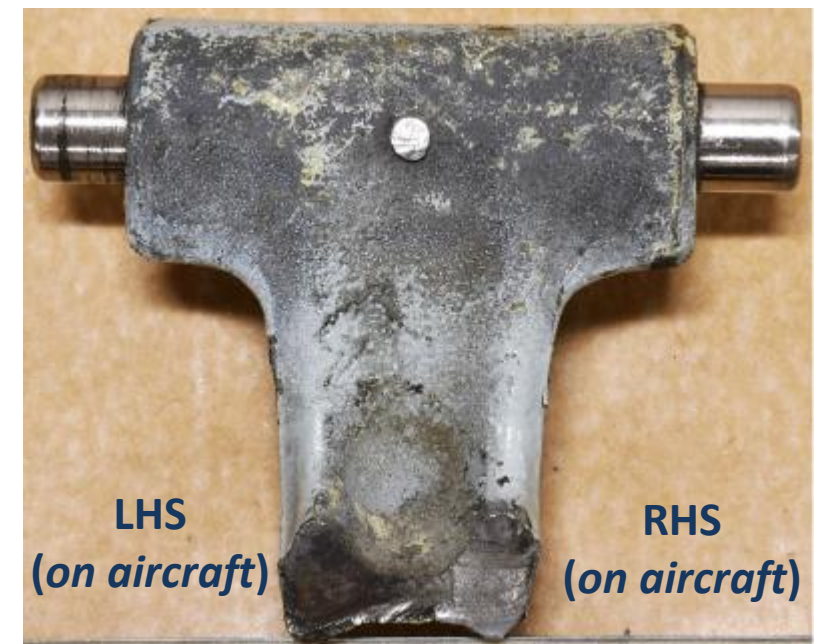
Hinge *Limit* Loads to Apply to FEM

- Two fatigue loading conditions, documented in the original aircraft design analyses, were scaled to limit loads and applied to a finite element model (FEM) of the hinge
  - COND #1: In-flight pressure on the door tries to open the “gooseneck”
  - COND #2: Air drag on door during landing tries to close the “gooseneck”
- Peak stress areas in FEA aligned with assumption that corroded side of hinge had higher stresses and cracked first

COND #1	COND #2
RHS Vertical Reaction	$R_{RHS\_V}$	155.4	104.8
RHS Drag Reaction	$R_{RHS\_D}$	72.5	-34.6
LHS Vertical Reaction	$R_{LHS\_V}$	16.0	-17.3
LHS Drag Reaction	$R_{LHS\_D}$	698.8	-147.4

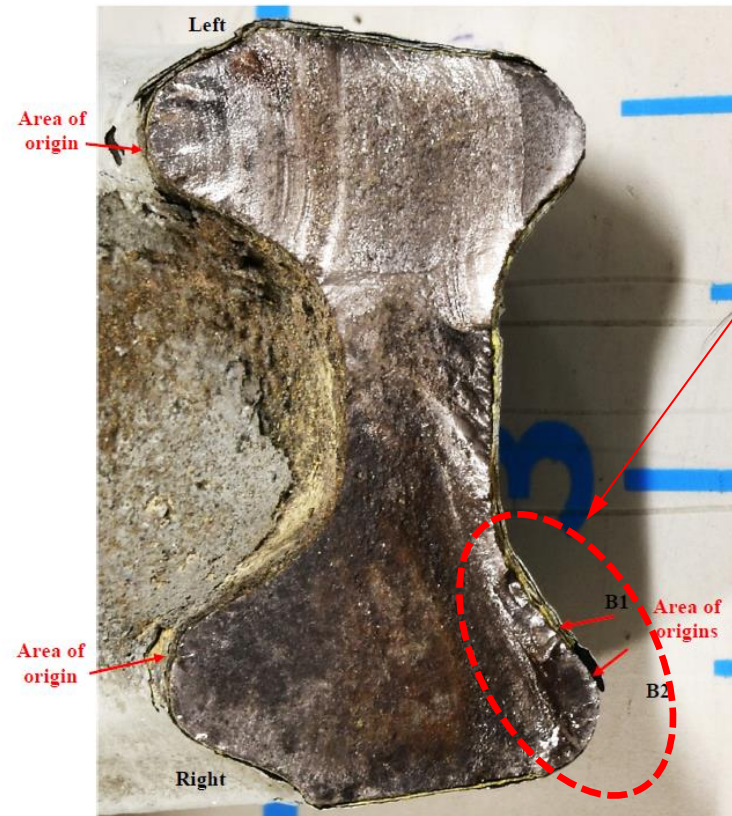
- The fractography report indicated that reverse-direction cracking was observed in the outer radius of hinge:
- Loading COND#2 (landing air drag) puts the outer radius in tension, but its magnitude is low—on the order of 9 ksi—for a pristine part
- However, as the inner radius crack grows larger and larger, the magnitude of this tension rapidly increases with loss of section, peaking at the correct location
- Though not explicitly modeled, it's conceivable the tensile stresses at some point may be high enough to initiate the observed reversed crack growth from existing stress risers.

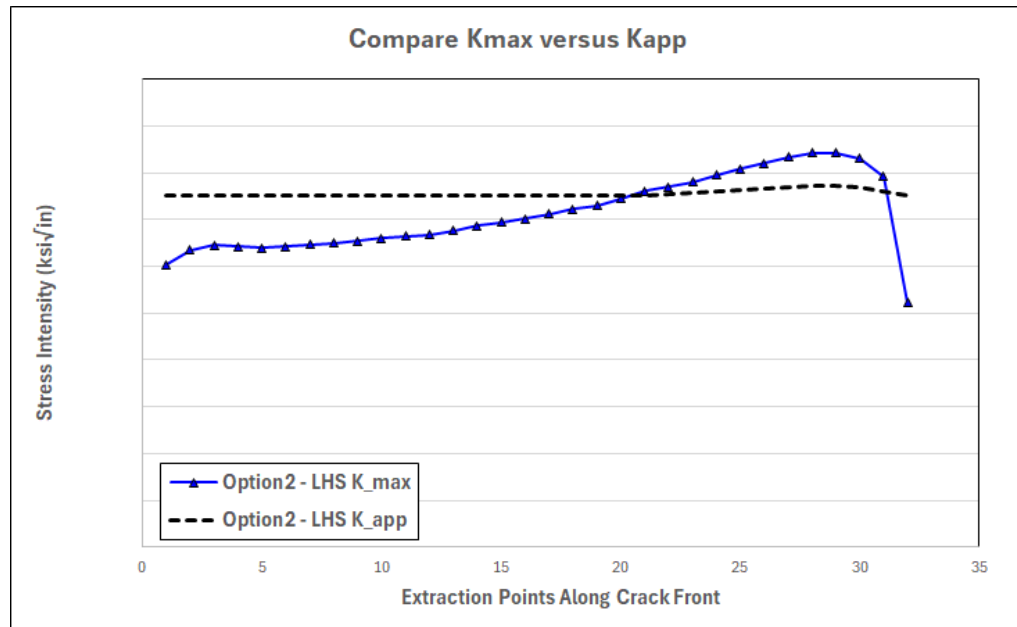
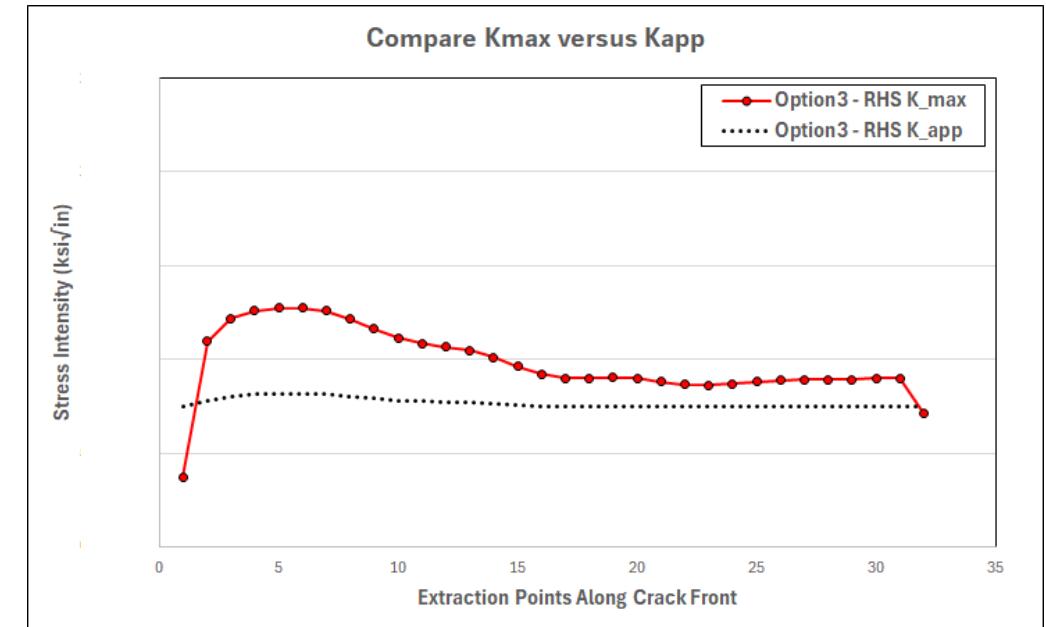
- Fractography images were used to estimate crack front geometries at transition to dimpled rupture zones and build StressCheck models having those crack front geometries
- Assumed peak load condition (COND #1) was applied to the model
- Comparison of  $K_{max}$  to  $K_{app}$  along crack front points lends credence to assumed load level

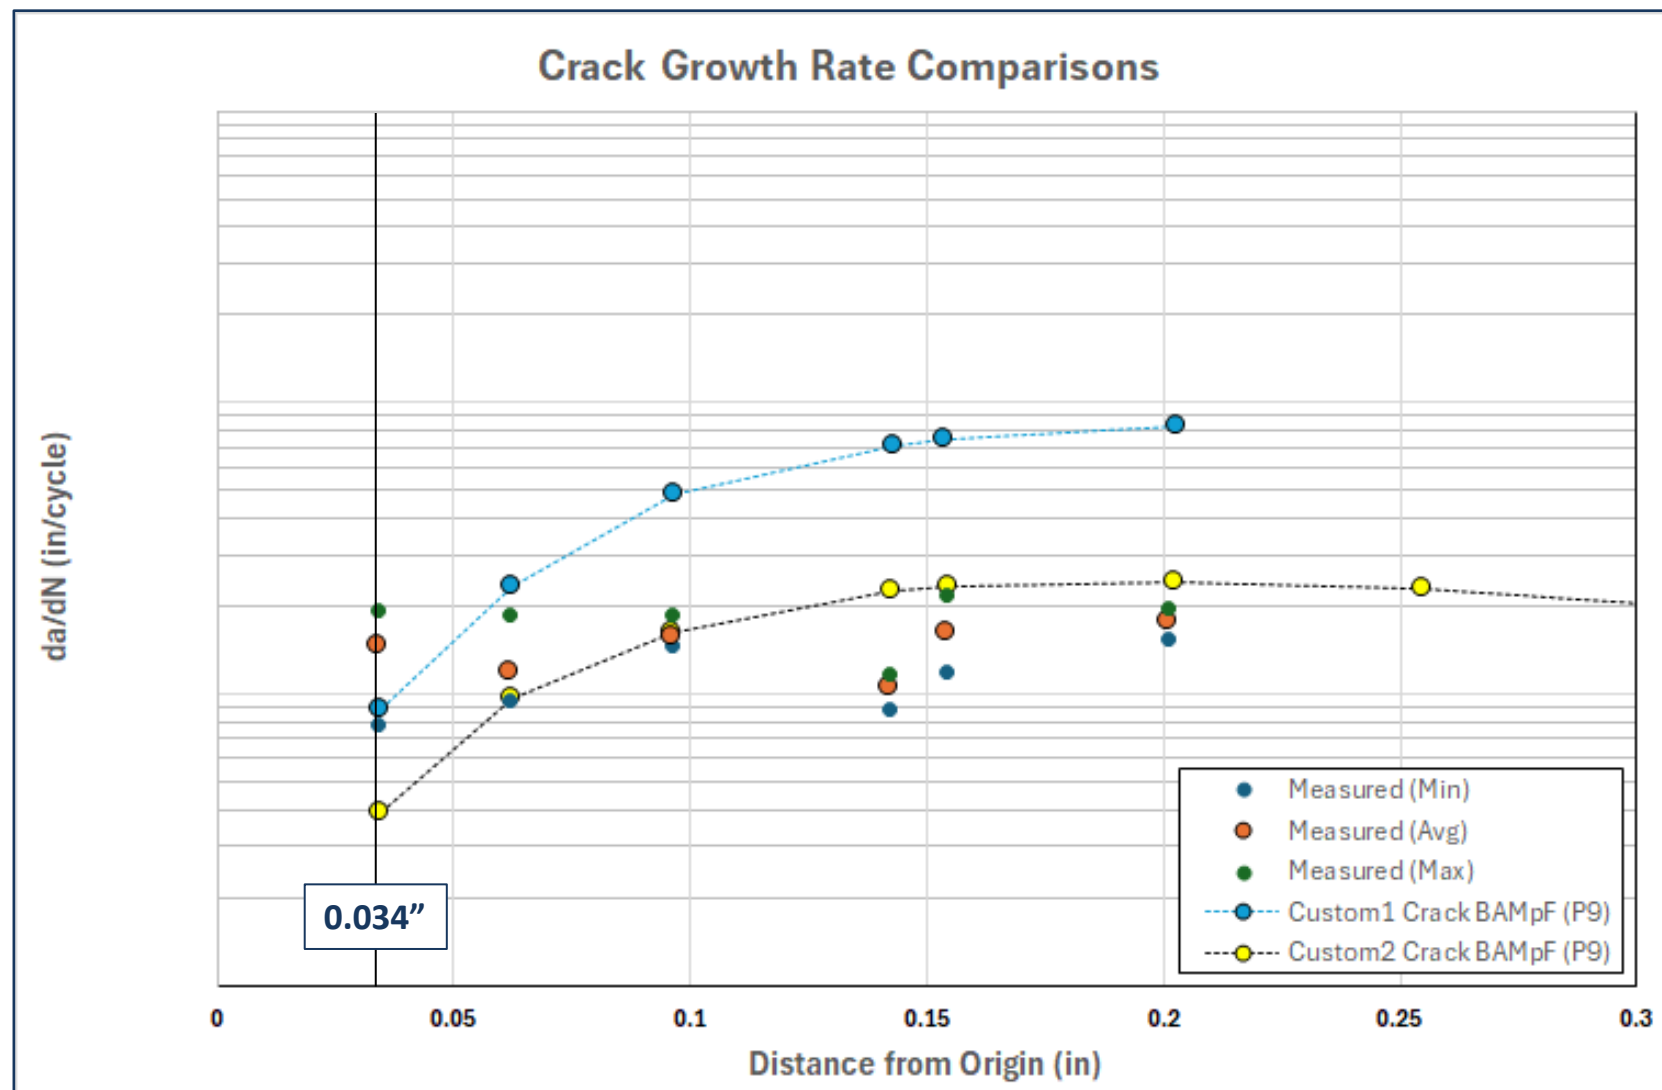
0.034” Semicircular crack

- BAMpF models were created having the two custom primary pre-crack geometries shown on the right (“Custom 1 Crack” & “Custom 2 Crack”)
- At secondary crack origin, each assumed an 0.034” semicircular IFS which was based on the starting dimension of available measured da/dN data
- Each used  $\sigma_{max} = 81.3$  ksi and  $R = -0.188$

In both these models, the pre-cracked zone for larger crack was modeled as a slit in the CAD (i.e. static geometry with no crack front modeled)

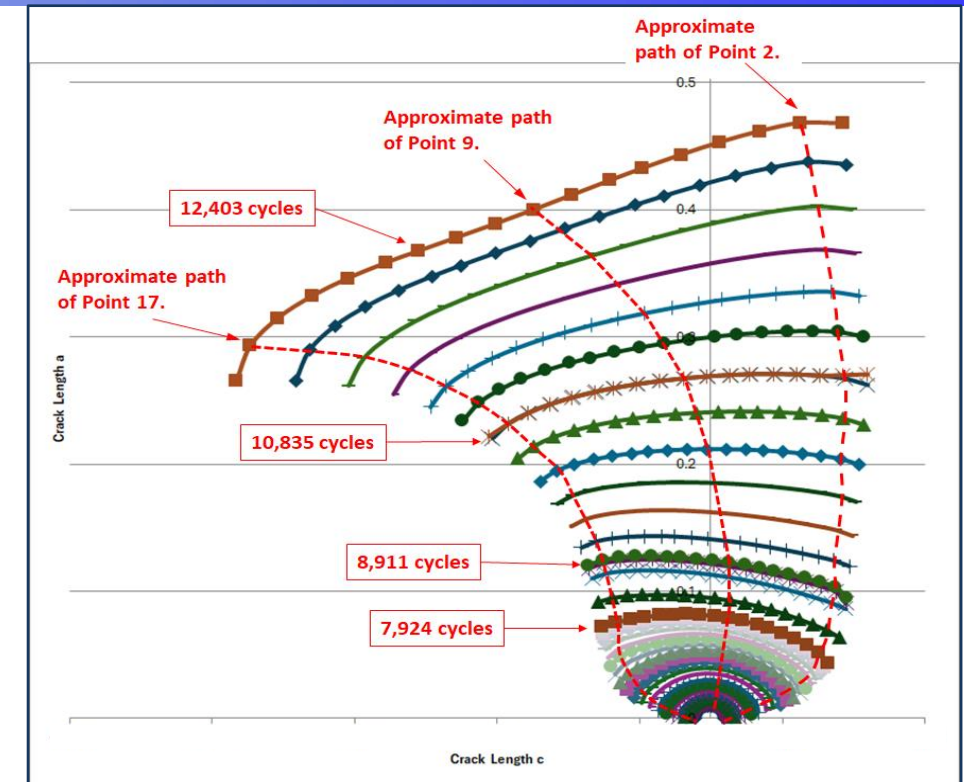
- A new BAMpF model was created having a 0.010" semicircular crack on the higher-stressed RHS of the hinge.
- The model predicted  $\approx 12,400$  stress cycles to grow the crack to the shape shown at right, which nearly matches the extent of the corroded RHS region on the failed hinge.

DTA model results shown here assume a 0.010" semi-circular initial flaw at this higher stress location on RHS.

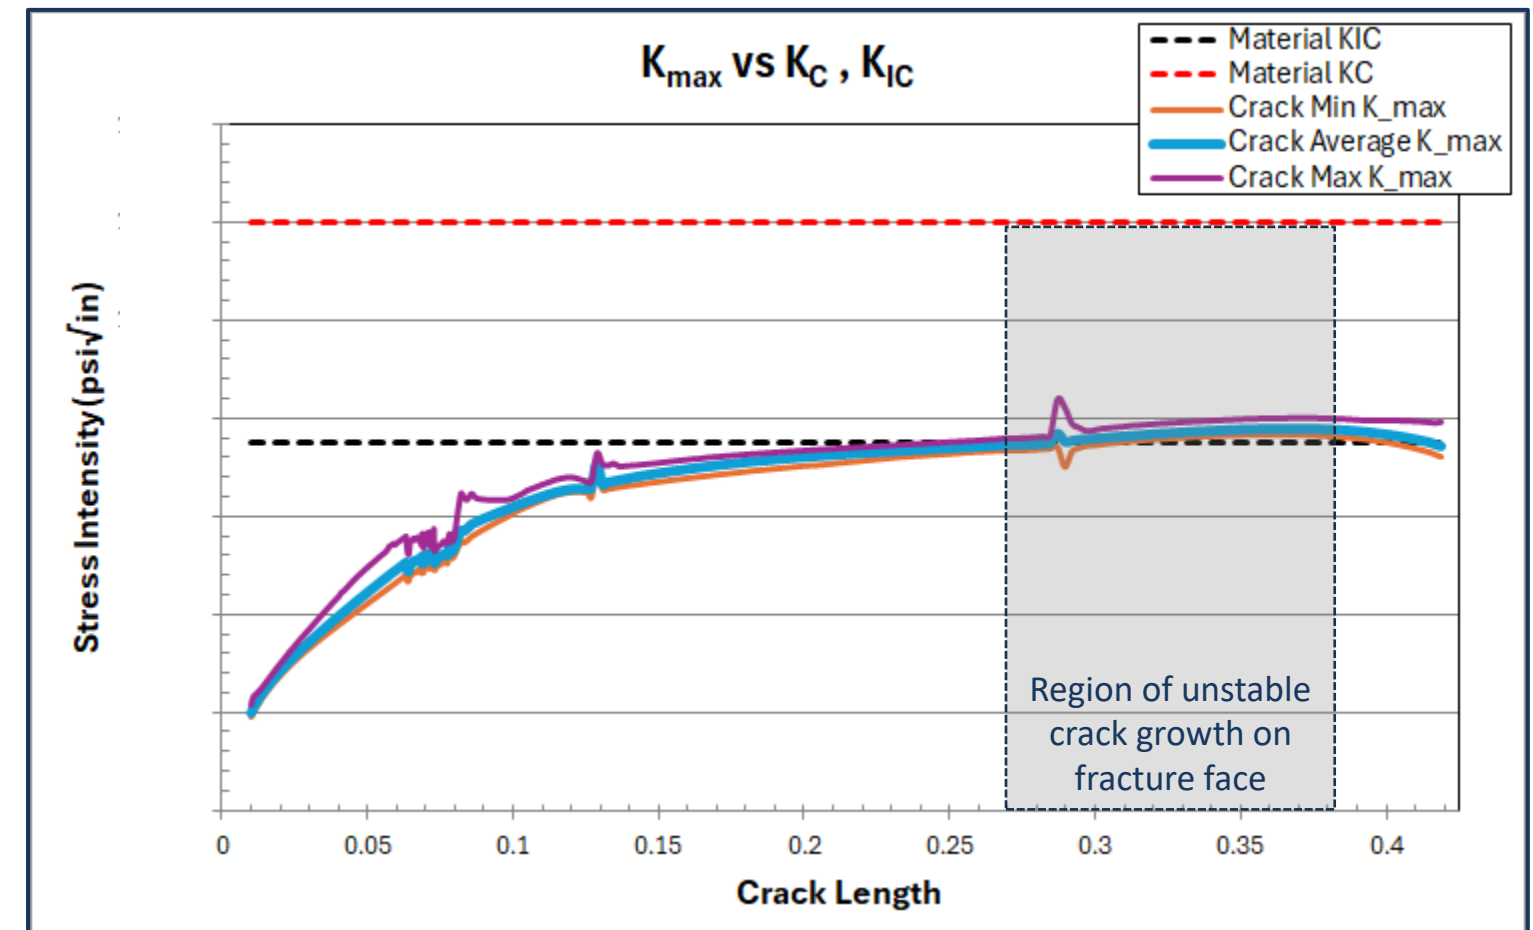
- Plots below show comparison of crack front  $K_{max}$  data versus  $K_C$  and  $K_{IC}$  over the cycle life and center crack point path length
- The region where predicted crack  $K_{max}$  begins to exceed  $K_{IC}$  agrees reasonably well with observed region of unstable crack growth on fracture surface
- (Possibly more cycle capacity based on previous residual strength checks that included LHS crack)

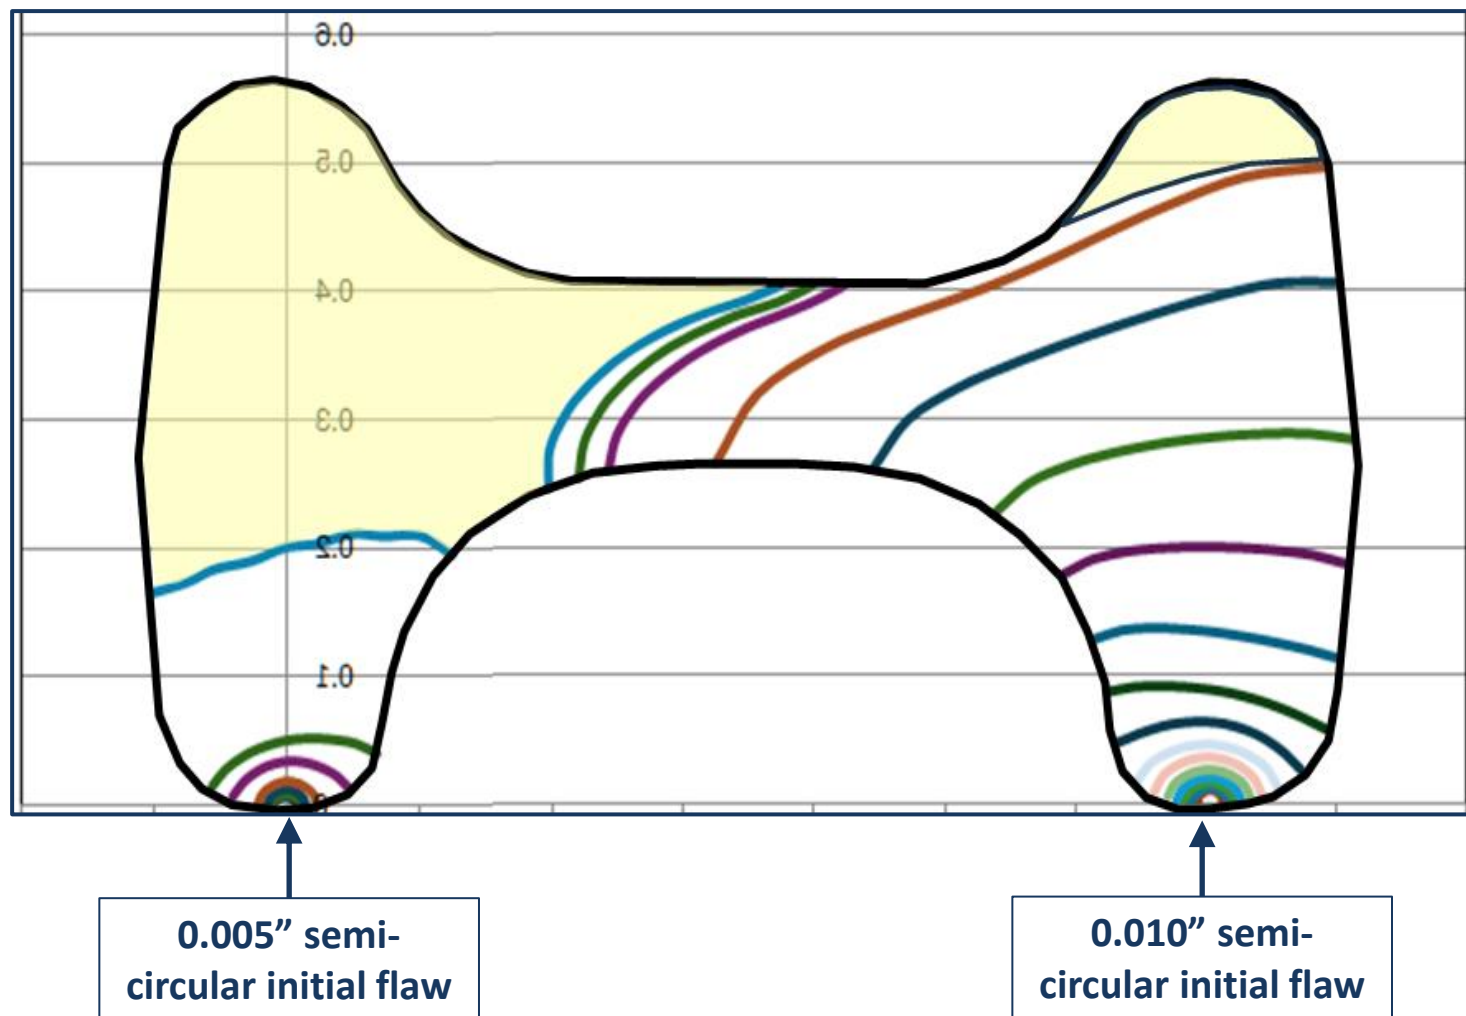
2-Crack BAMpF Model

- A new 2-crack BAMpF model was created having semicircular cracks of sizes observed on failed part
  - 0.010" on the higher-stressed RHS
  - 0.005" on the secondary LHS
- Goal: grow the primary crack past the  $\approx 12,400$  cycles from single crack DTA model but include effects, if any, due to the presence of a secondary crack

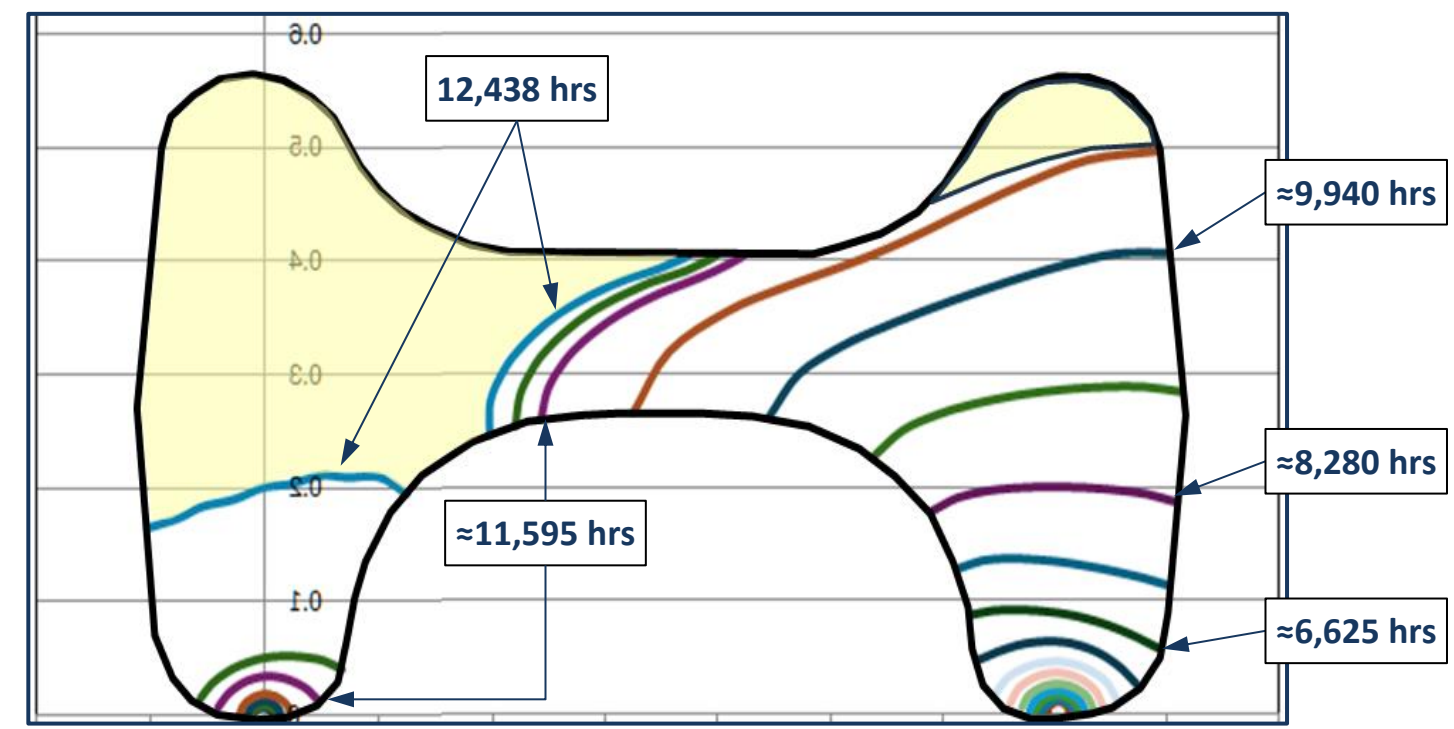
- Scaling new total cycle prediction to the fleet average total flight hours requires a new cycle-to-hours rate of  $15,018/12,438 \approx 1.207$  cycles/hr
- Prediction *may* explain corrosion seen over large area of RHS of fracture face—primary crack shape is large long before final fracture
- Recurring inspection interval has increased but still less than desired 2,000 EFH

Life from 0.250" DFS: 5,443 hrs  
 → Recurring inspection interval: 1,814 hrs

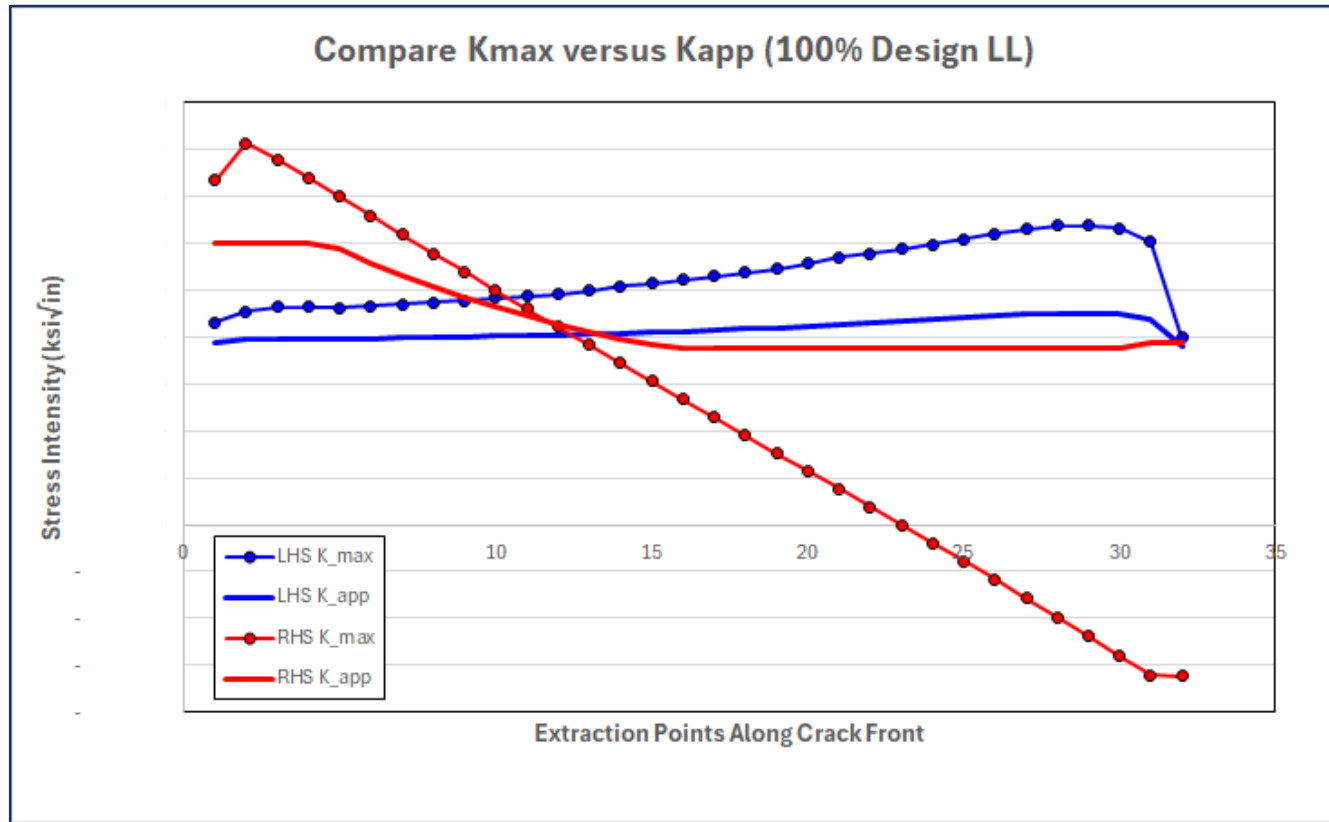
# $K_{max}$ versus $K_{app}$ (Residual Strength)

- Half-cracked checks
