# **Damage Tolerance Facts and Fiction**

**Ulf G. Goranson  
Boeing Commercial Airplane Group  
U.S.A.**

**14th Plantema Memorial Lecture  
Presented at the  
17th Symposium of the International Committee on Aeronautical Fatigue  
Stockholm, Sweden, June 9, 1993**

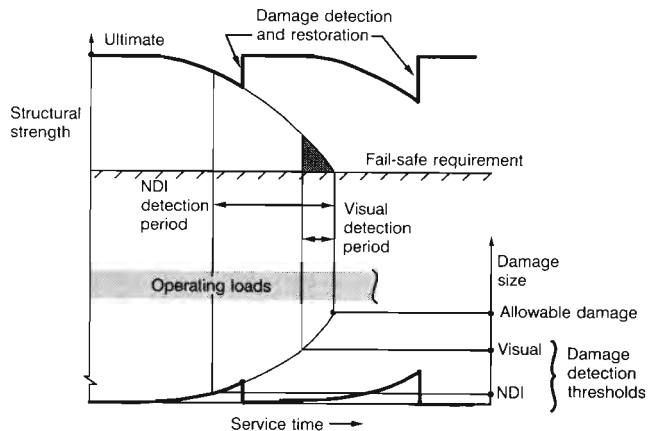
Figure 1. Strength Requirements for Damage Tolerant Structure

Certification of commercial jet transports mandates damage tolerant designs in all instances where it can be used without unreasonable penalty. The technical capability has evolved to relate inspection requirements to damage growth which, in the past, were based on service experience. Primary airframe components are designed to meet specific static and dynamic loading conditions that greatly exceed normal operating loads, Figure 1. As the airplane progresses through its service life, damage may occur and reduce static strength capability (residual strength). Structure is damage tolerant if damage that may occur, can be discovered and repaired before the residual strength falls below the regulatory fail-safe capability. The damage detection period is dependent on structural characteristics as well as maintenance and inspection procedures. Once damage has been detected, strength must be restored to the ultimate design level. Aging airplane structure may be affected by widespread fatigue damage that alters the detection requirements. This is due to the effect of local damage at multiple sites on residual strength capability.

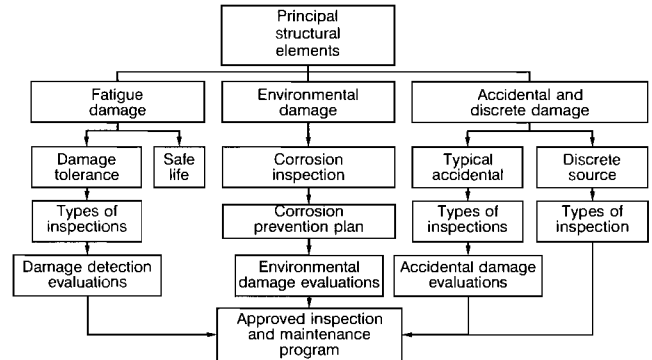
Figure 3. Principal Damage Sources for Maintenance Planning Considerations

- Damage Detection (Inspection Program): A sequence of inspections in a fleet of airplanes with methods and intervals selected to achieve timely damage detection. Structural inspection programs are typically developed by use of rating systems for each of the three major forms of damage, Figure 3.

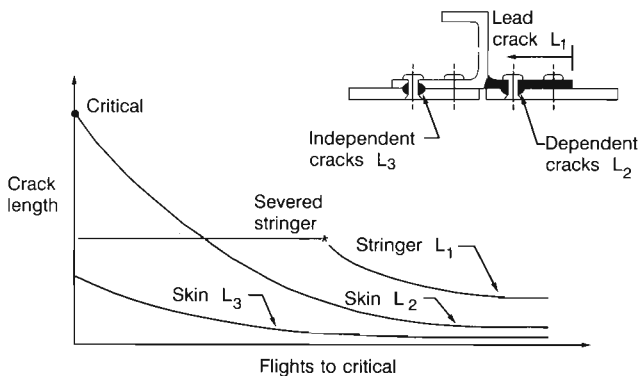
Figure 4. Local Cracking Pattern Example for a Spanwise Wing Splice

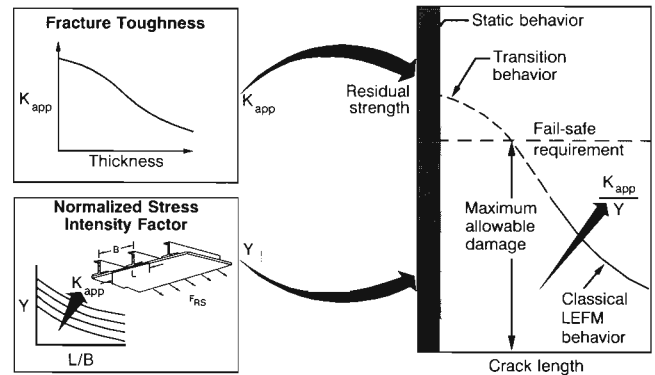
Figure 5. Residual Strength Technology Standards

Monolithic and particularly brittle material structures tend to conform closely to the traditional engineering methods of fracture mechanics. Built-up airplane structures consist of multiple sheet, stiffener, and fastener elements. Interaction between these cracked and uncracked elements causes significant redistribution of stresses. Failures are often precipitated by local exhaustion of plastic strain capability of the most critical elements, and/or net section failures involving a mixture of fracture mechanics and transitional behavior in some elements. Special failure criteria and deflection parameters are necessary to characterize the residual strength properties for damage levels ranging from short secondary cracks in adjacent details to larger primary cracks in details subject to inspection, Figure 5.

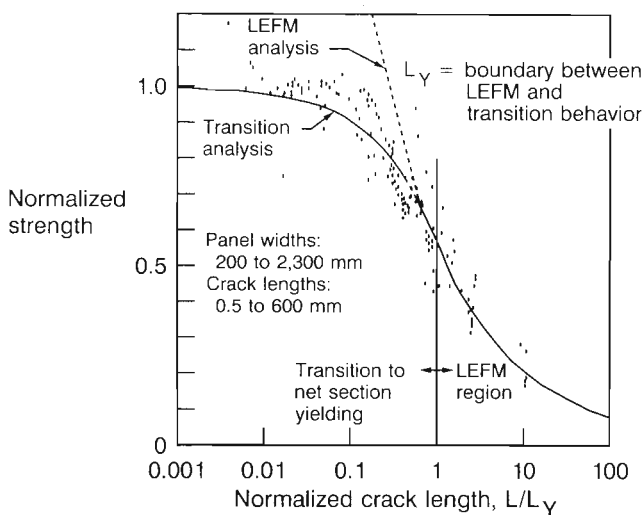
Figure 6. Residual Strength Test Verification Examples

A composite of normalized failure behavior plotted against crack length ( $L$ ), normalized to the length beyond which linear elastic fracture mechanics applies ( $L_Y$ ), is shown in Figure 6. An analytical representation of this behavior also is shown. The data for  $L/L_Y$  greater than unity were obtained primarily from center cracked panels fabricated from wing upper surface material, while similar data for wing lower surface materials fall in the transition region, belying their ductile behavior. The region near uncracked behavior was obtained by tests of 225 mm wide specimens containing small part-through or through thickness cracks.

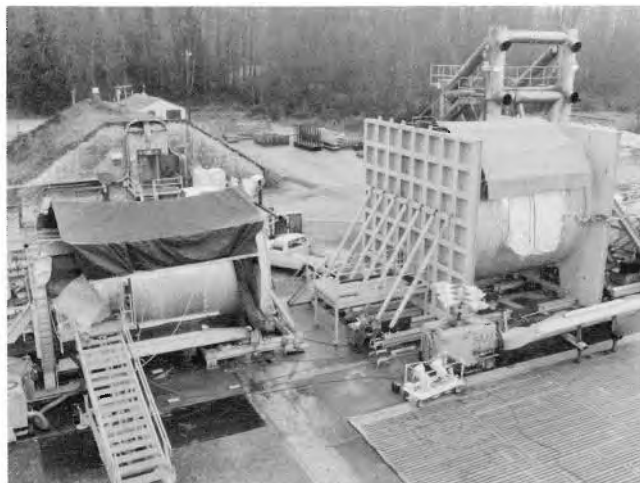
Figure 7. Fuselage Pressure Test Fixtures

body, Figure 7. These fixtures were designed to accommodate testing for fatigue, crack growth, and residual strength of large pressure panels with a variety of structural designs and details.

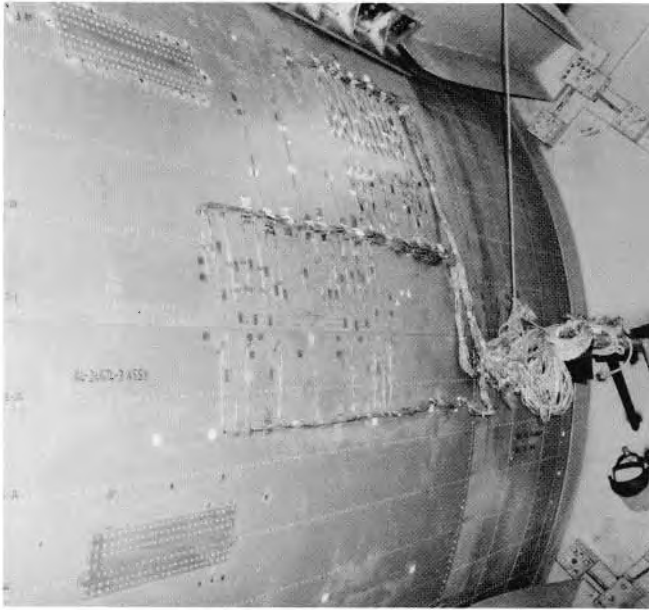
Figure 8. Typical Fuselage Pressure Test Panel

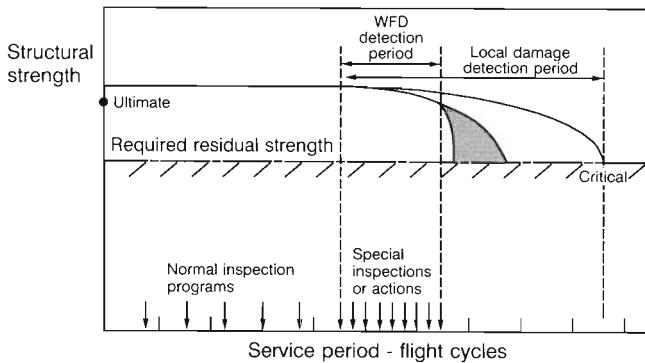
Figure 9. Damage Detection Comparisons for Local and Widespread Fatigue Damage

The major lesson learned is that although damage at multiple sites has been addressed in residual strength analyses since the regulatory changes of FAR 25.571 in 1978, the presence of widespread fatigue damage can significantly reduce these local damage containment areas. The safe damage detection period between the threshold of detection and limit load capability may also be reduced in the presence of widespread fatigue damage as shown in Figure 9.

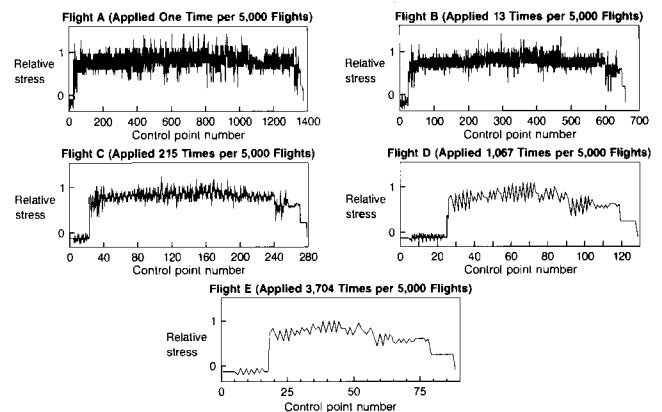
Figure 13. Wing Lower Surface Spectrum Example

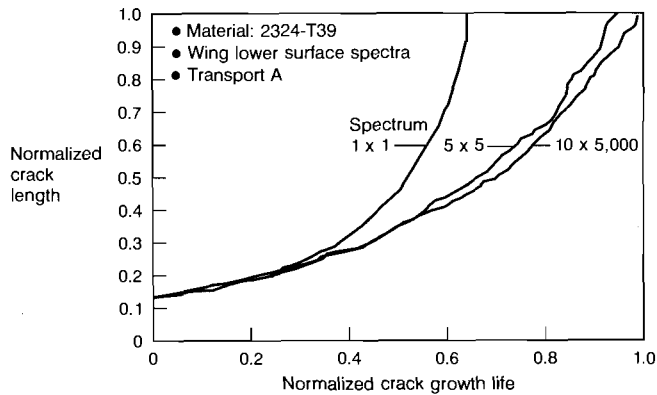
Figure 14. Effect of Spectrum Complexity on Crack Growth

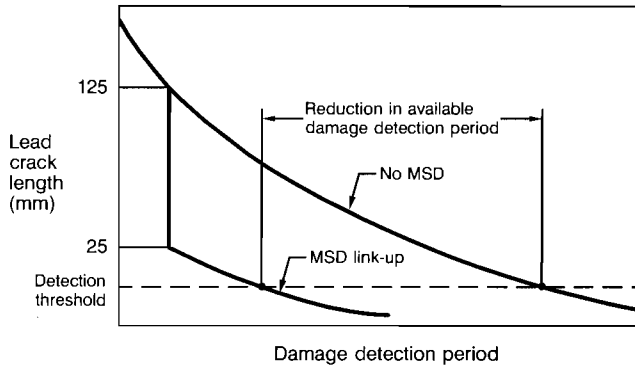
Figure 16. Multiple Site Damage Link-Up Effects on Detection Period

Multiple site damage concerns discussed previously under residual strength also prompted revisions of the technology standards in 1986 to address link-up of small cracks in fuselage lap joints. Data from lap splice and pressure dome testing demonstrated rapid link-up after the initial connection between two adjacent holes, Figure 16. This analysis approach was later incorporated in revisions of supplemental inspection programs. Subsequent testing of a 737 fuselage retired from service provided additional verification of the link-up process.

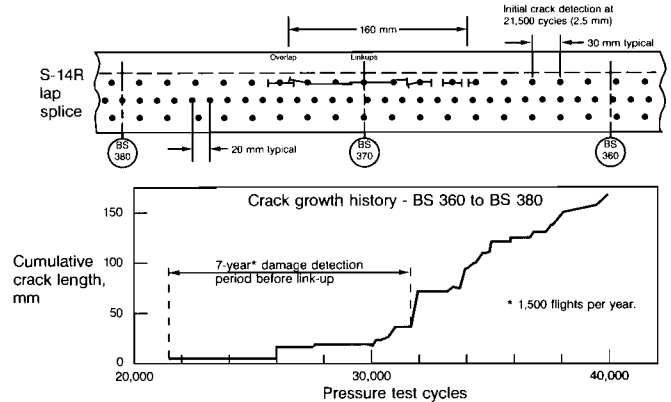
Figure 18. 747-100SR Fuselage Lap Splice Test Results — Stringer 14L

A 747-100SR with an equivalent of 20,000 full pressure cycles (flights) was obtained from service and monitored as the fuselage was pressure tested to 40,000 cycles. An initial crack was detected in the lap splice in S14R at 21,500 cycles. This crack eventually linked up with other small cracks and grew to approximately 150 mm by the time the test was concluded at 40,000 cycles, Figure 18. Assuming 1,500 flights per year of normal operations, the crack growth data from this test indicate a 7 year damage detection period before link-up. After link-up, tests indicate there is a significant, additional safe damage detection period.

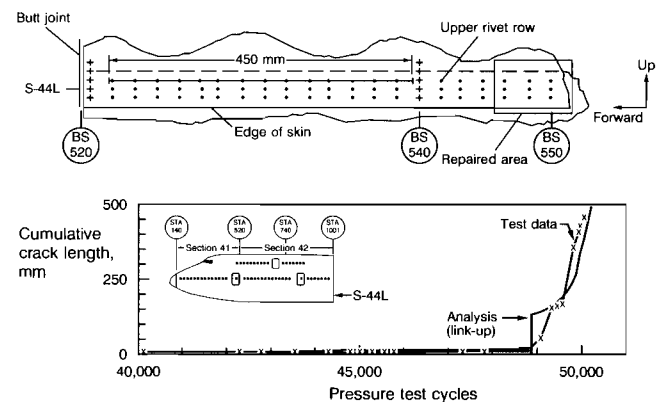
Figure 19. 747-400 Fuselage Lap Splice Test Results—Stringer 44L

Sections 41 and 42 from the 747-400 production line were also pressure cycled to determine some of the fatigue and damage tolerance characteristics of the latest production configurations. Cracks eventually started at several locations, 747-100SR, Figure 19. Recorded crack growth data indicate a long damage detection period between the time of detection and link-up, possibly longer than 10 years for an airplane making 1,000 normal operation flights per year. These test results show reasonable correlation with the link-up criteria previously discussed.

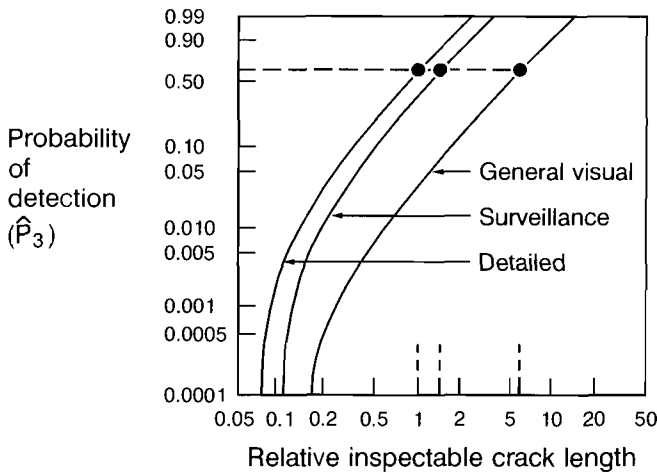
Figure 20. Relative Probability of Detection for Visual Inspection Methods

$P_3$  for visual inspections is based on an extensive review and analysis of fatigue cracks detected in service. Account has been taken of cracks remaining undetected during inspections prior to detection including those assumed to have occurred but not yet detected, Figure 20. Detection thresholds and characteristic crack lengths are defined by a three-parameter Weibull distribution.

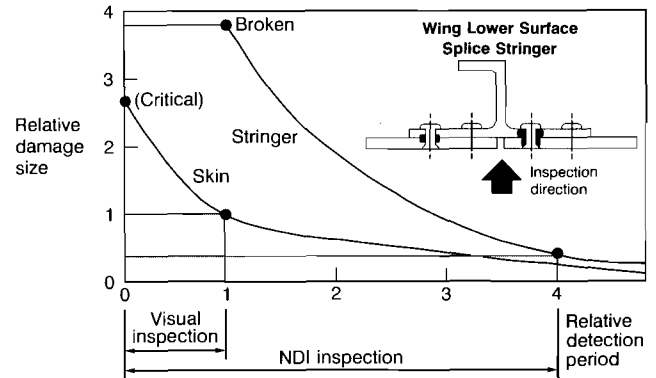
Figure 21. Visual Versus NDI Damage Detection Periods

with a reduced inspection frequency. Damage detection reliabilities have been established for different crack lengths in relation to the minimum detectable for typical inspection techniques and structural configurations, Figure 22. These  $P_3$  curves are appropriately modified to account for visual detection of surface cracks and multiple probe applications at different locations along the same crack during the same inspection of sub-surface cracks.

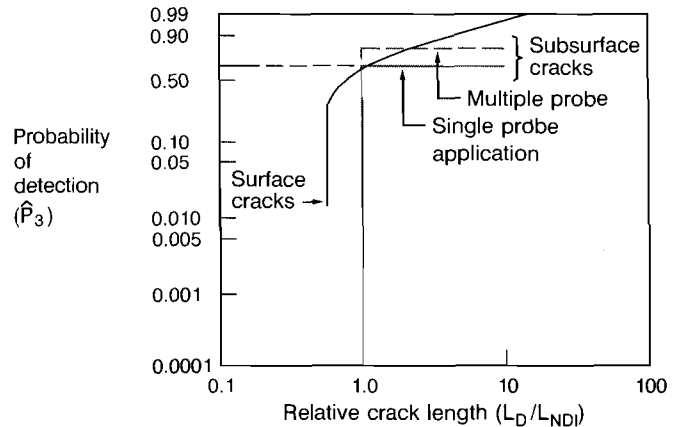
Figure 22. Probability of Detection for NDI Inspections

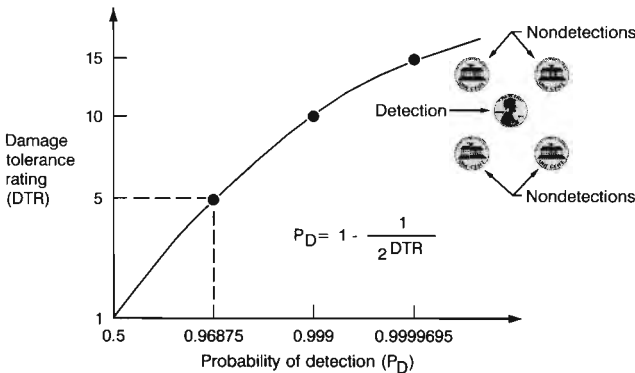
Figure 24. Probability of Detection Measurements

The measurement of detectability by DTR values provides a better comparison between  $P_D$  levels on a suitable engineering scale, Figure 24. The detection evaluation can be performed for varying inspection intervals and methods which are summarized on a form suitable for individual operator use, Figure 25.

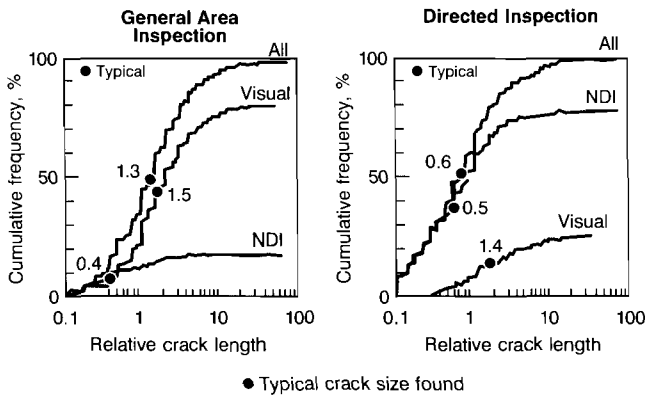
Figure 28. Distribution of Cracks Found in Service

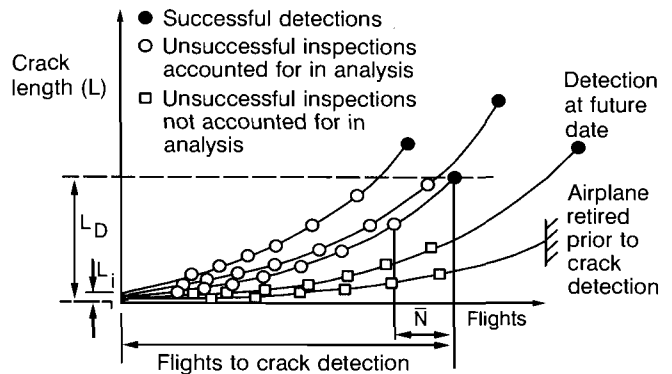
Figure 29. Detection and Nondetection Events

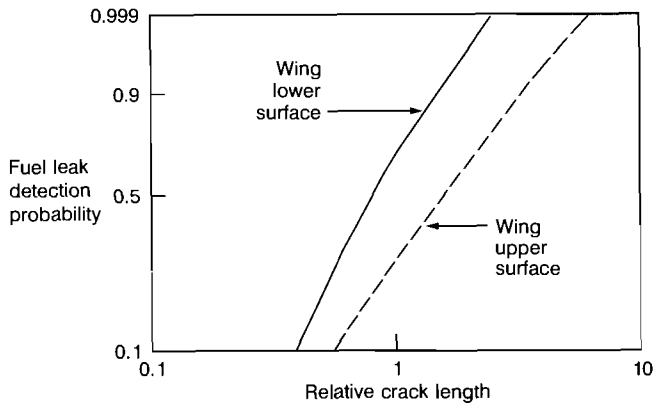
Figure 31. Probability of Fuel Leak Detection

The probability of crack detection as a consequence of a fuel leak was developed by evaluating cracks of known length reported in wet bay areas. Cracks found by fuel leak were isolated from those for which no leak was reported. The resulting sample of leaks and non-leaks was characterized using a Weibull distribution to give the probability of detecting a crack by fuel leakage as a function of crack length, Figure 31.

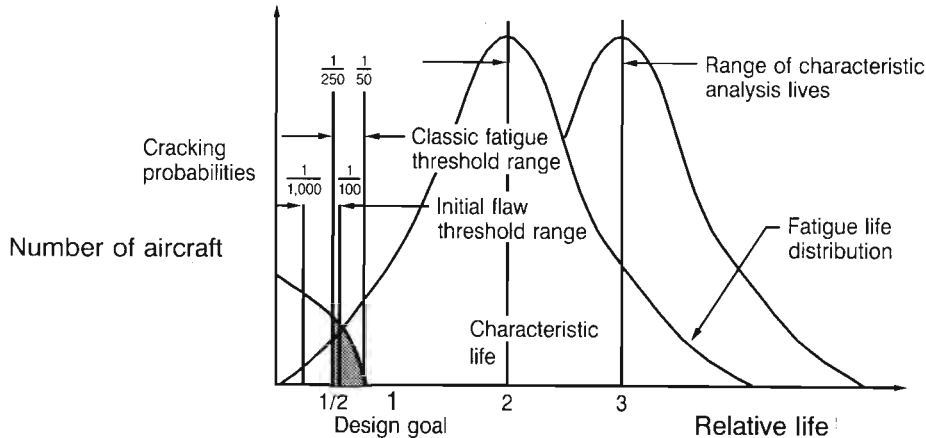
Figure 34. Threshold Examples Based on Classic Fatigue and Initial Flaw Concepts

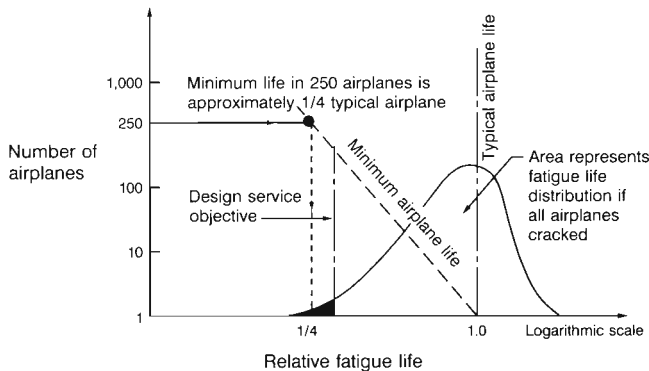
Figure 36. Variation of Minimum Life With Fleet Size

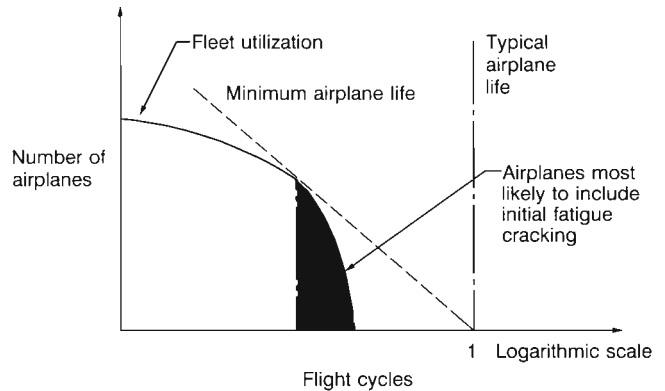
Figure 37. Fleet Cracking Order Based on Fatigue Life Distribution

The order of cracking is random and unique for each fleet. Airplanes with the highest number of flight cycles are most likely to crack first. The earliest cracking may occur when the fleet utilization curve meets the line defining minimum (first crack) life, Figure 37. Since the fleet size, production rate, and utilization are different for each fleet, a varying initial crack threshold results. The most likely group of airplanes to experience the initial cracking are those with more flight cycles than defined by this meeting point. These airplanes are suitable candidates for an aging fleet inspection program.

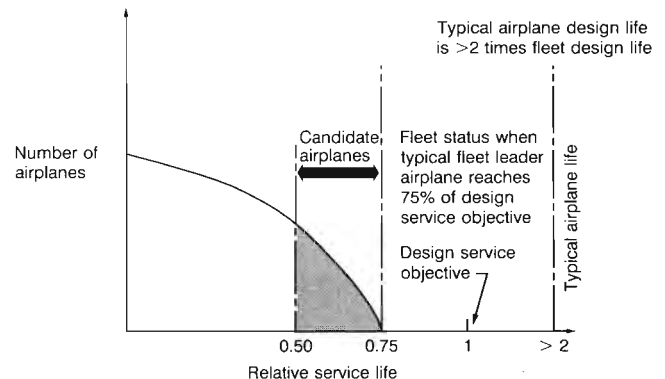
Figure 38. Supplemental Inspection Candidate Airplane Criteria

Based on typical Boeing fleet distributions, the candidate airplanes most likely to experience initial fatigue cracking are those exceeding 50% of the fatigue design service objective when a normal service airplane reaches 75% of the same life goal, Figure 38. Because the relationship between typical and minimum fatigue life is constant, the candidate fleet will not change unless there are significant changes in airplane distribution, composition, or utilization. The candidate population is therefore not changed as additional airplanes reach half of the design objective. This provides for a fleet leader population that moves with the total fleet and eliminates life thresholds that usually result in an increasing number of airplanes subject to supplemental inspection requirements.

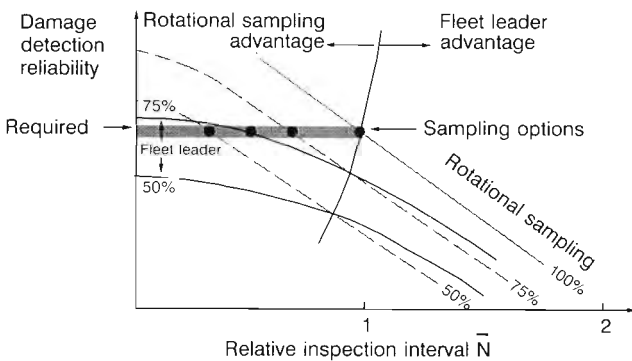
Figure 39. Fleet Sampling Options

Fleet leader sampling involves repeat inspections at regular intervals of a specified number of airplanes with the highest number of flight cycles in each operator's fleet. Rotational sampling involves inspections of a fraction of an operator's candidate fleet with a specified interval until all candidate airplanes are inspected at least once.

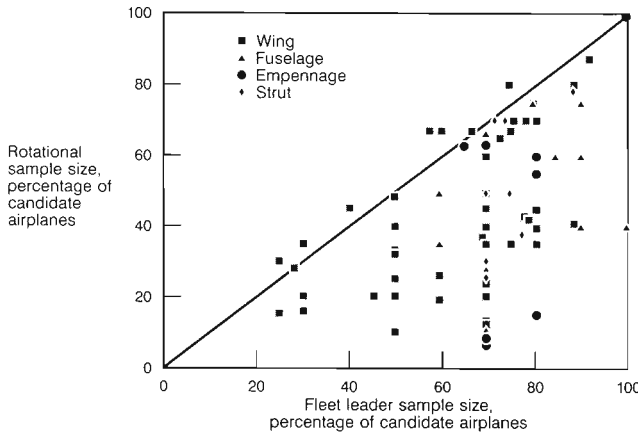
Figure 40. Fleet Sampling Efficiency Comparisons

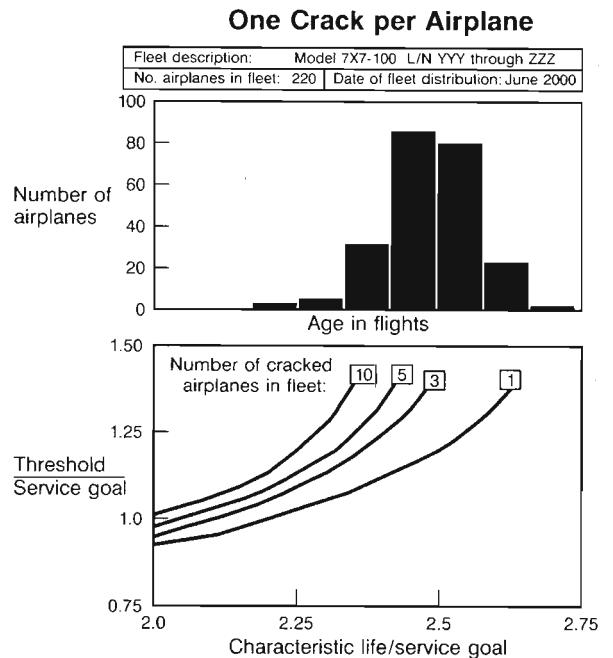
Figure 41. Fleet Service Cracking Estimate Example— One Crack per Airplane

Fatigue life distributions coupled with fleet usage characteristics can be applied to address inspection threshold selections. Figure 41 shows the inspection thresholds for different numbers of projected airplanes with single cracks in a major component. Figure 42 shows threshold estimates for varying numbers of cracks per airplane as well as number of assumed airplanes with cracks in the fleet. These projections can be determined for different calendar years to supply the engineer with estimates when structural and/or other corrective actions need to be implemented, Figures 43 and 44.

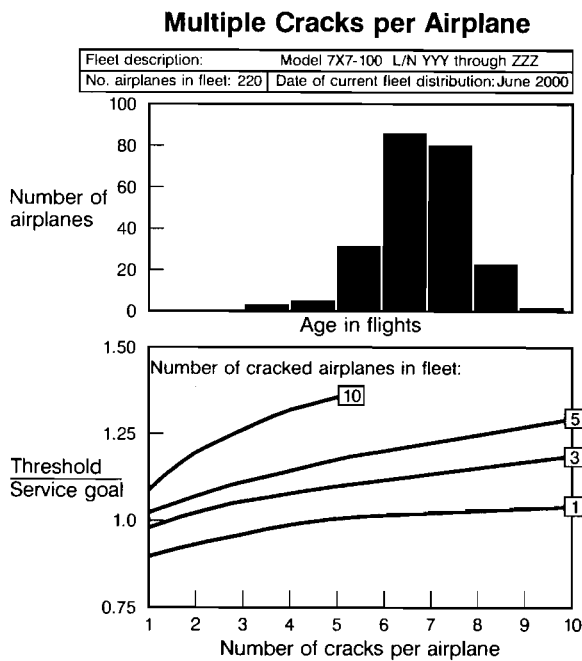
Figure 42. Fleet Service Cracking Estimate Example — Multiple Cracks per Airplane

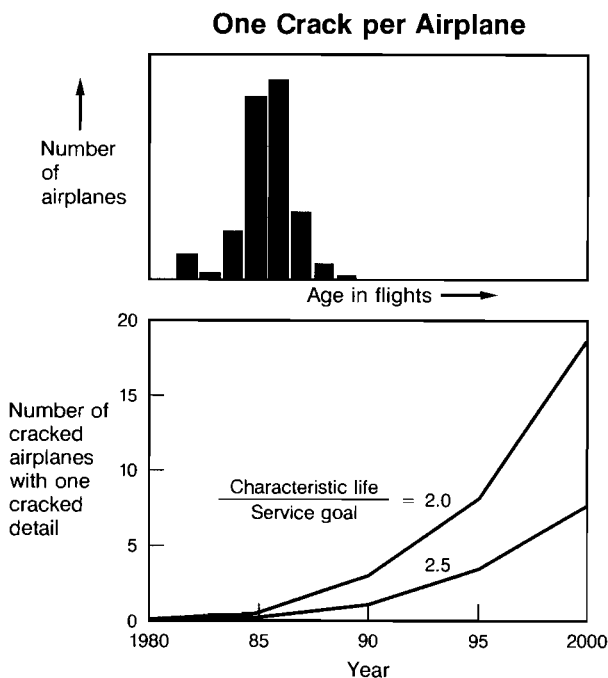
Figure 43. Predicted Fleet Cracking Example — One Crack per Airplane

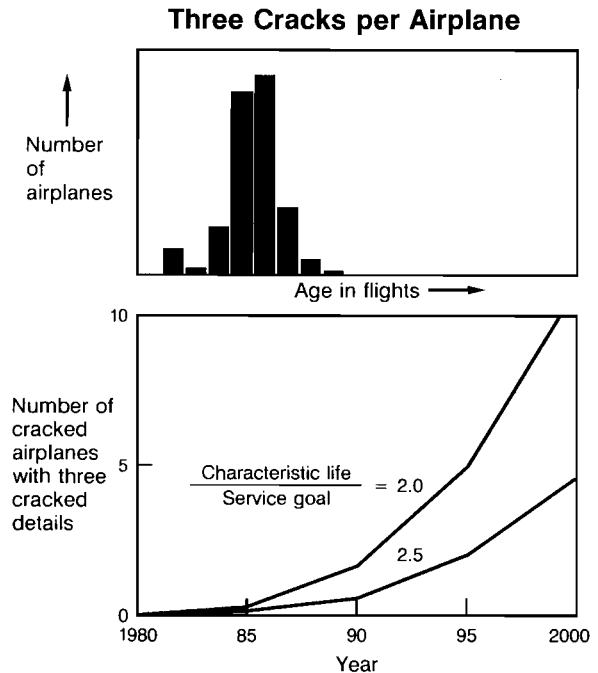
Figure 44. Predicted Fleet Cracking Example — Three Cracks per Airplane

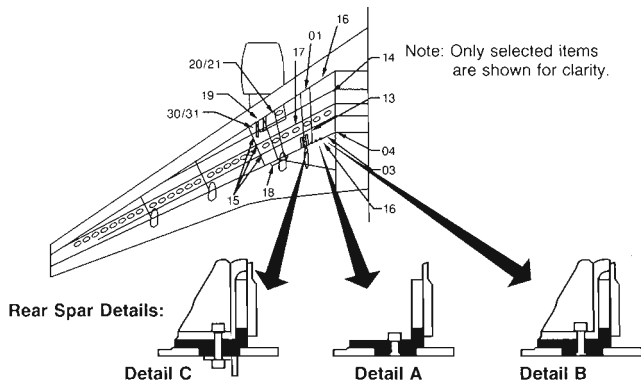
Figure 45. Structurally Significant Item Examples for Wingbox

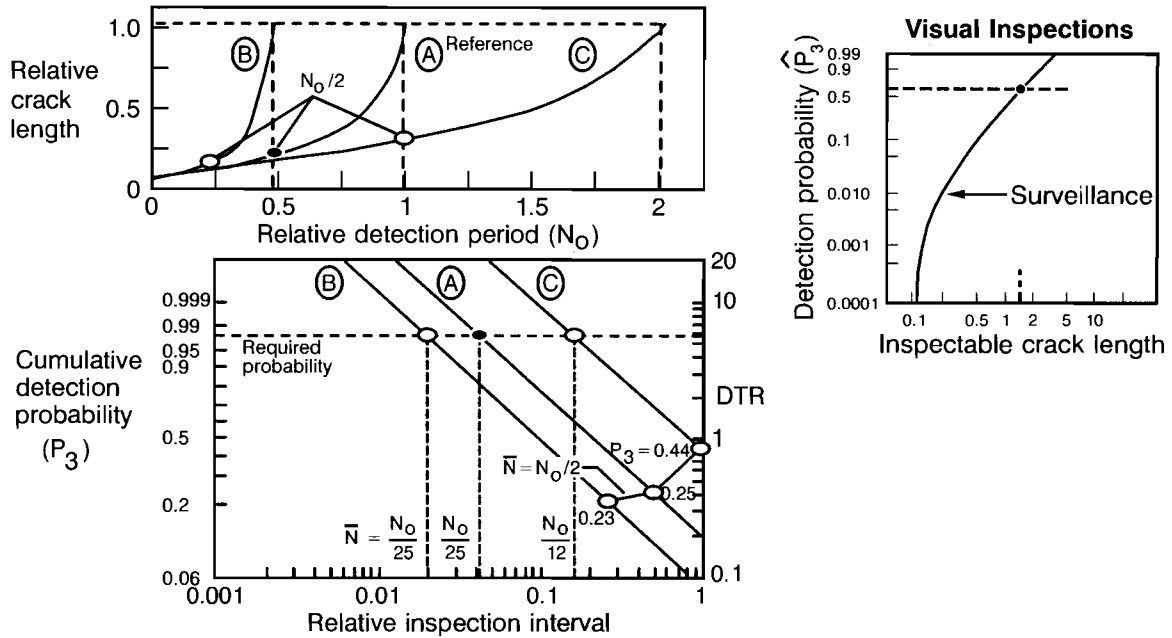
Figure 48. Cumulative Detection Probability — Detection Period Variation

The commonly used practice to set inspection intervals to half the damage detection period fails to provide a quantitative damage detection reliability. Figures 48 through 52 show cumulative damage detection probabilities under different combinations of damage growth characteristics and inspection options compared to results for inspection intervals equal to half the damage detection periods. It is apparent that required detection probabilities result in quite different inspection intervals compared to simple factoring of the detection period by two.

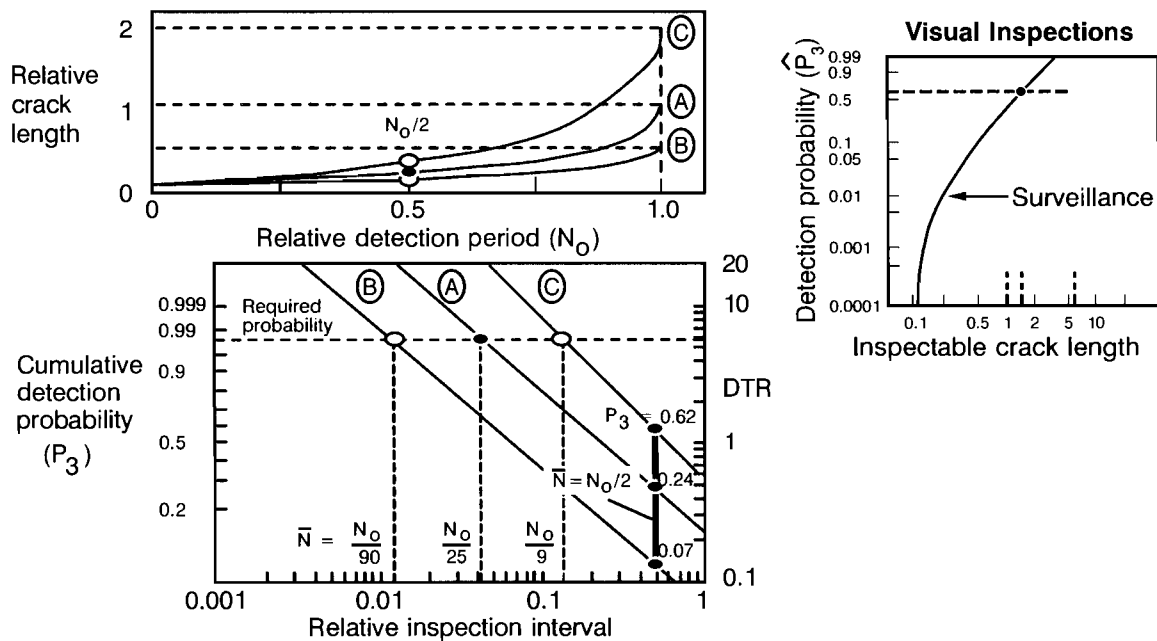
Figure 49. Cumulative Detection Probability — Critical Crack Length Variation

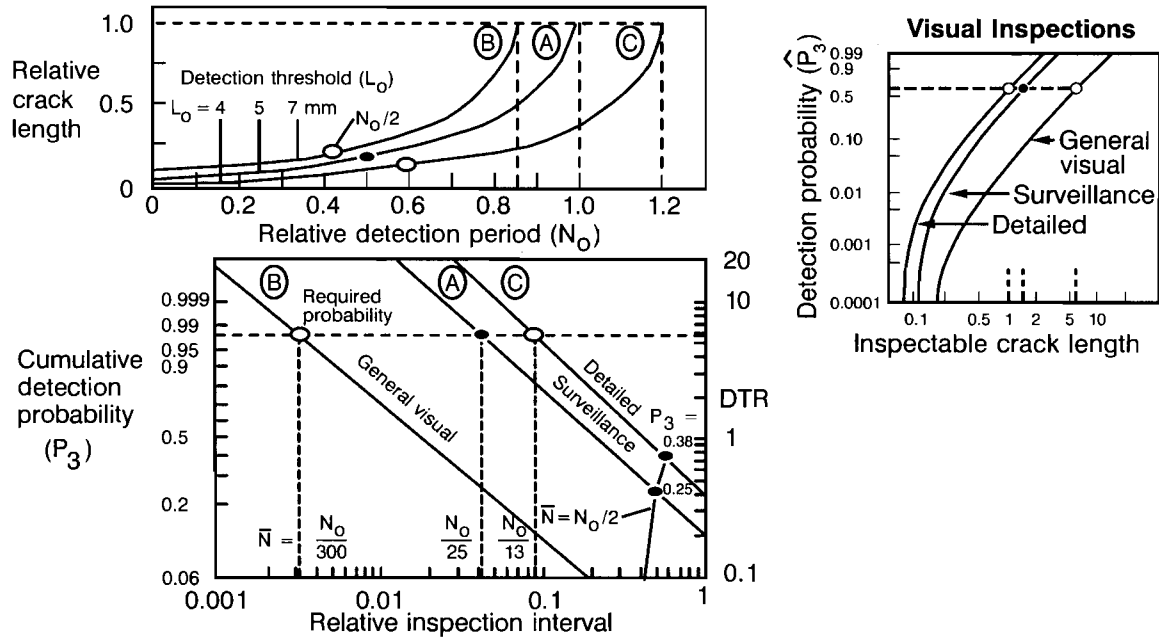
Figure 50. Cumulative Detection Probability — Inspection Type/Detection Threshold Variation

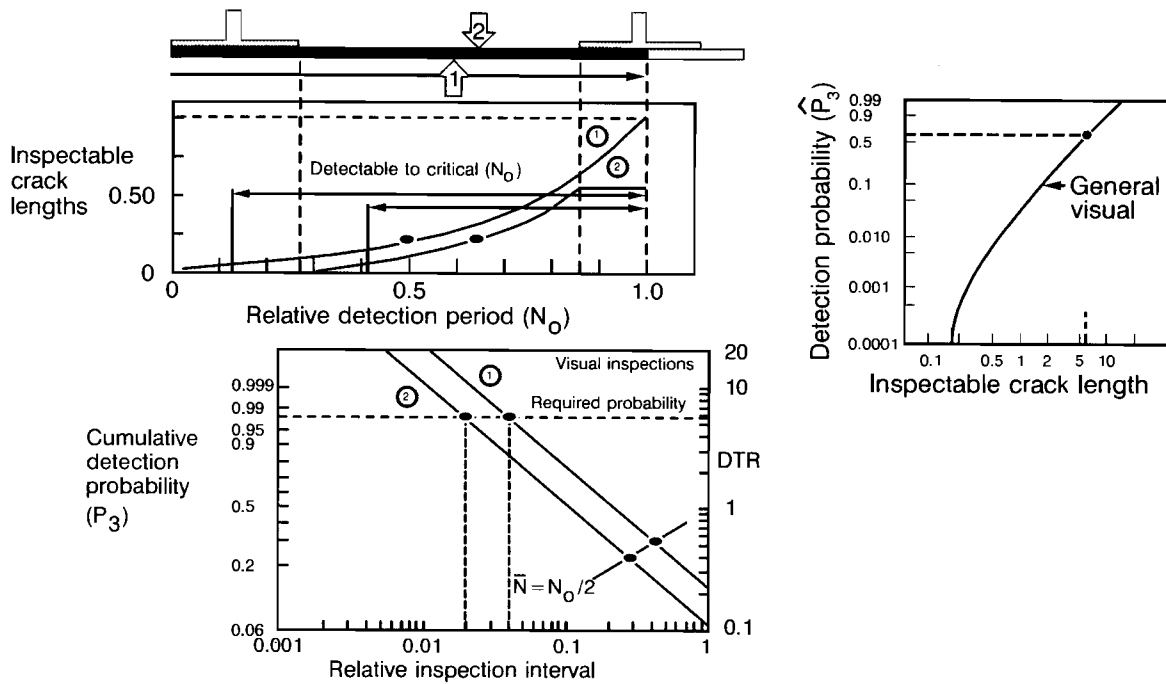
Figure 52. Cumulative Detection Probability — Inspection Direction Variation

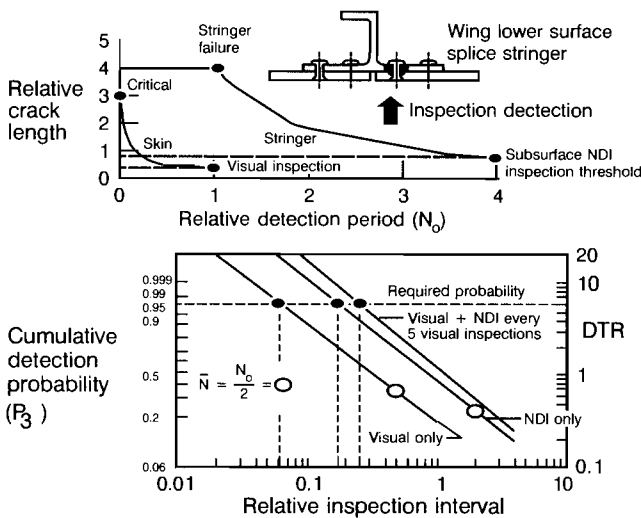
Figure 53. Cumulative Detection Probability — Inspection Method Variation

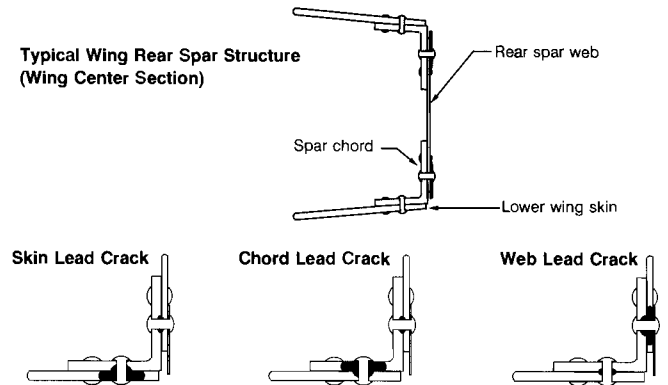
Figure 54. Wing Spar Chord Cracking Pattern Examples

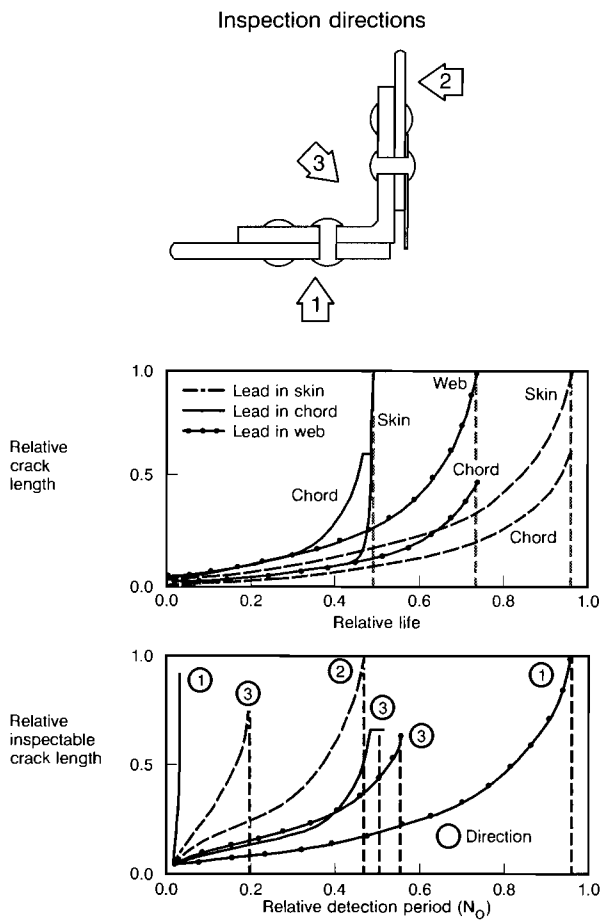
Figure 55. Spar Chord Crack Growth Curve Examples — Wing Center Section

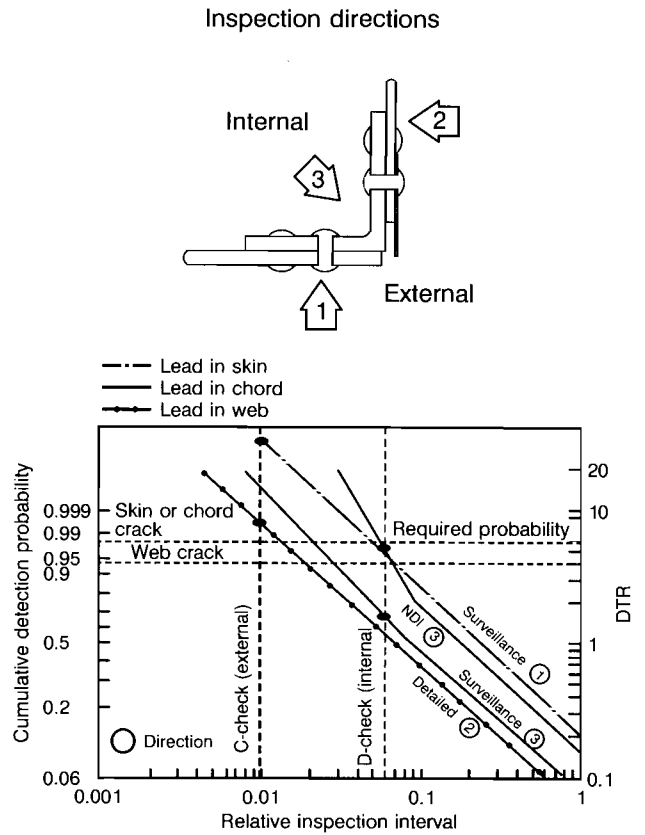
Figure 57. Cumulative Detection Probability — Cracking Pattern/Inspection Direction Combinations

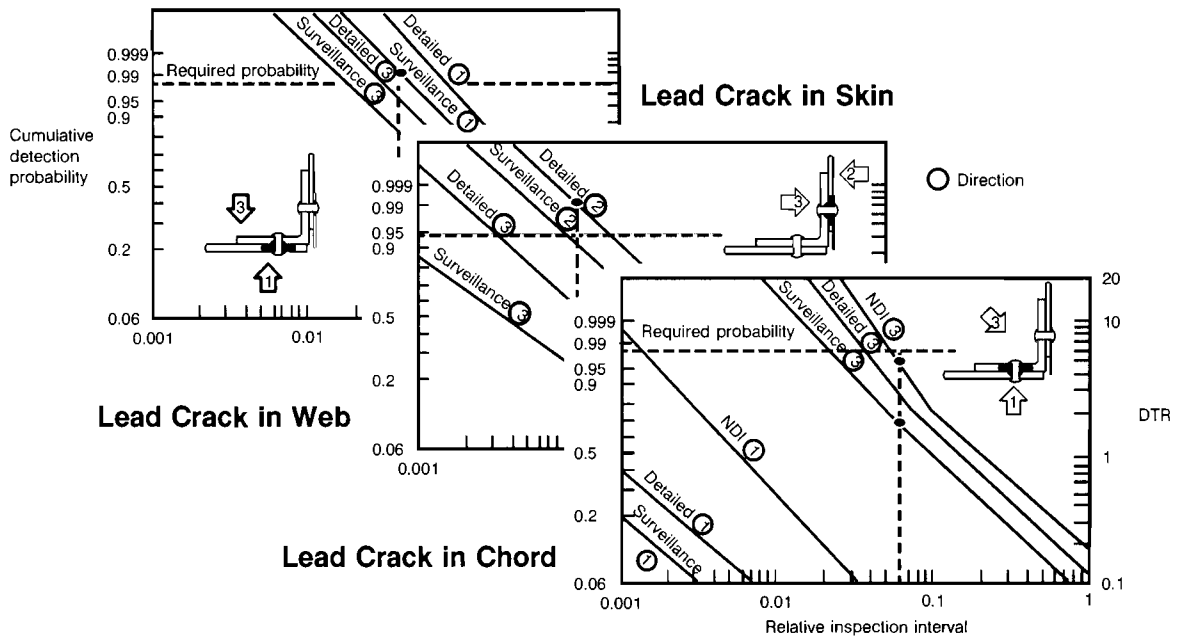
Figure 56. Cumulative Detection Probability — Cracking Pattern Variation

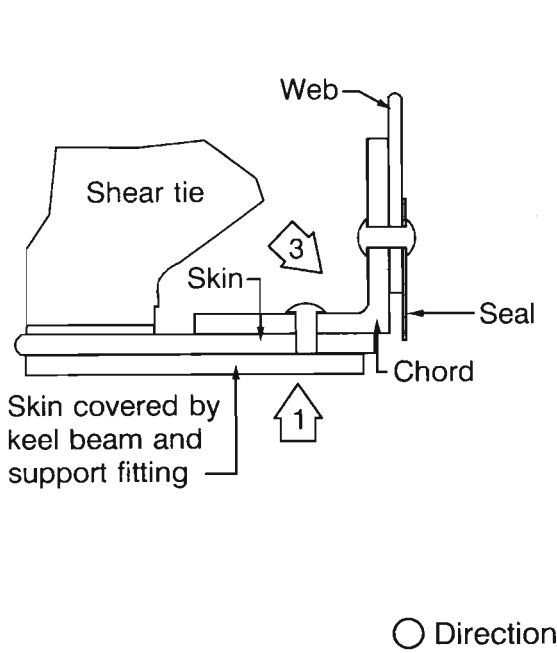
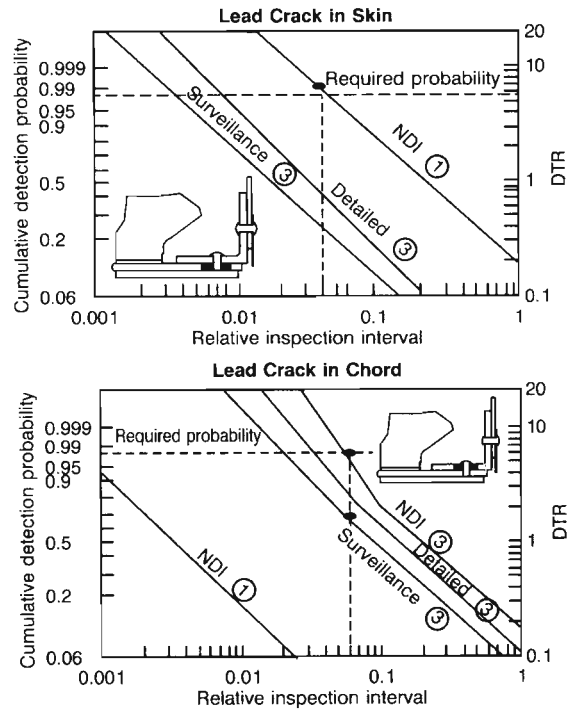
Figure 58. Cumulative Detection Probability Locally Hidden Skin Details

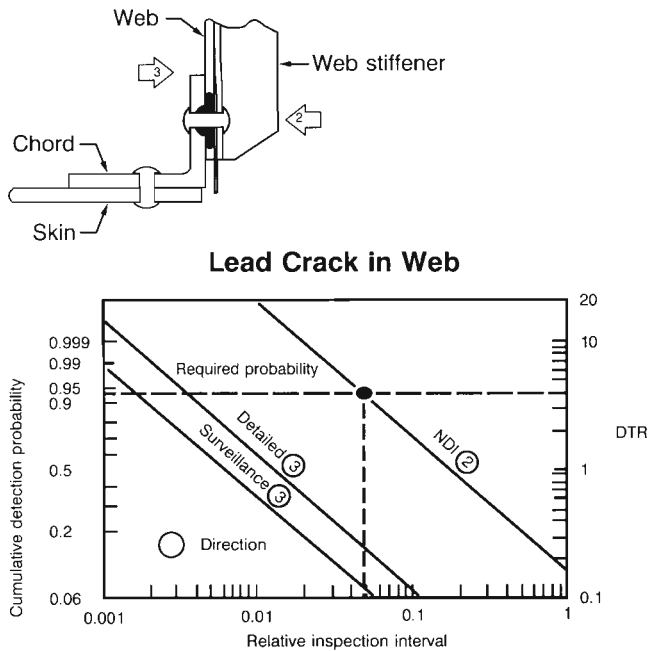
Figure 59. Cumulative Detection Probability Locally Hidden Web Details

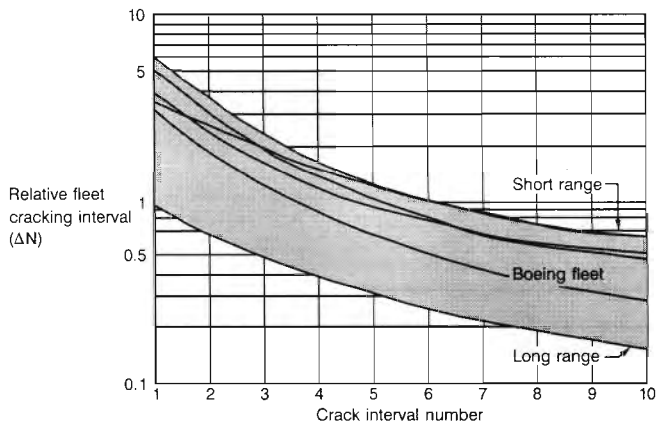
Figure 60. Fleet Cracking Variation —  $\Delta N$

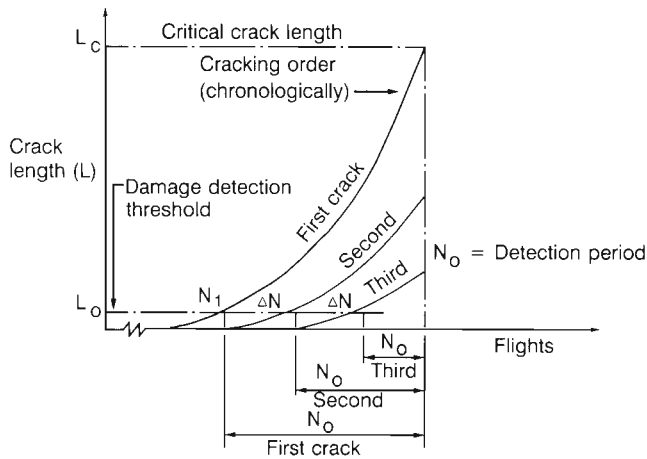
Figure 61. Multiple Cracking in the Fleet

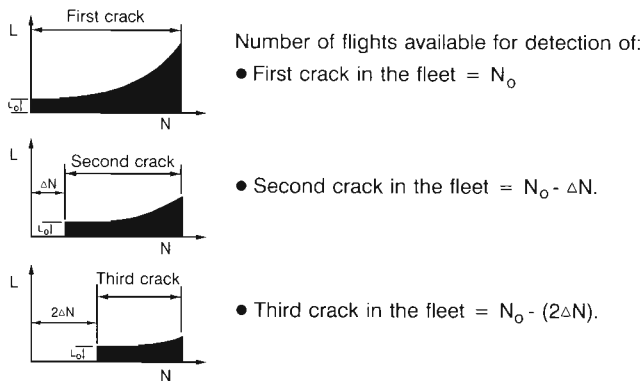
Figure 62. Multiple Fleet Cracking Contributions to Damage Detection

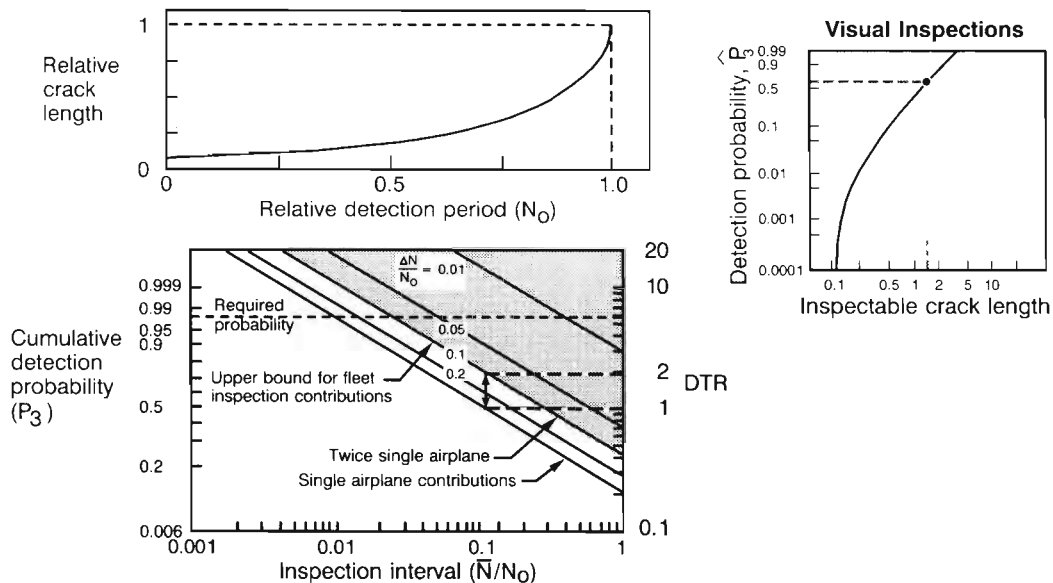
Figure 63. Cumulative Detection Probability — Fleet Inspection Detection Contributions

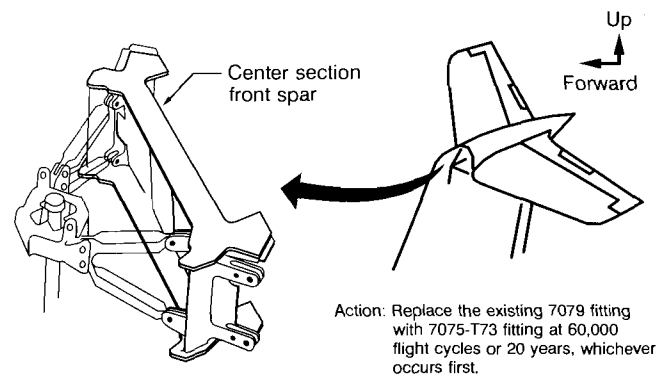
Figure 68. Mandatory Service Bulletin Modification Example for 727 Horizontal Stabilizer Front Spar Center Section With Stress Corrosion Problems

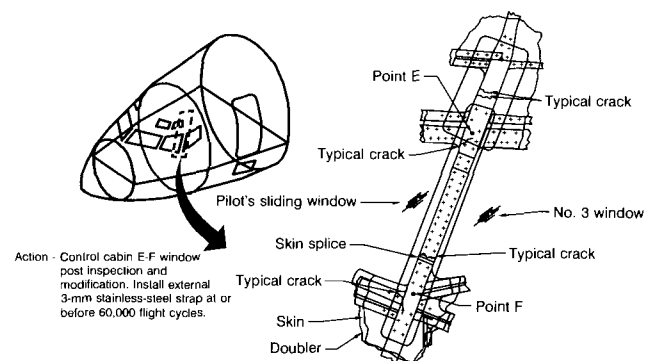
Figure 69. Mandatory Service Bulletin Modification Example for 727 Cab Window Post With Fatigue Problems

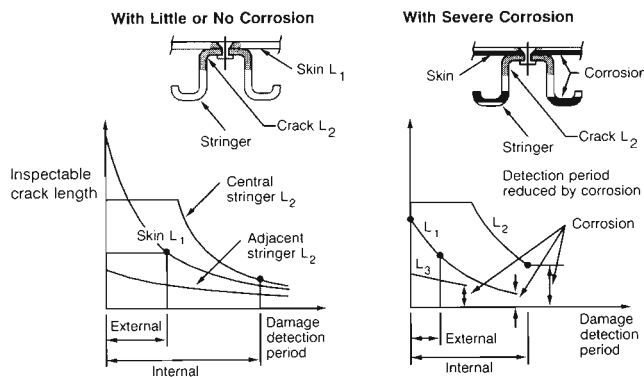
Figure 70. Corrosion Effects on Fatigue Damage Growth

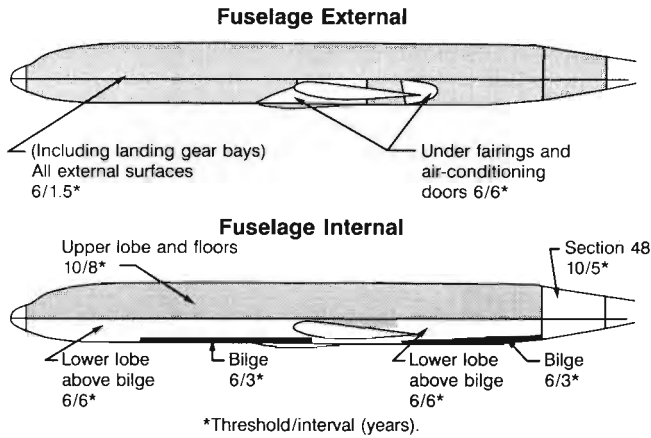
Figure 72. 727 Corrosion Control Program — Example

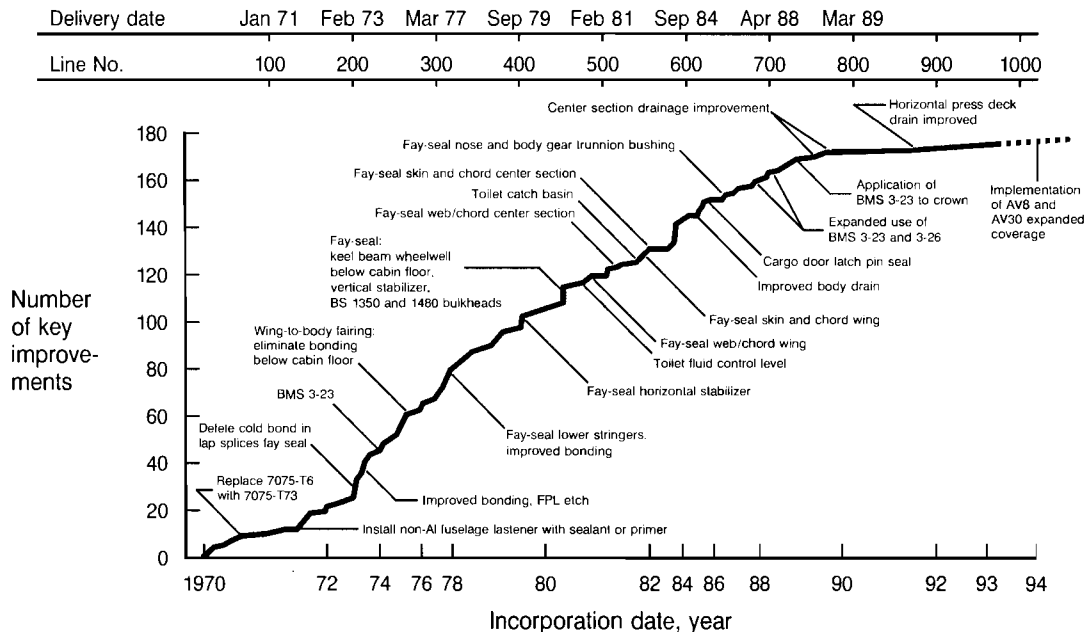
Figure 77. 747 Corrosion Prevention Design Improvement Effects on Service Performance

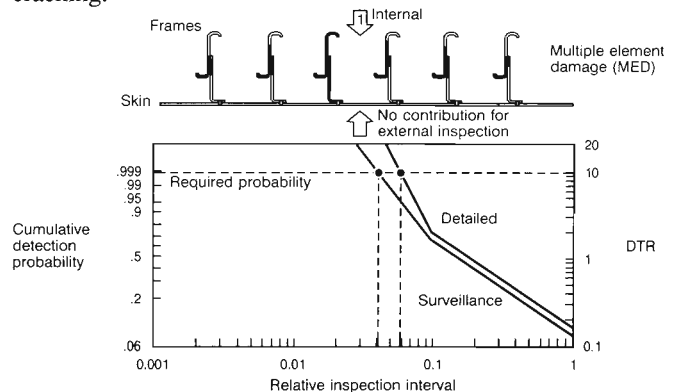
Figure 80. Example of SSID Inspections of Failed Internal Frames
