# **Damage Tolerance Facts and Fiction**

**Ulf G. Goranson  
Boeing Commercial Airplane Group  
U.S.A.**

**14th Plantema Memorial Lecture  
Presented at the  
17th Symposium of the International Committee on Aeronautical Fatigue  
Stockholm, Sweden, June 9, 1993**

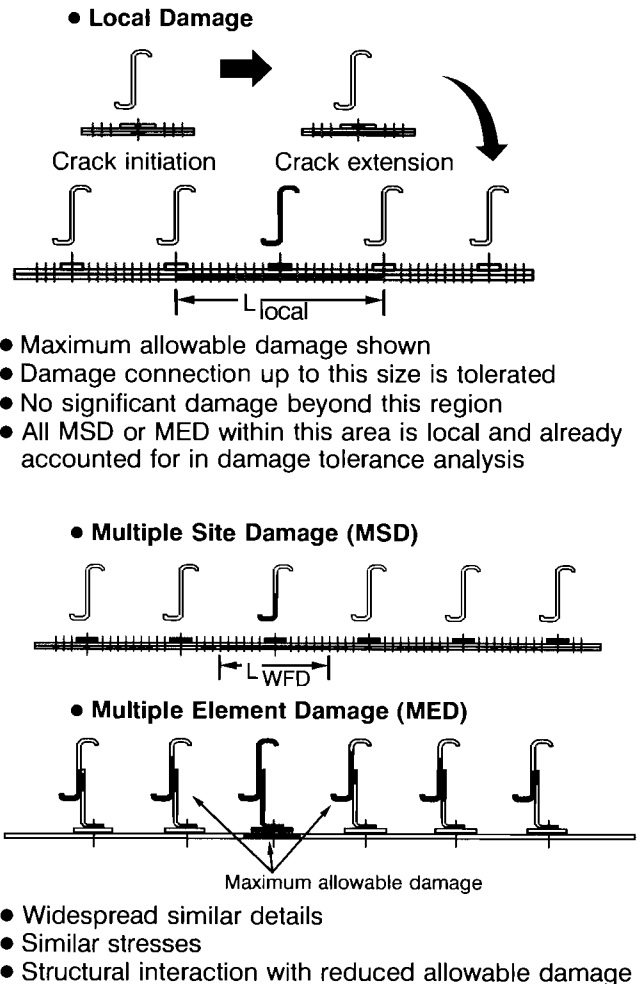
Figure 81. Example of Local Versus Widespread MSD or MED

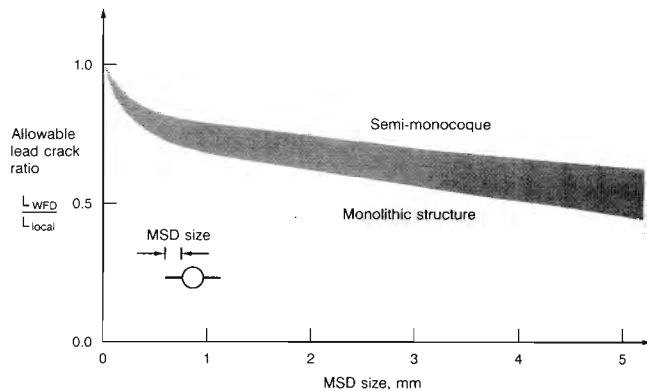
Figure 82. MSD Influence on Allowable Lead Crack Size

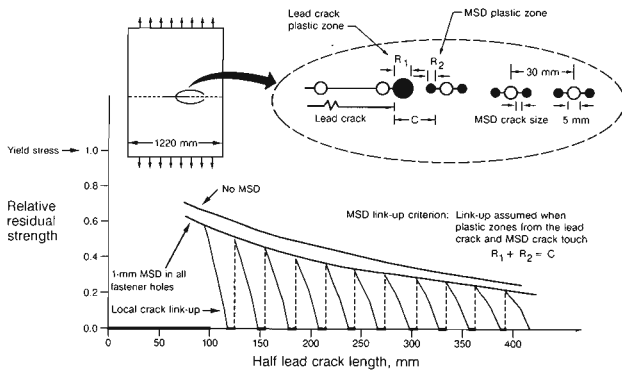
Figure 88. Residual Strength of an Unstiffened Panel Containing MSD at Each Fastener Hole

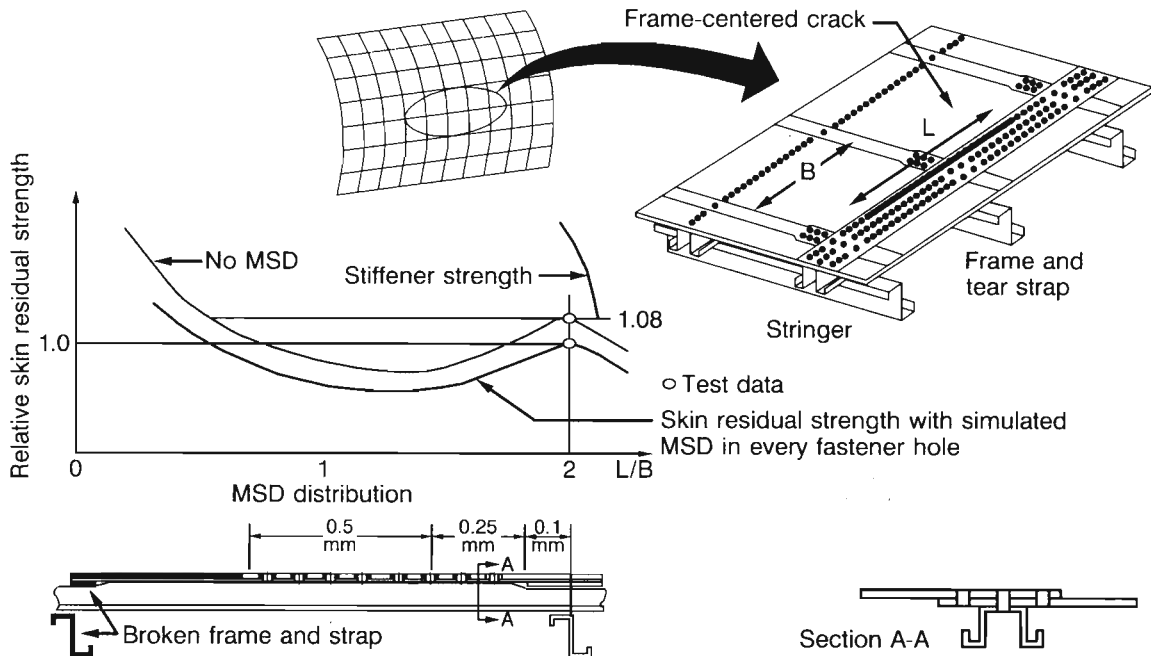
Figure 91. Residual Strength of a Stiffened Panel Containing a Frame Center Crack Along the Lap Joint With Varying MSD Distributions

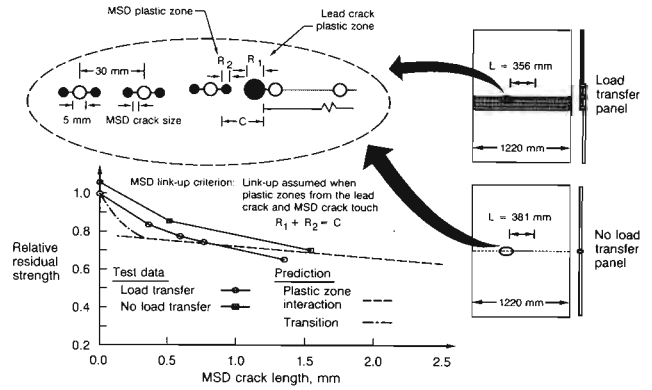
Figure 90. Test and Predictions of Failure Stresses for Flat Panels Containing MSD at Each Fastener Hole

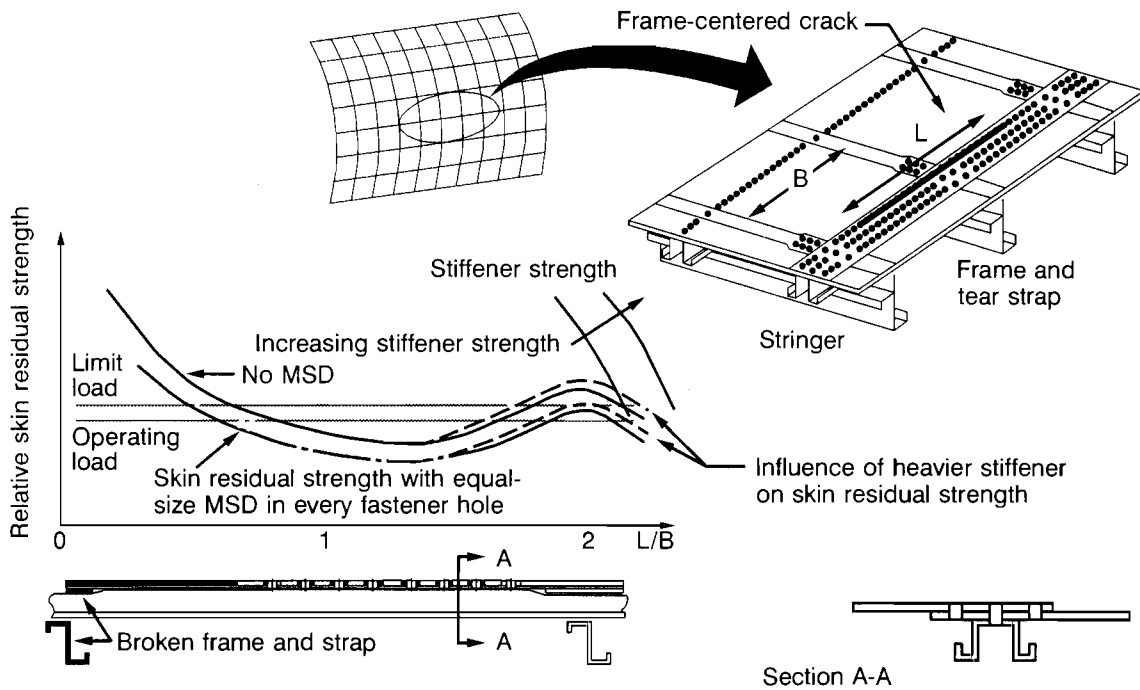
Figure 92. Stiffening Influence on Residual Strength in the Presence of MSD

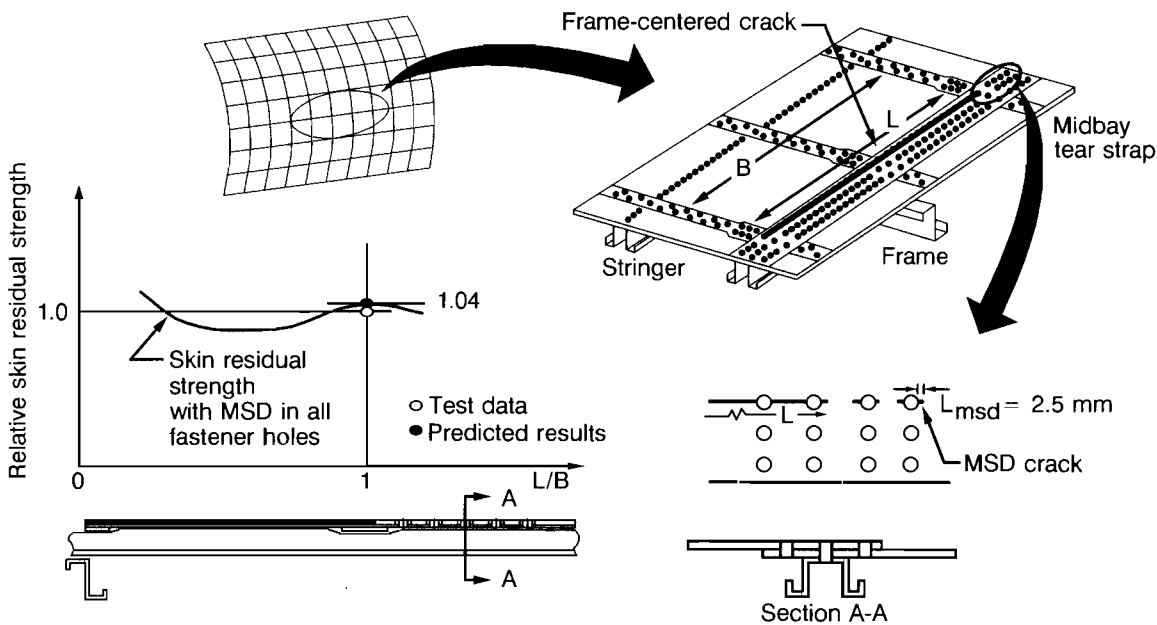
Figure 93. Residual Strength Test/Analysis Comparison for a Stiffened Panel

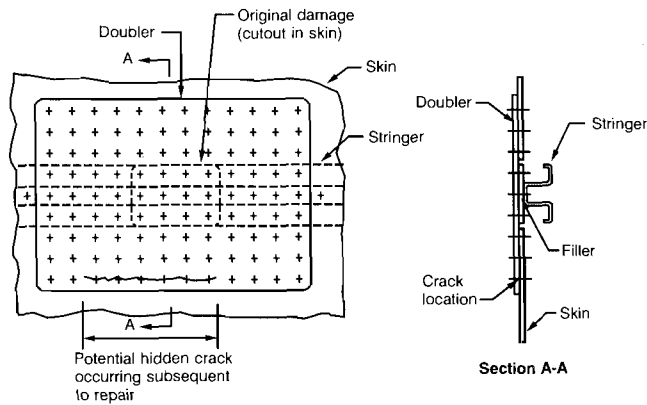
Figure 94. Typical Fuselage External Skin Repair

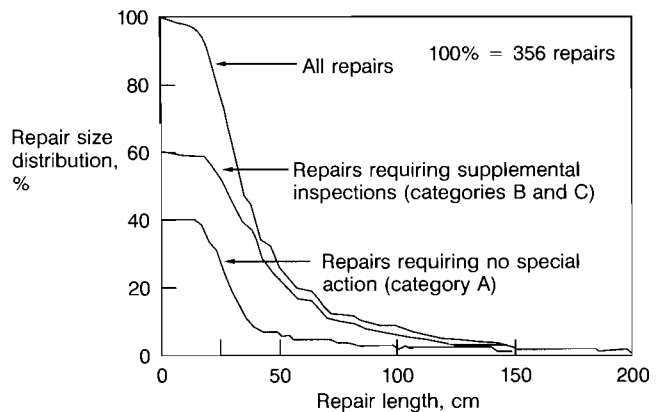
Figure 96. Fuselage Repair Size Distributions Based on Fleet Surveys

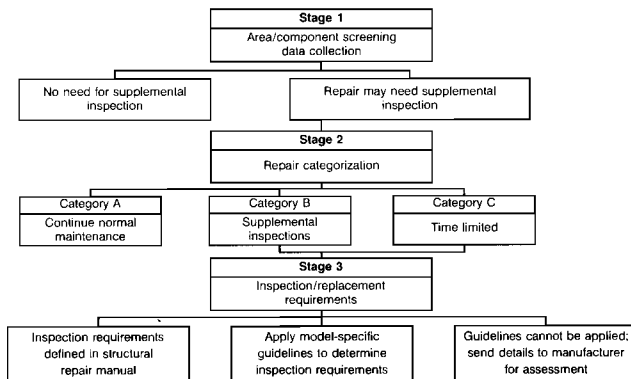
Figure 98. Repair Assessment Stages
